Solar PV facility screening study for public and educational facilities on Antigua and Barbuda

United Nations Electricity Supply Partnership
Technical Report **Final Draft 30 Jan 2018**

EXECUTIVE SUMMARY

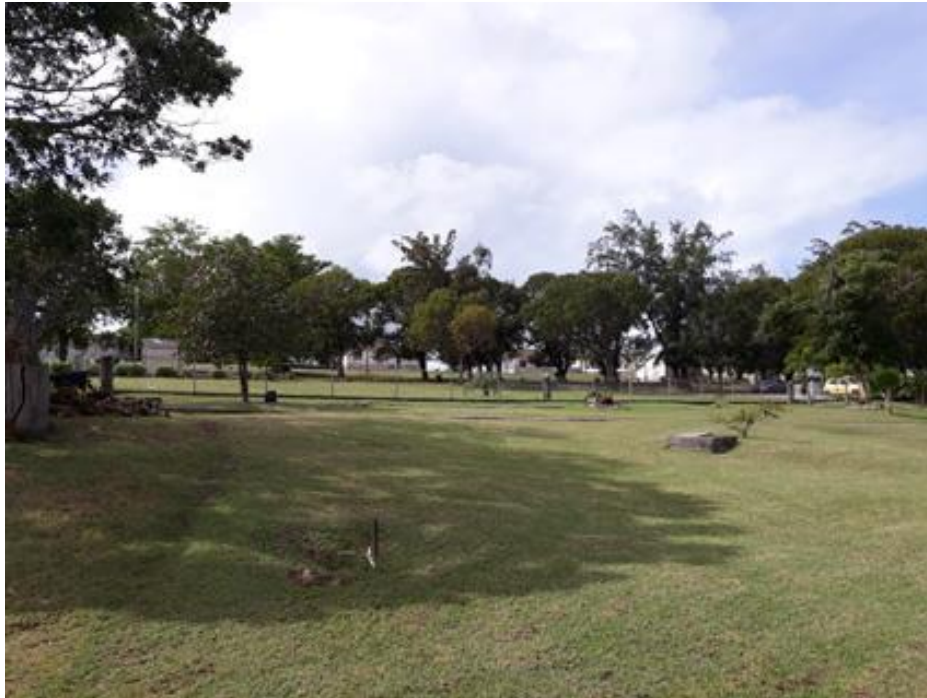
Shading from trees impacting the potential ground mount site at Fiennes Institute

Recommendations A detailed analysis of the shading issues, where present, should be conducted on-site, using a Solar Pathfinder or one of many newer software-based instruments. This equipment will confirm and quantify any shading issues and enable on site design modifications. Note that these modifications may include trimming or cutting down trees in exceptional cases, but this is not always advisable or feasible (for example very tall trees and trees on neighboring properties).

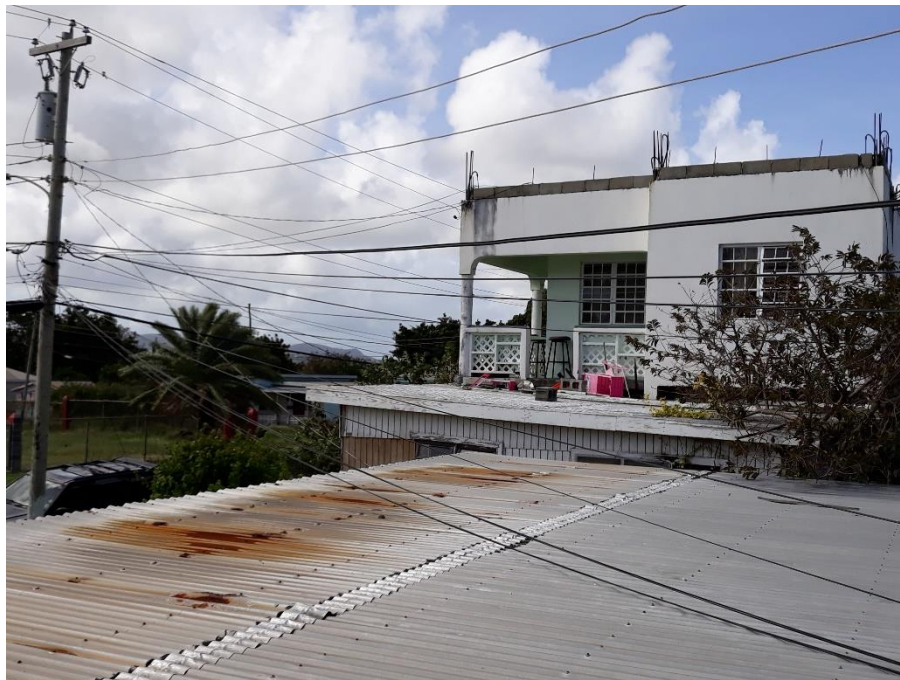
Powerlines lying on the roof of Parhams clinic

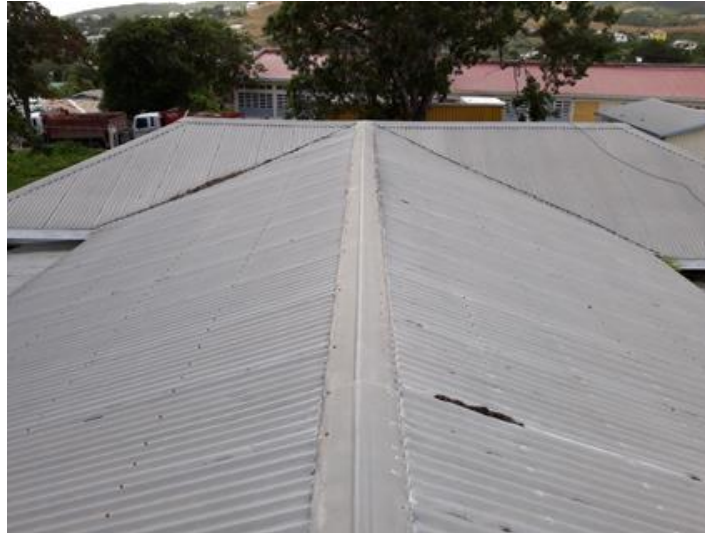
Swetes clinic – A complex roof requiring tilt and shade analysis

Recommendations For hurricane risk management and cost reasons only flush (flat lying) roof installations are recommended (see below). This increases the importance of maximizing the use of south facings and undertaking a tilt analysis to accurately forecast the average annual energy production. In some cases, the reduction in energy anticipated from flush installations should be rebalanced by increasing the number of panels.

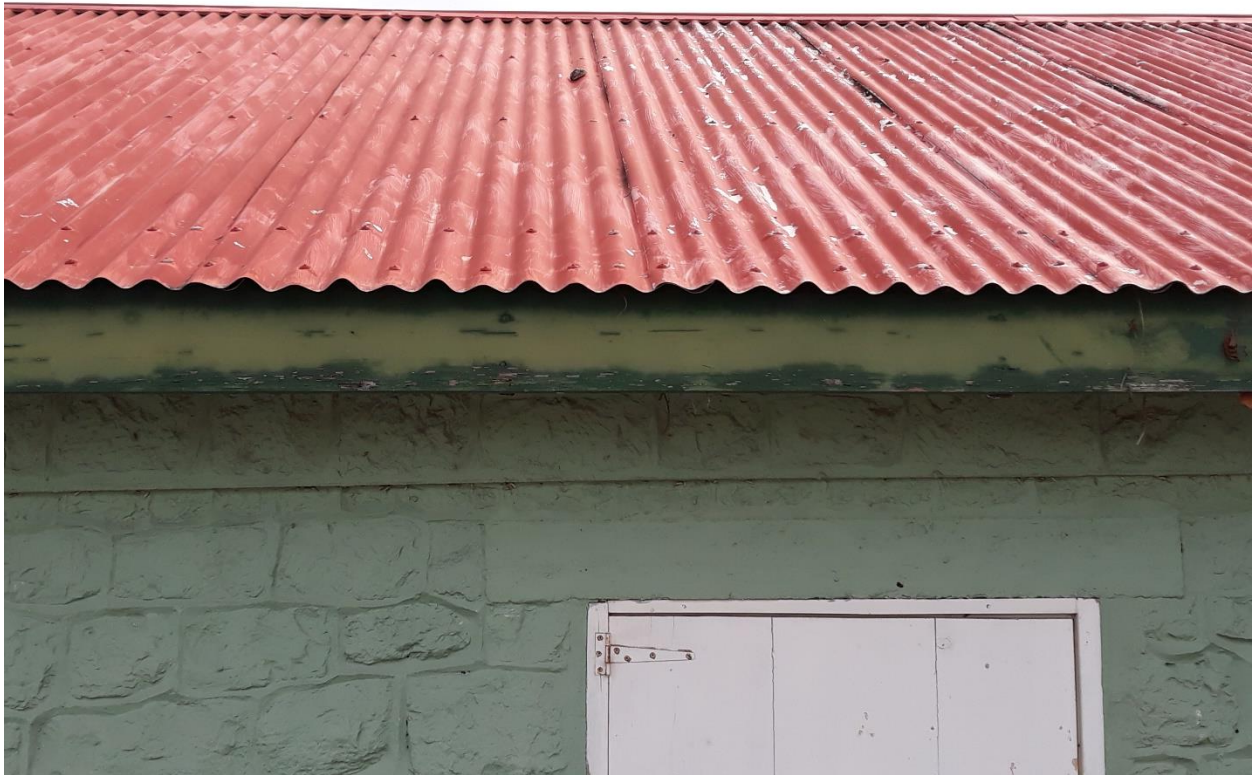
Wilikies clinic – A sheet metal roof in moderate condition but fixed with nails. Also a window shutter suitable for storm protection. Note the stonework on the oldest buildings appears stronger than some new build masonry.

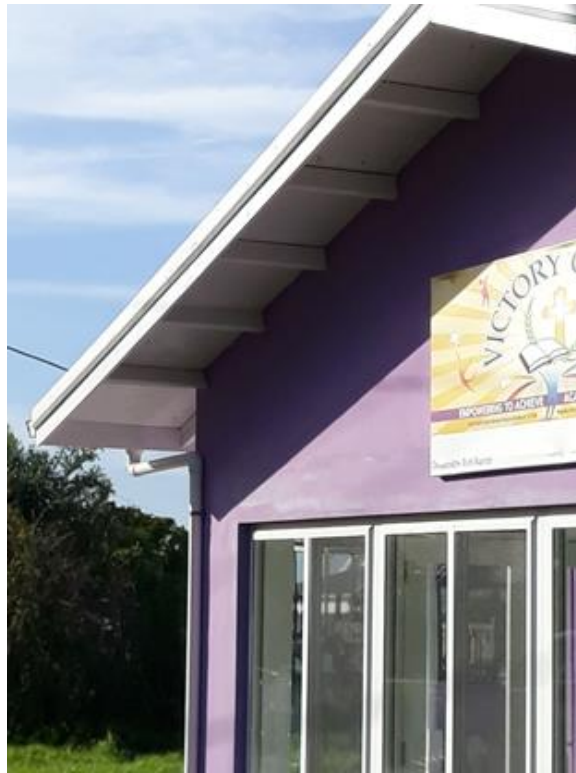
Victory Centre – Recent build showing traverse rafters, ply deck and extended eaves

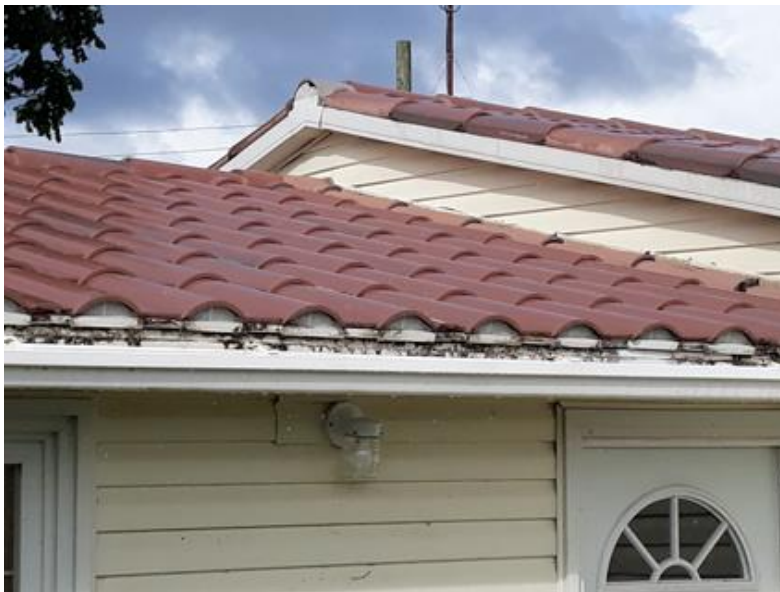
Good Shepherd home for children – A plastic roof on a plastic clad structure: the structure is fully concealed and visible only through partial dismantling.

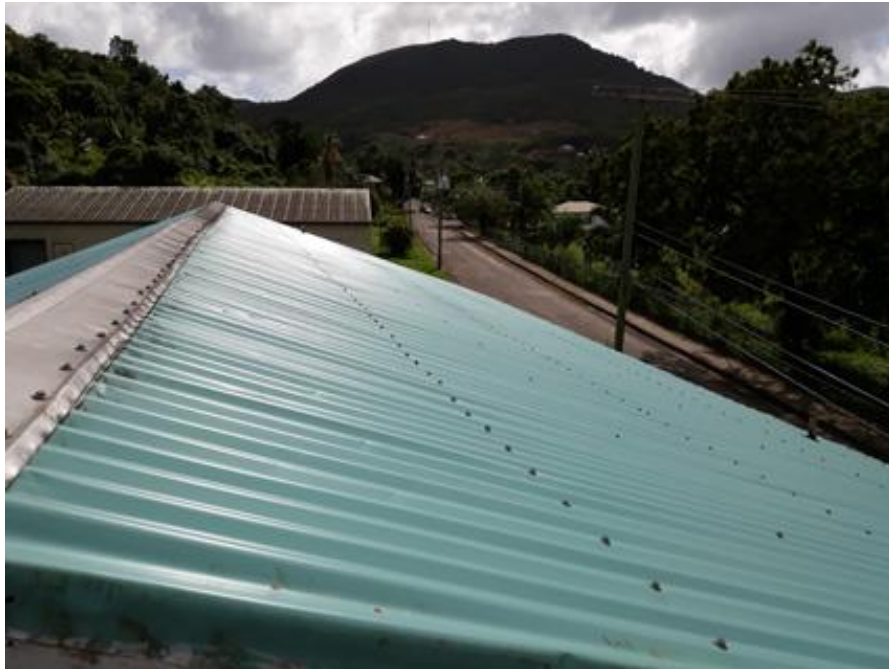
Bendalls clinic – A recently replaced metal roof with roof screws, fixed into battens or traverse rafters and only limited fixings into the pitched rafters. Roof integrity is controlled by the rafters.

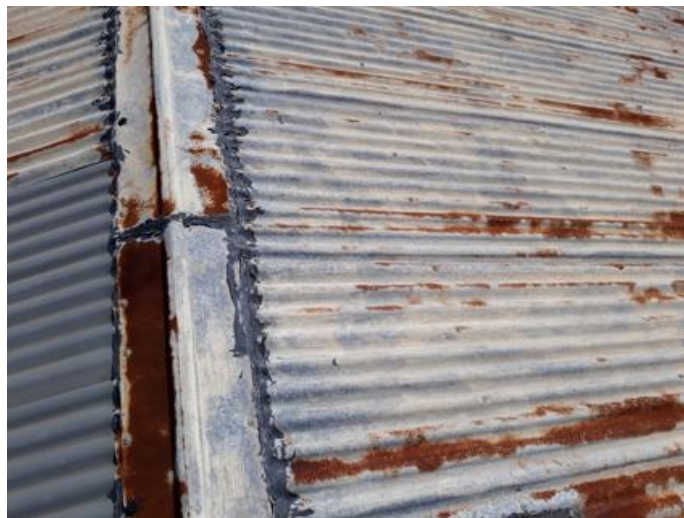
Holberton Hospital Childrens Wing – A degraded roof with weak fixings, degraded caulking and replacement sheets of different ages.

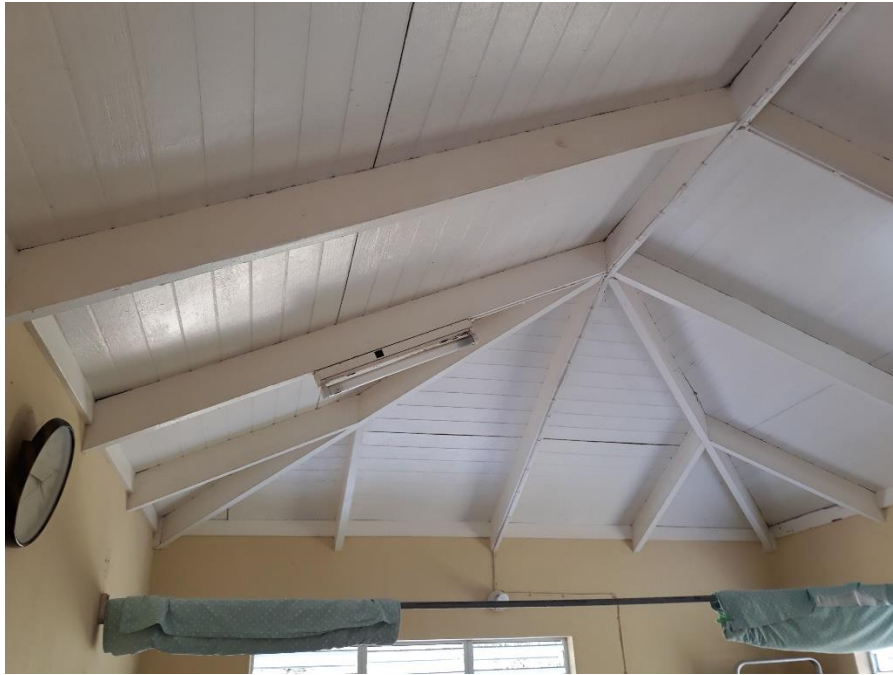
Bolans clinic interior – The absence of an internal ceiling enables a view of the rafters and roof deck planks. Note the rafter inserts into the masonry wall top and the absence of straps and metal fixings at rafter junctions.

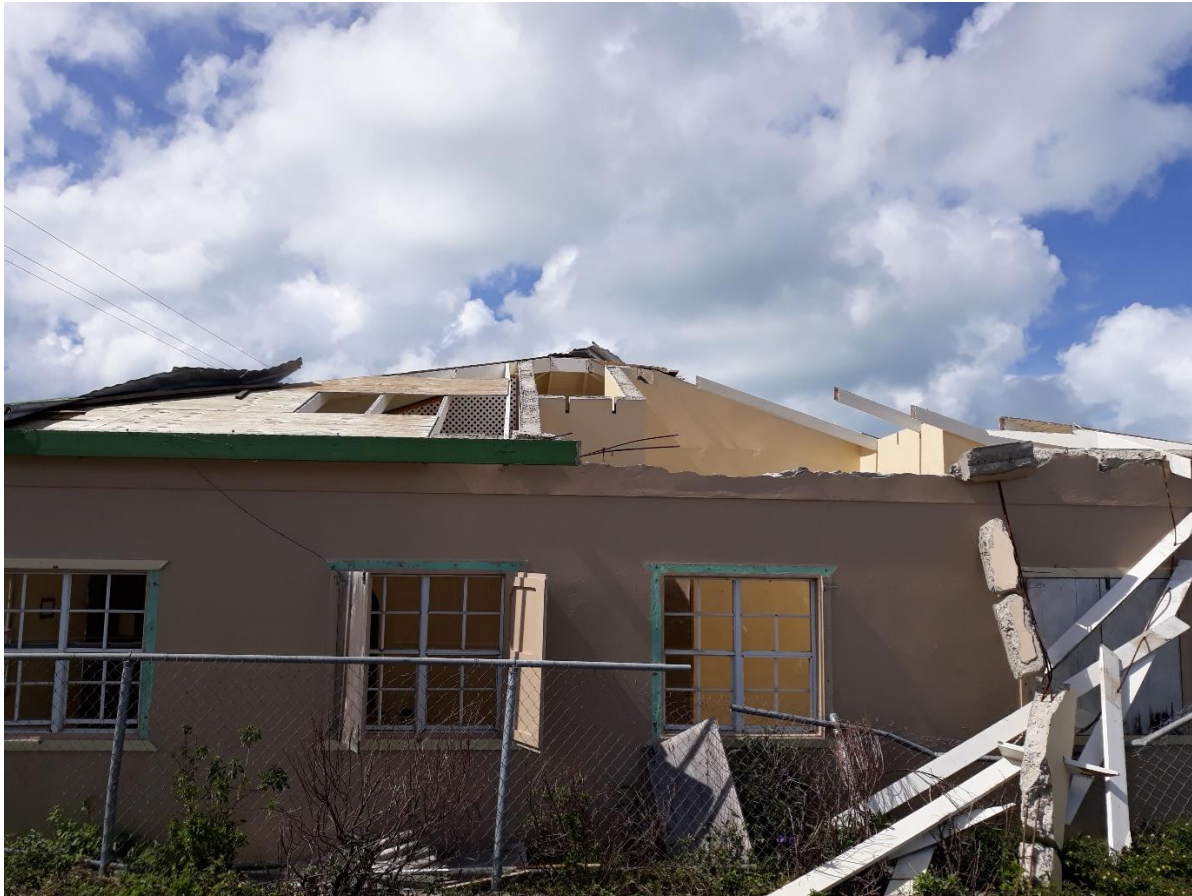
Barbuda Codrington Fire station – Showing all 4 modes of roof failure from hurricane winds. 1. Metal sheet separation from the ply roof deck. 2 Ply roof deck separation from the rafters. 3. Rafters breaking off with sections of roof deck & sheet. 4 Rafters torn out of the walls and pulling out masonry in the process. Note the horizontal reinforcing bar laid in the concrete top of the masonry wall failed in sections - due to a lack of vertical strapping.

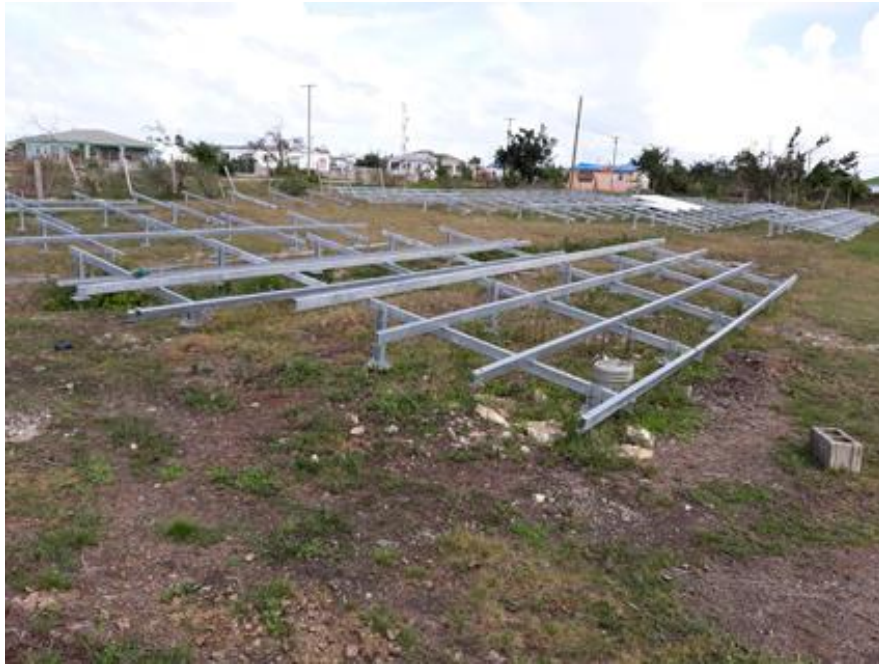
Codrington Power station 100kWp solar array – The hurricane destroyed 95% of the ground mounted panels

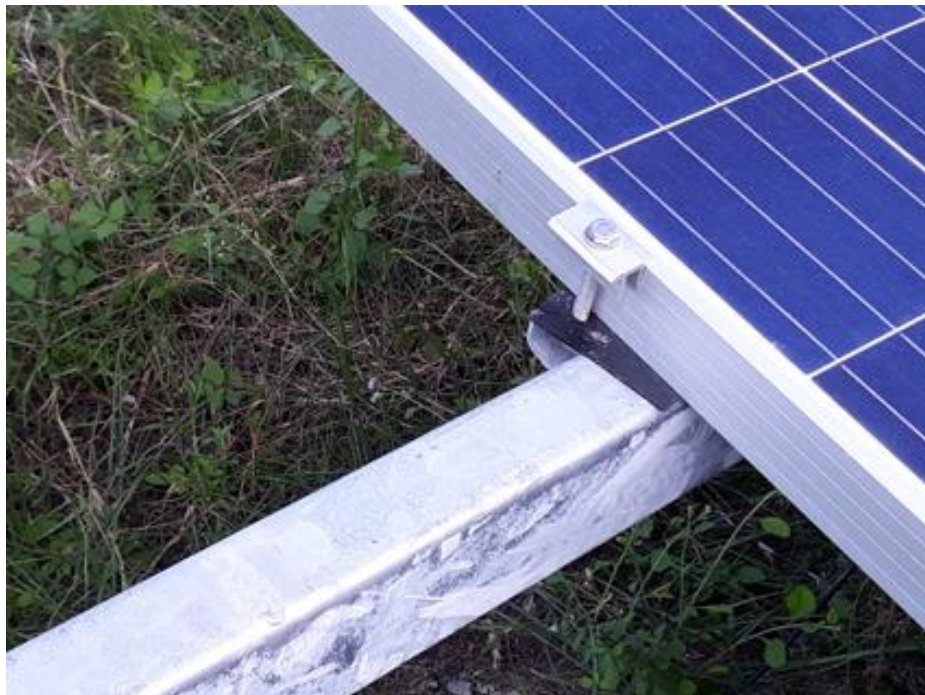
Codrington array – The alloy fixings between the PV panels and the racks can be the weakest point for wind vulnerability

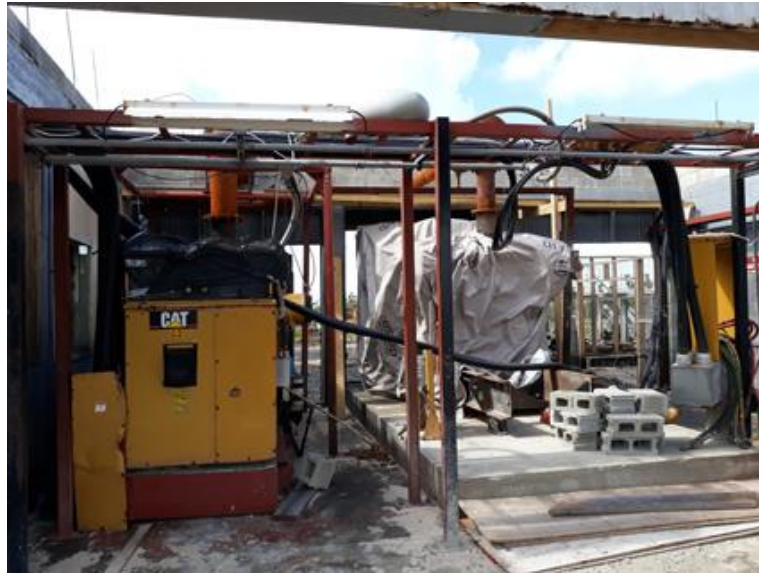
Codrington power station – The generator house was deroofed. Critical infrastructure such as this should be strongly hardened against hurricane winds

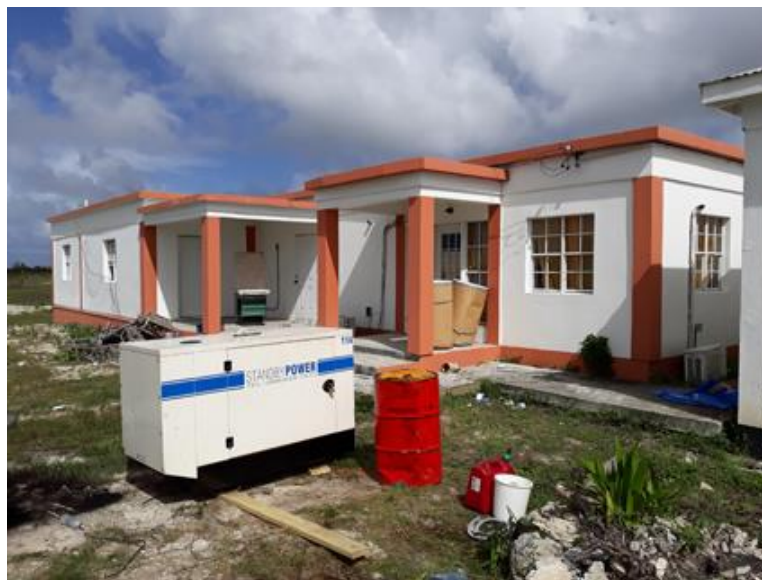
Codrington Hospital – Parts of the hospital had flat concrete roofs, which were not affected by the hurricane

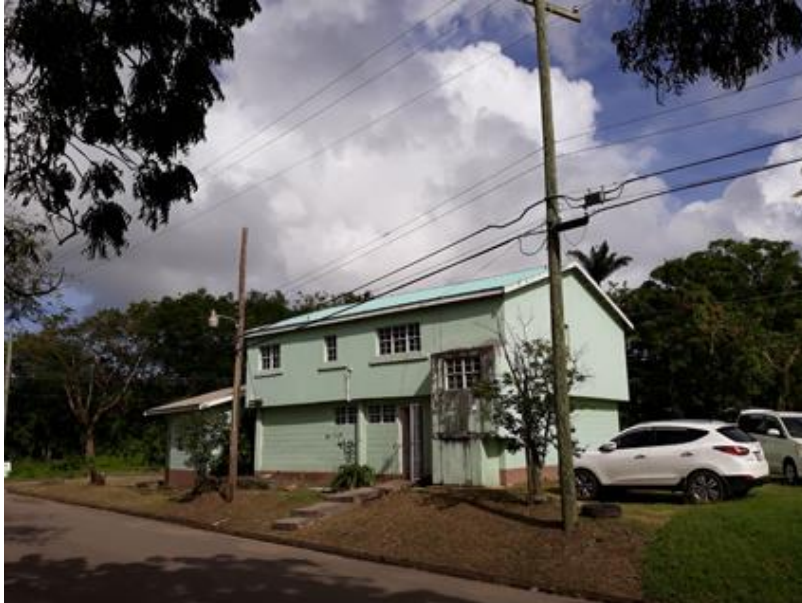
Summary Bendalls clinic is a small freestanding masonry building with 2 storey and 1 sections and a pitched timber and sheet metal roof. Its age is in excess of 20 years and its condition overall is moderate. It is in a flat rural area with low wind exposure. The 2nd storey sheet metal roof is in good condition with roof screws. The flood risk is assessed as moderate to low – the building is on a very gentle slope 2m above a valley floor.

Recommendations Routine rooftop installation.

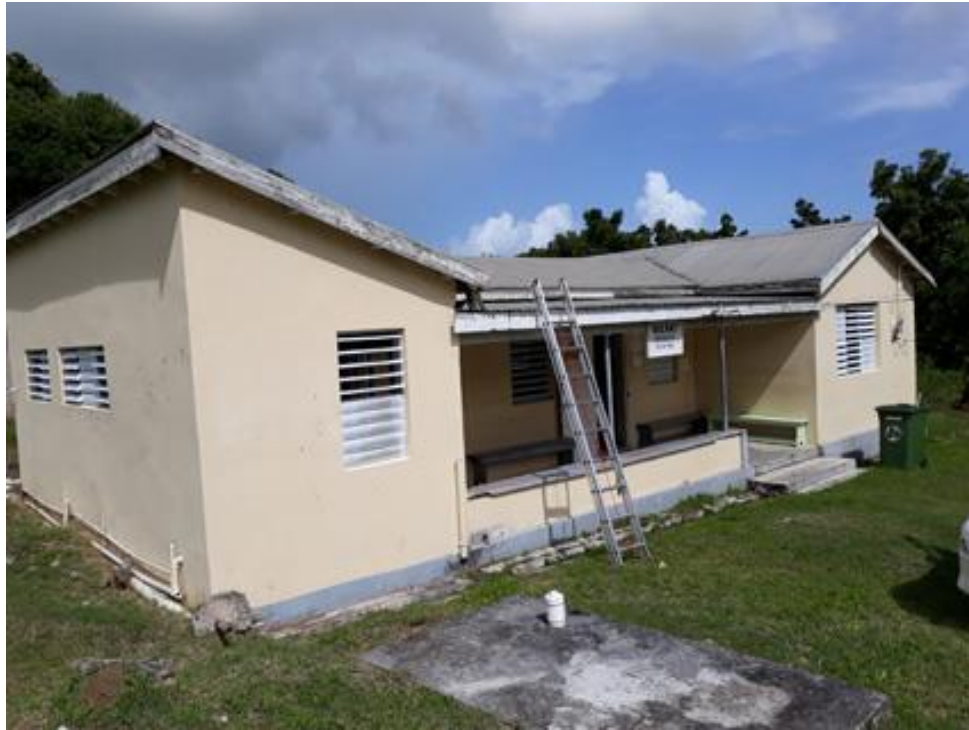
Summary Bolans clinic is a small freestanding 1 storey masonry building with a pitched timber and sheet metal roof. Its age is in excess of 30 years and its condition overall is fair to poor. It is in a hilly area with moderate wind exposure. The roof sheet metal is in a fair condition with a combination of roof screws and nails. The timber structure is notably aged with widely spaced rafters. The flood risk is assessed as low – the building is on a hilly area with only a very small catchment upstream and adequate drainage.

Recommendations Rooftop installation. Invest in roof strengthening and sheet replacement.

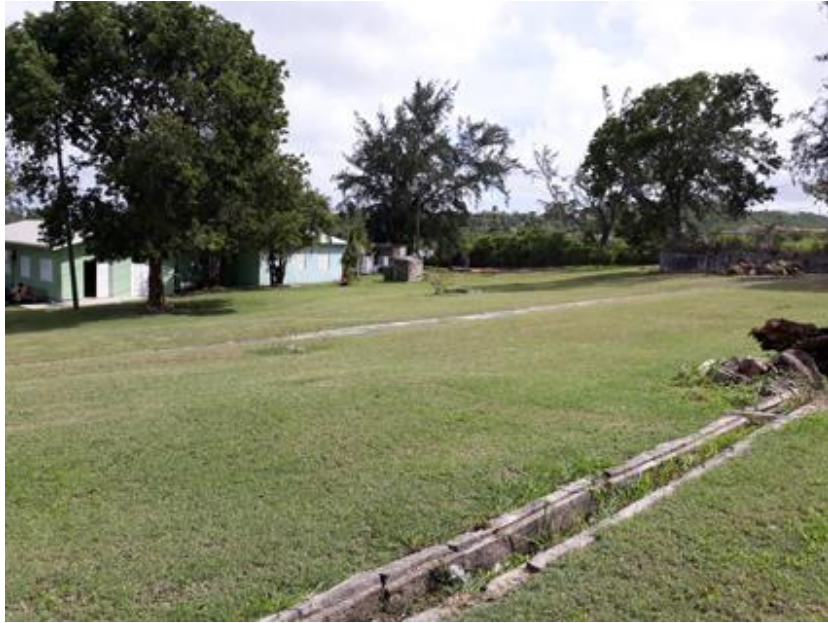
Fiennes Institute – Proposed ground mount site

Summary Fiennes Institute is a collection of 1 storey buildings in a grassed compound with many trees. All of the buildings have major shading issues and are unsuitable for rooftop installations. A relatively open grassed area is available for a ground mounted array, within the fence, whilst a more open area is noted just uphill to the southeast. The flood risk is assessed as low – the building is on a side of hilly area with only a very small catchment upstream and adequate drainage.

Recommendations Ground installation. If possible, move the array location uphill, analyze shade in detail and move the fence and trim/remove trees as needed.

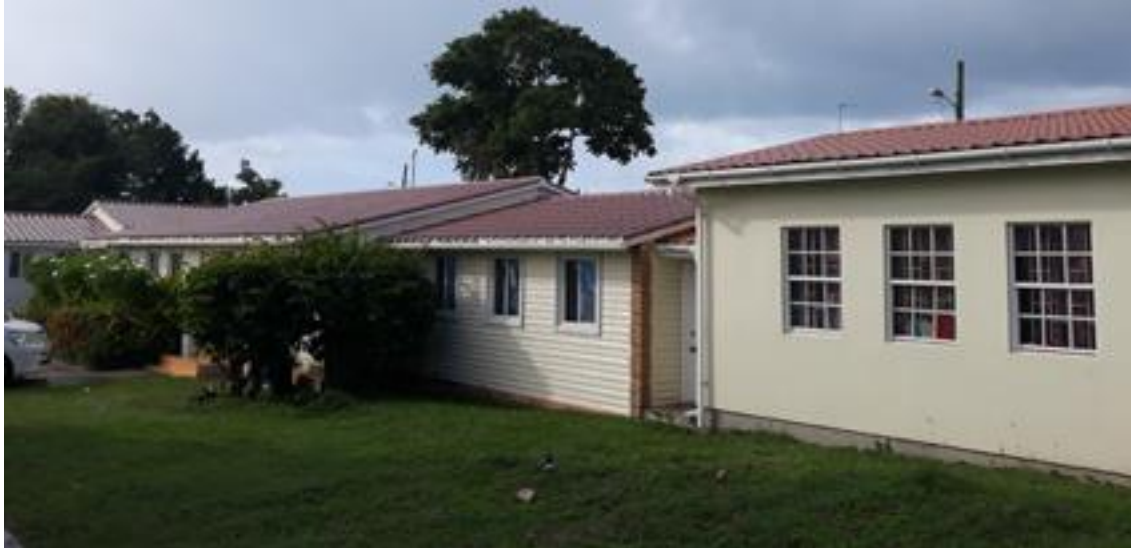
Good Shepherd Home for Children – showing the plastic roof tiles

Summary The Good Shepherd site is in the suburbs of St Johns and has two buildings: A church and the home itself. The church has steeply pitched roof with east and west faces and is not very suitable for PV installation.

Recommendations Rooftop installation. Anticipate complications and potential cost escalations linked to the need to remove and reinstall the roof to fix the PV mounts to the rafters.

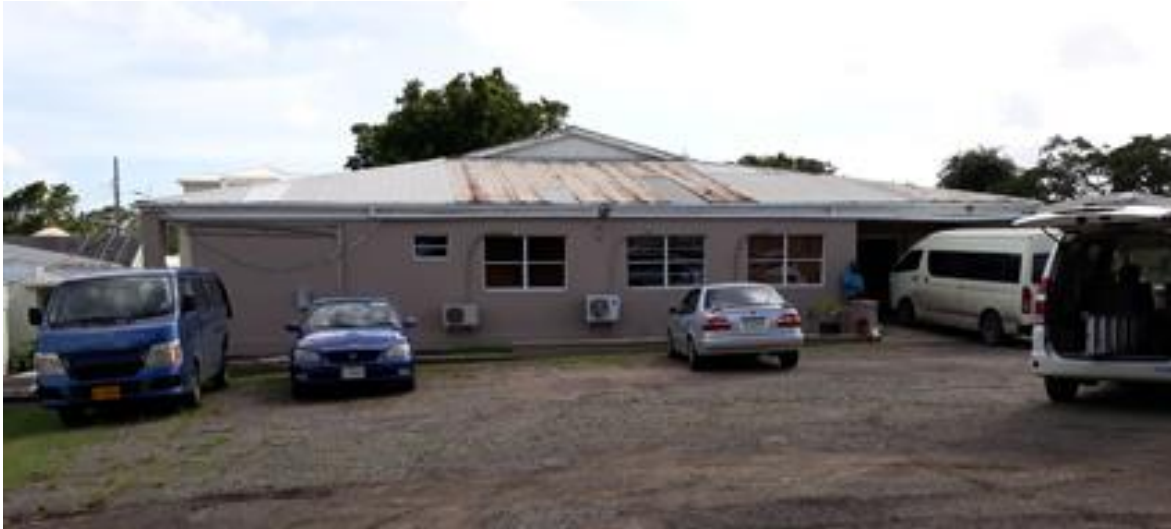
Holbertons Hospital – Childrens Ward

Summary The Holbertons Hospital Childrens Ward is a large freestanding 1 storey masonry building with a pitched timber and sheet metal roof. Its age is in excess of 30 years and its condition overall is fair. It is on a ridgetop with high wind exposure. The roof sheet metal is in overall poor condition, with extensive corrosion and several replaced sections. The flood risk is assessed as very low – the building is on a ridge

Recommendations Rooftop installation. Invest in roof sheet replacement and in roof strengthening for wind resistance. Shade analysis for any installation on the south pitch.

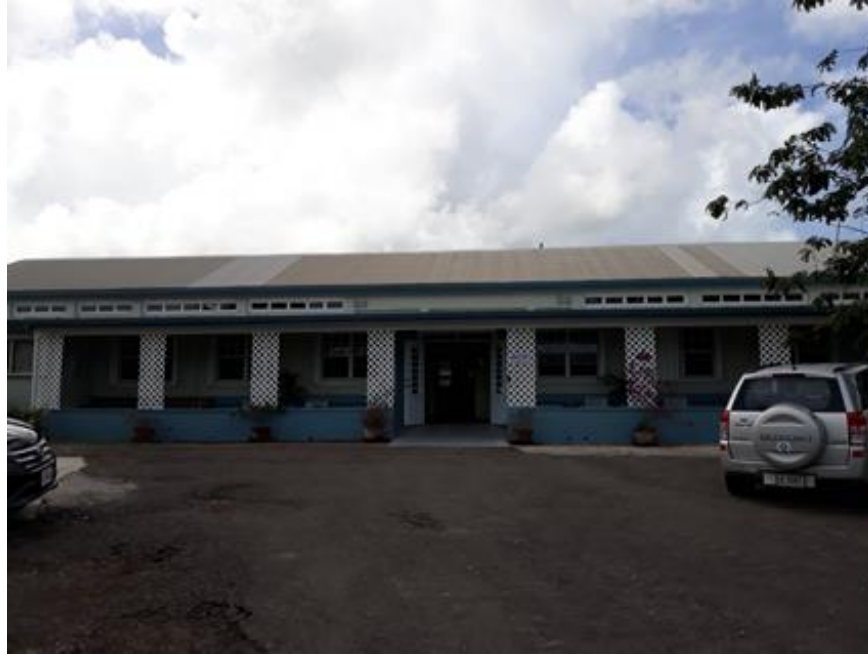
Holbertons Hospital - Hospice

Summary The Holbertons Hospital Hospice is a large freestanding 1 storey masonry building with a pitched timber and sheet metal roof. Its age is more than 30 years and its condition overall is good, due to a recent renovation. It is on a ridgetop with high wind exposure. The sheet metal is in overall good condition. The flood risk is assessed as very low – the building is on a ridge.

Recommendations Rooftop installation. Invest in roof strengthening for wind resistance.

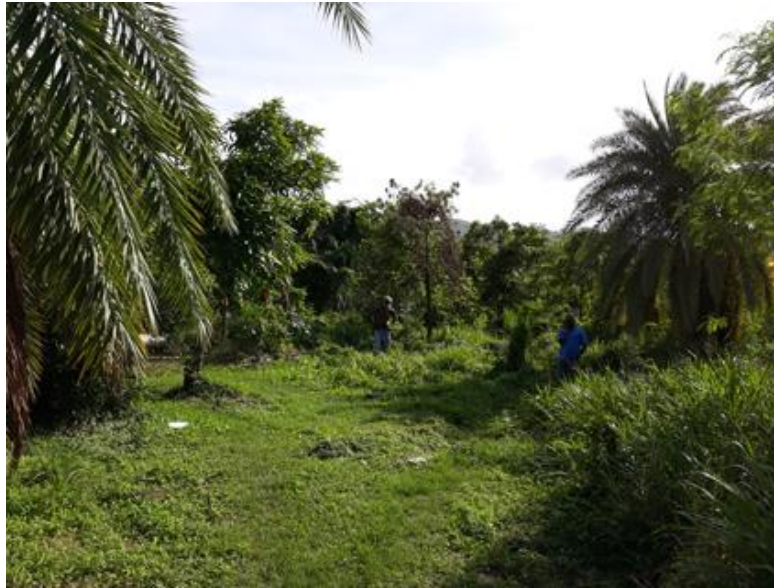
Nyahbinghi – Potential ground mount with tree shading issue

Summary The Nyahbinghi Theocracy school site is in a relatively collection of very small buildings in an orchard and market garden setting. All buildings noted have major shading issues and are unsuitable for rooftop PV installation. Any low-level ground mount in the central community space would also be problematic due to tree shading. More open ground is available in the garden area to the south, however this would still have shading constraints, as well as long wiring runs.

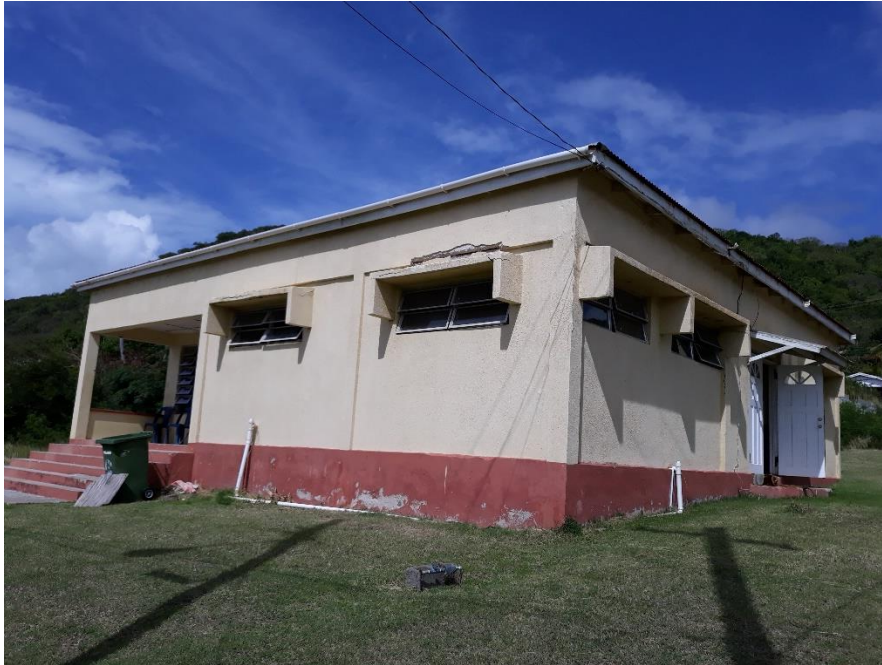
Old Road clinic

Summary The Old Road Clinic is a small freestanding 1 storey masonry building with a bespoke and problematic roof. The original roof is fully concealed but was reported by staff to be a concrete flat roof. Due to reported leaks a second pitched roof with a timber structure and sheet metal was installed on top of the original. Inspections indicate that this second roof structure is not well bonded to the original. The secondary roof sheet metal cover is completely corroded and has failed in many places. Evidence of ongoing leaks was noted inside the building.

Recommendations Do not invest in PV installation at this site prior to resolving the problems with the building.

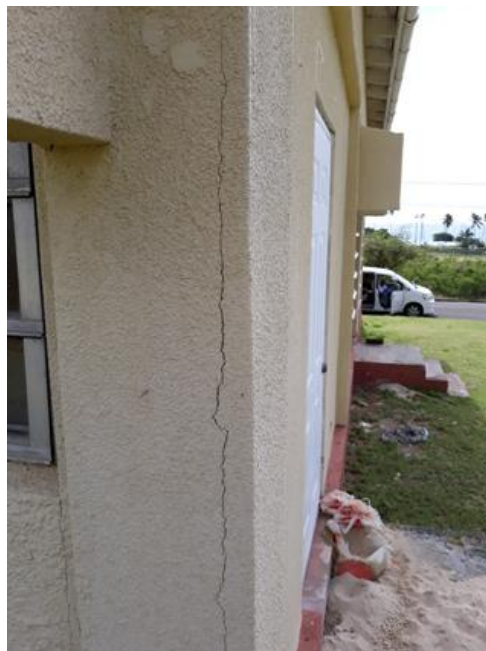
Old Road – Cracked concrete column, probably due to reinforcing steel corrosion

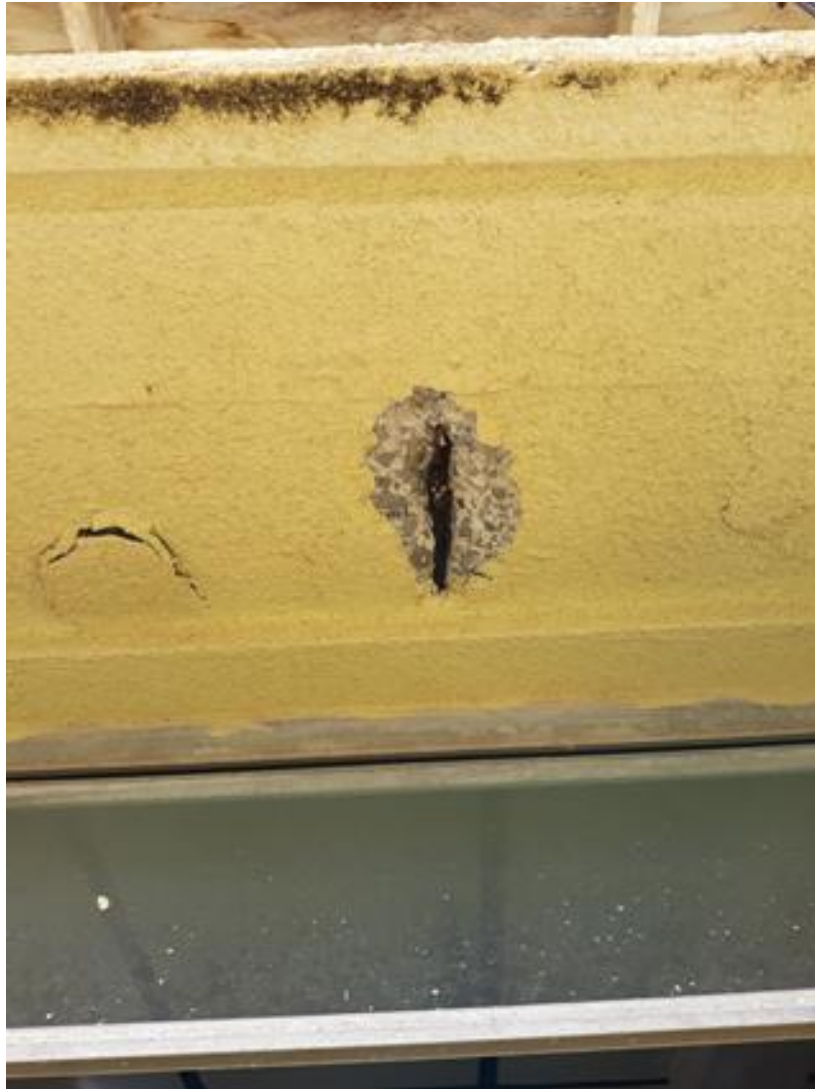
Old Road – Detail of reinforcing steel corrosion inside concrete beam and lintels

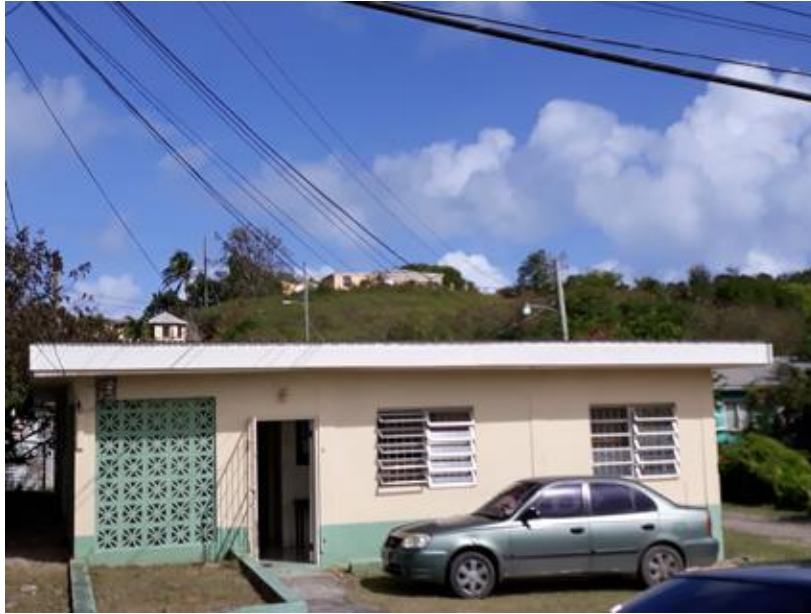
Parham clinic – showing obstructing powerlines

Summary Parham's clinic is a small freestanding 1 storey masonry building with a flat timber and sheet metal roof. Its age is in excess of 20 years and its condition overall is fair. It is in an enclosed valley area with moderate wind exposure. The roof sheet metal is in fair to poor condition.

Recommendations Construct a new fabricated steel shade structure with rooftop PV, as per the generic recommendation in Section 2.7, option B of this report. Position the structure on the southern edge of the existing building. Demand resolution of the power line safety issue by the electrical utility.

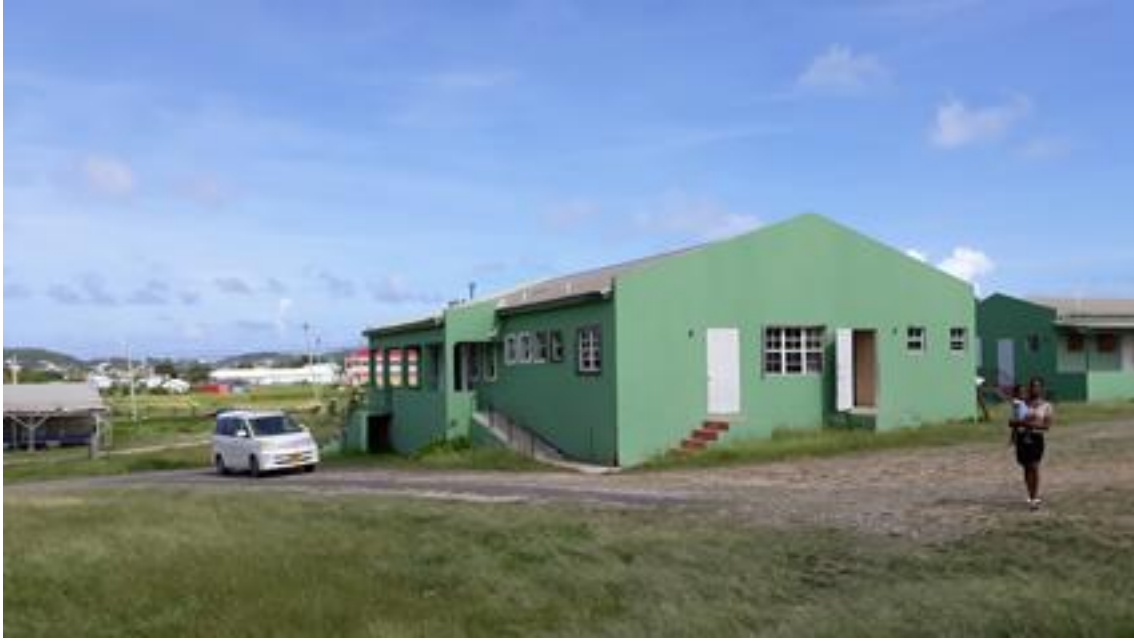
Summary Potters clinic is a small freestanding 1 storey masonry building with a pitched timber and sheet metal roof. Its age is in excess of 20 years and its condition overall is moderate. It is in an open semi-rural area with moderate wind exposure. The sheet metal roof is in good condition with roof screws. Flood risk is assessed as very low – the facility is on the side of a hill with adequate drainage.

Recommendations Routine rooftop installation.

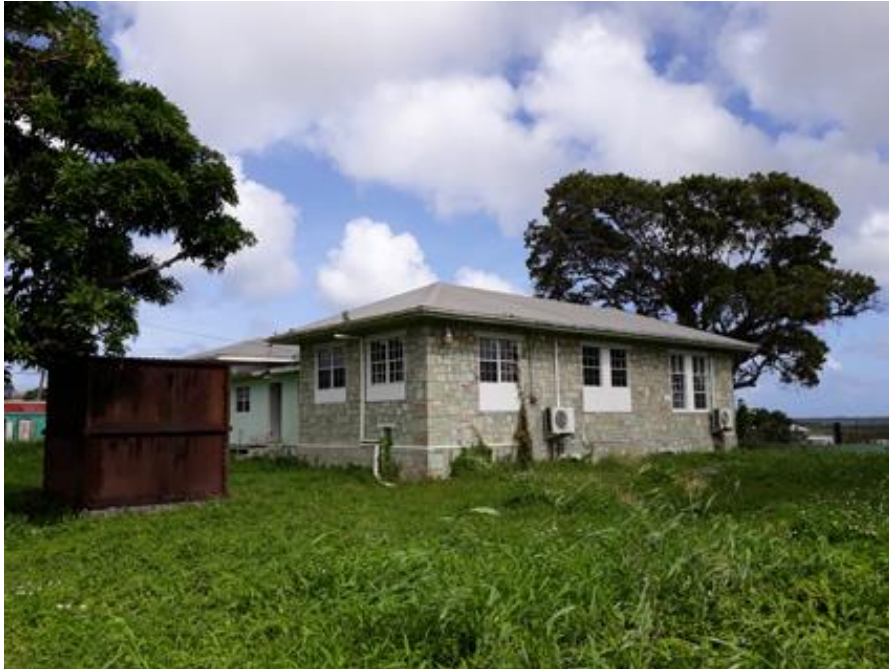
Summary Swetes clinic is a small freestanding 1 storey stonework building with a complex footprint and a pitched timber and sheet metal roof. Its age is more than 40 years and its condition overall is moderate due to renovation. It is in a residential hilltop area with several large trees and moderate to high wind exposure. The sheet metal roof is in fair condition with roof screws. Flood risk is assessed as low – the facility is on the top of a hill.

Recommendations Routine rooftop installation with shade analysis.

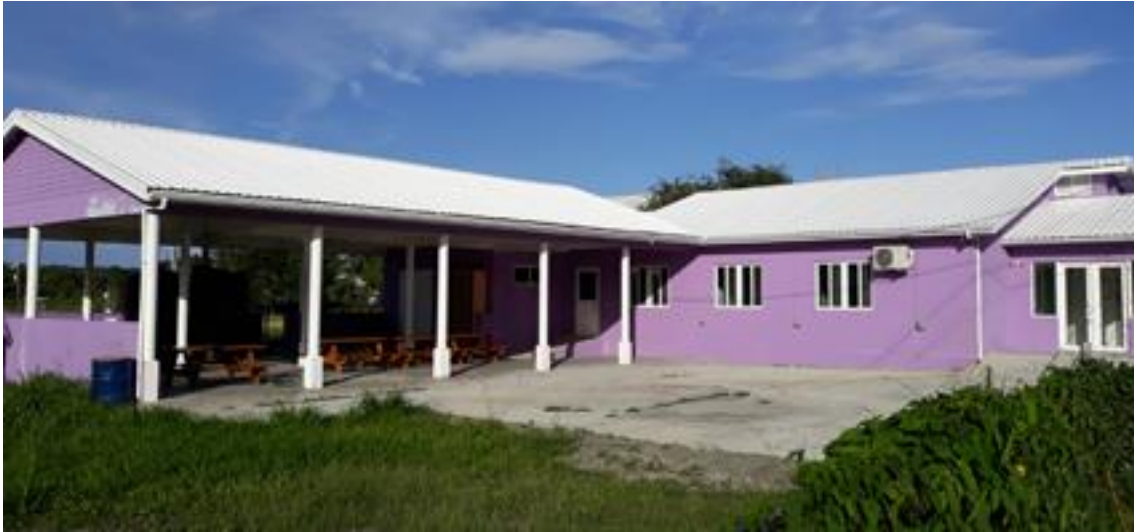
Summary The Victory Centre is a small freestanding 1 storey masonry building and a pitched timber and sheet metal roof. Its age is reported at 5 years and its condition is very good. It is in a residential and recreational flat area with and moderate wind exposure. Trees are noted to the east and south. Flood risk is moderate, due to the flat site.

Recommendations Routine rooftop installation with shade analysis.

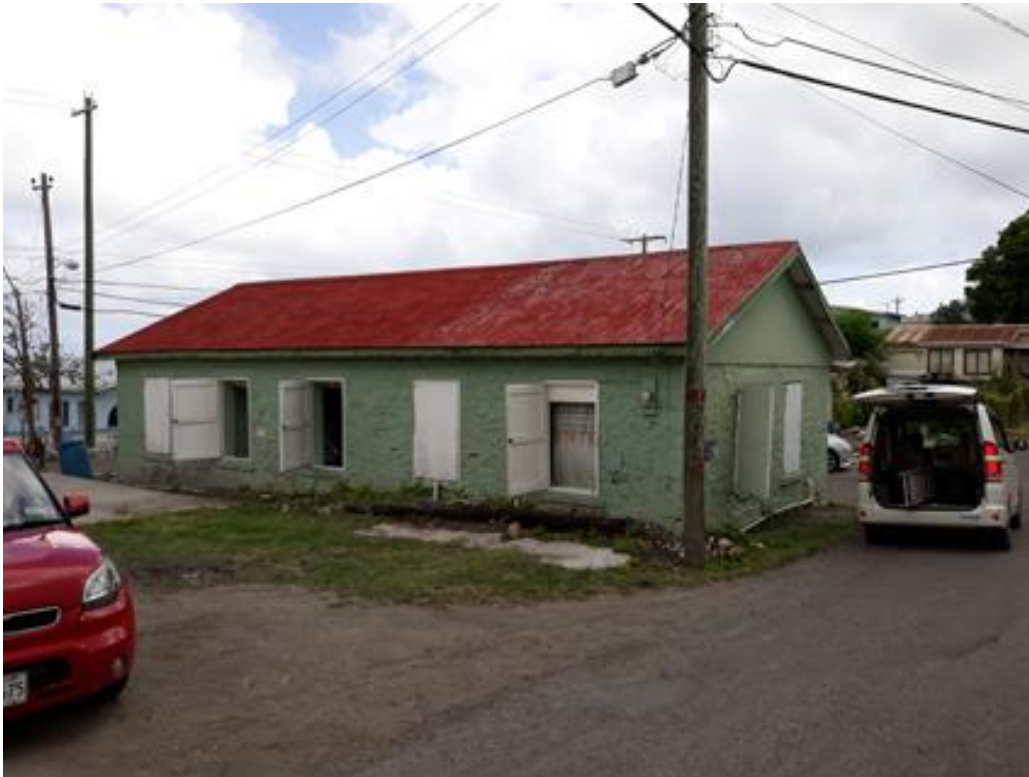
Wilikies clinic

Summary The Wilikies Clinic is a small freestanding 1 storey stonework building and a pitched timber and painted sheet metal roof. The building age appears to be more than 40 years. The site is a hillside with high wind exposure. The sheet metal roof is in good condition but fixed mainly by nails. One nearby tree is noted to the west. The flood risk is assessed as low – the site is on the side of a hill.

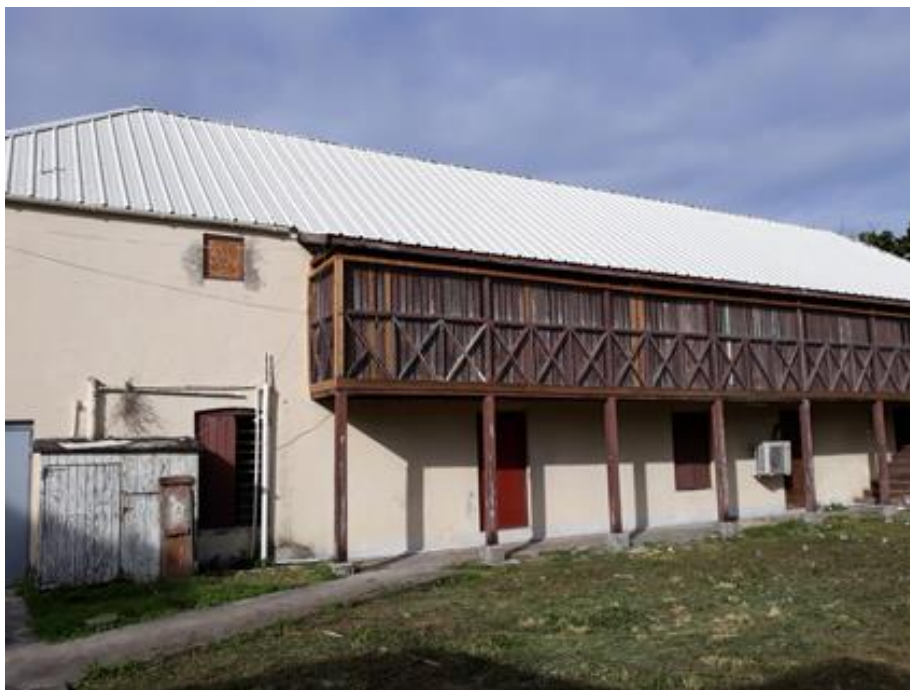
Clearvue – Male 2 storey ward, showing industrial sheet metal roof

Recommendations Rooftop installations. Invest in rooftop strengthening for wind resistance.

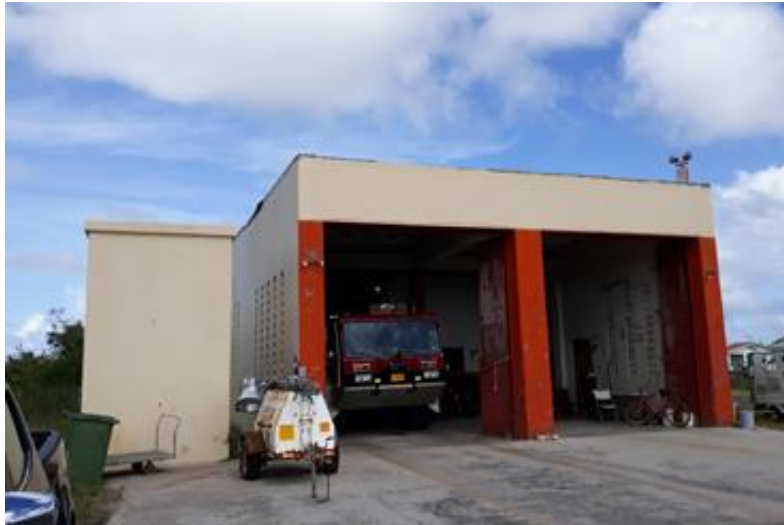
Barbuda Codrington Airport fire station hangar

Summary The Barbuda Airport fire station hangar is a bespoke industrial hangar for the airport and island fire engine. It is a very solid concrete and steel structure that showed no major damage from the hurricane. In general it is ideal for a rooftop installation, except for the unfavorable pitch of the roof at 5 degrees north. A flush installation on this roof would sacrifice up to 30% of potential energy compared to an optimum south facing.

Recommendations Rooftop installation, if designed to support the airport terminal office.

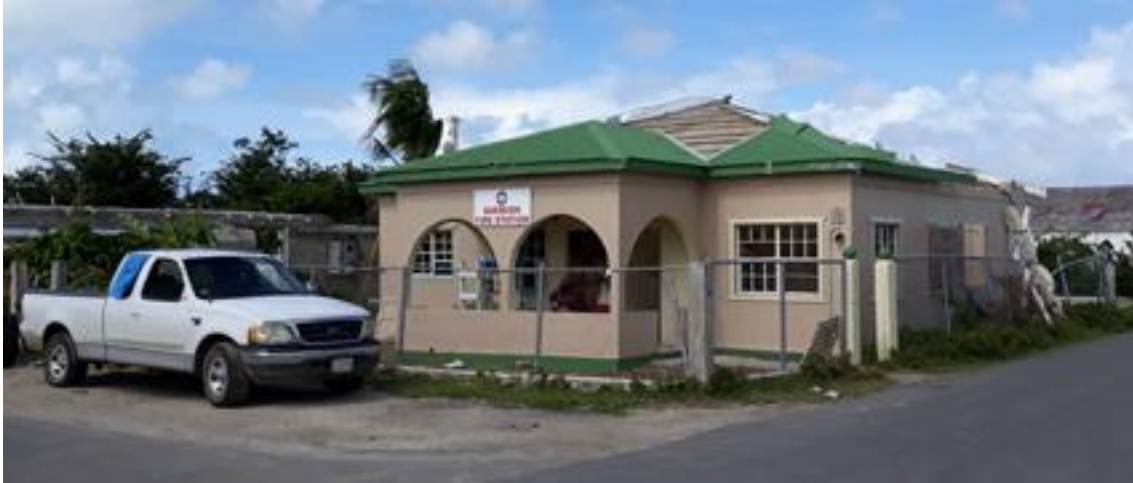
Summary The Codrington fire station hangar is a 1 storey masonry building located in residential Codrington. It was badly damaged in the hurricane and provides useful evidence of the uplift failure modes of the Antiguan roof design. The following damage was noted:

Recommendations Rooftop installation, integrated into the rebuild and strengthening works.

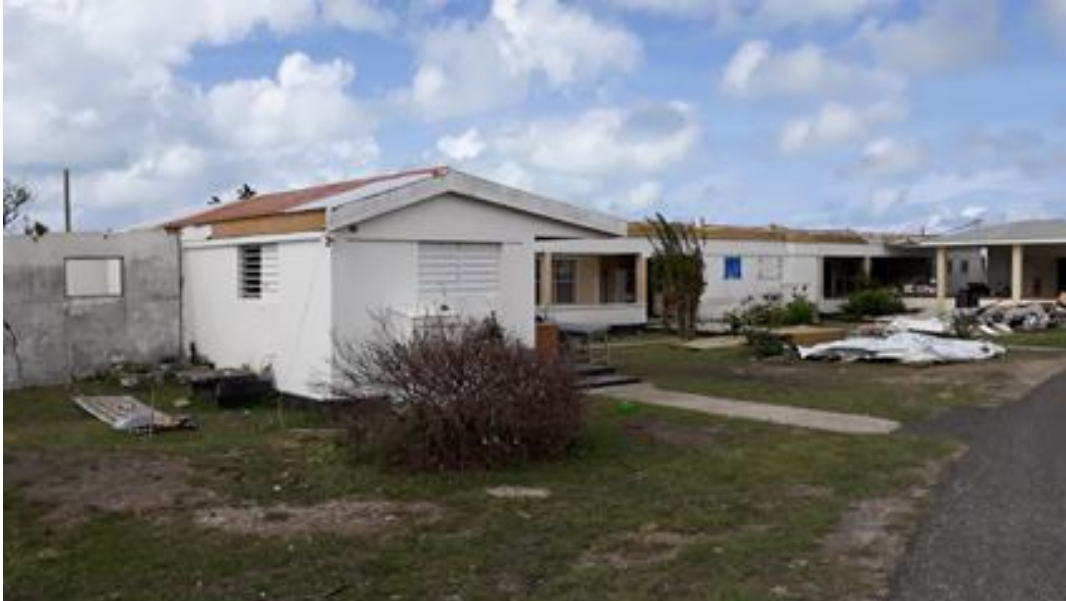
Barbuda Hannah Thomas Hospital

Summary The Hanna Thomas Hospital is a collection of 1 storey masonry building on an open site on the edge of Codrington. It was badly damaged in the hurricane but is now partly operational. The steel roofed sections were effectively completely deroofed. In contrast, as expected, the flat concrete roofed sections remained intact apart from broken windows.

Recommendations Rooftop installation on the concrete sections, integrated into the overall rebuild works.
