Solar PV facility screening study for public and educational facilities on Antigua and Barbuda

United Nations Electricity Supply Partnership
Technical Report **Final Draft 30 Jan 2018**

EXECUTIVE SUMMARY

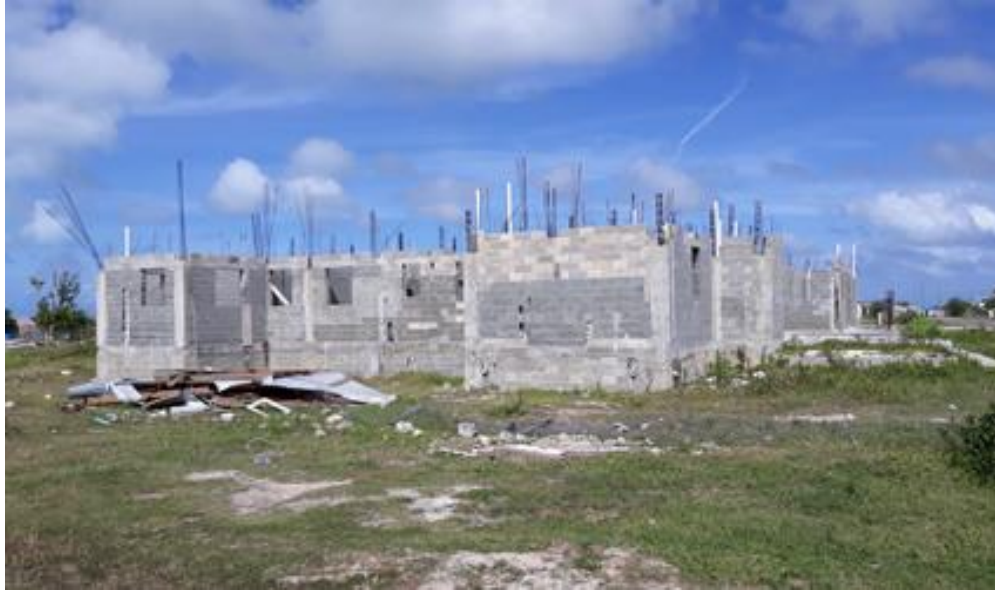
Barbuda Justice Center construction site

Summary The Barbuda justice center is located next to the council building in central Codrington. It is however only partly built as of January 2018 and work has halted due to the hurricane. There is space for a ground mount however ongoing building works put any such installation at risk. There is also obviously no electricity demand from the center itself, however the council building would be a logical customer for any electricity.
