JUMBY BAY SILT REMOVAL

Benthic Marine Assessment Report

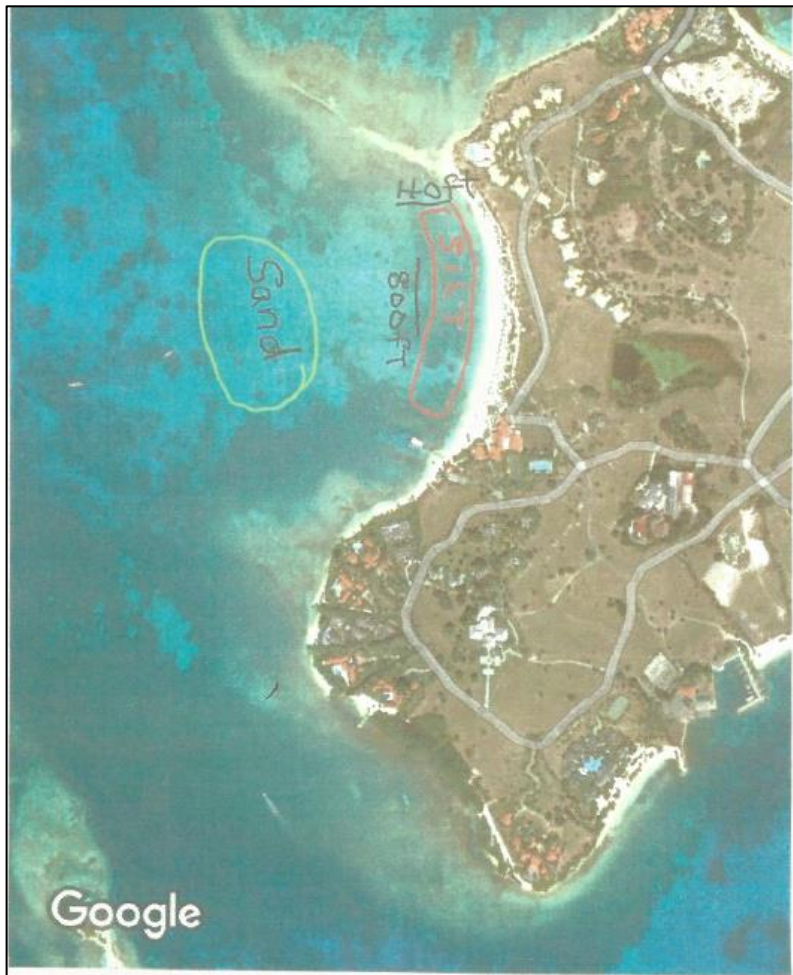
Map 1: Area of Interest. Map provided by Blue Ocean

The Jumby Island LTD has submitted a proposal for the removal of silt from the bay on the western side of Long Island, and to replace this area with suitable sand. The area of removal is said to be 800ft (243.8m) long (North to South) by 40ft (12.2m) wide (West to East), covering a total of 32000 sq ft (2972.9m²) or approximately 0.73 acres. The depth of the excavation is to be 16in (0.4m), and the proposal is to replace the silt with suitable sand from offshore.

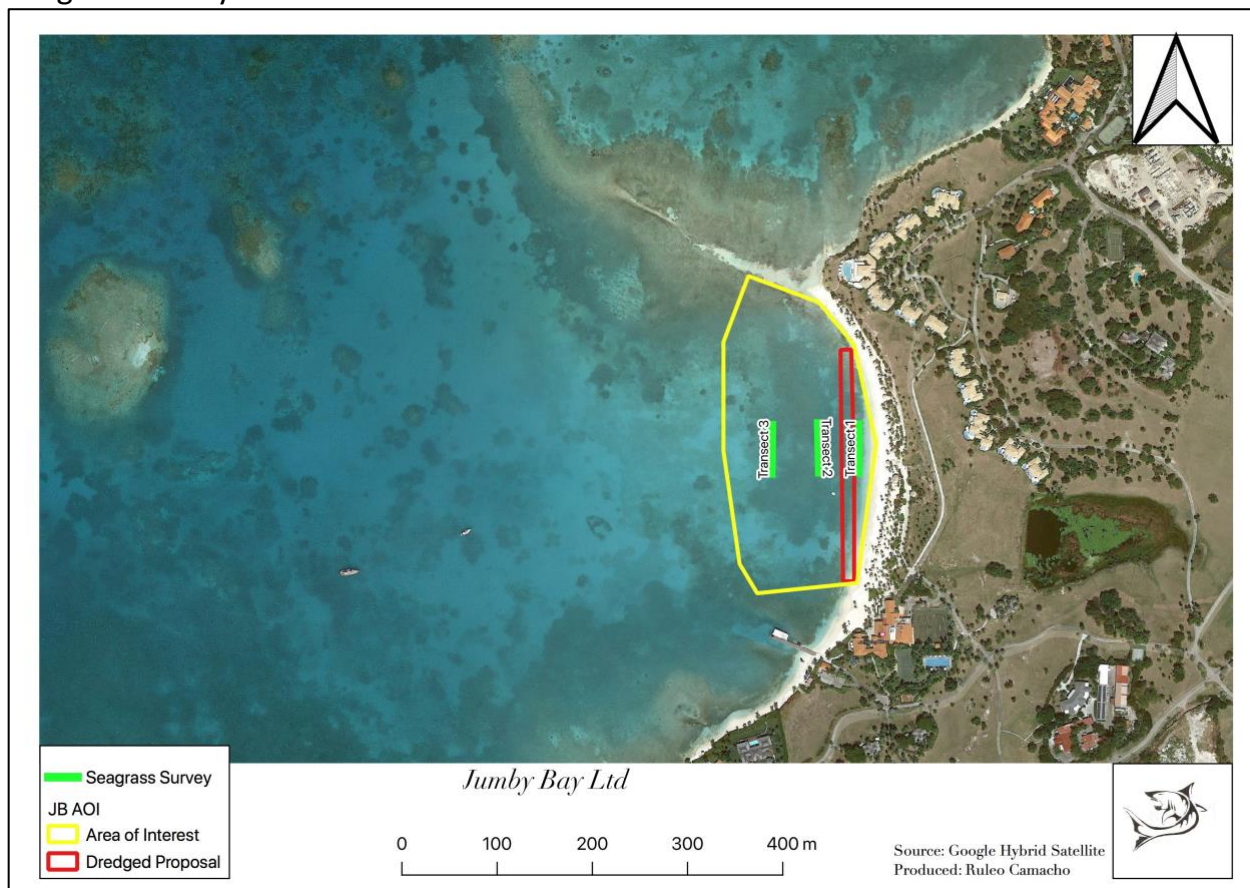
Map 3: Seagrass Surveys.

Three Seagrass survey transects were executed using the above-described methodology (Map 3, Picture 1). Each transect was separated by 130-150ft (39-46m), in an effort to capture the ecological characteristics of the area of interest specified in Map 3. Transect 1 was conducted nearest to the shore, in an average depth of 3.5ft (1m). Transect 2 was conducted adjacent to the swim platform in the swim area, and depth was 6ft (1.8m). Transect 3 was executed beneath the swim line, and the depth average was 5.5ft (1.7m).

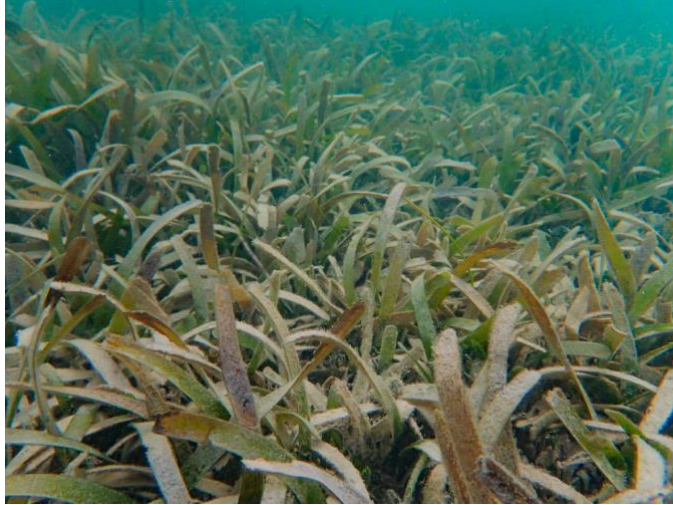
Picture 2: Turtle Grass

The benthic substrate was dominated by the native species of seagrass, i.e., Turtle Grass

(*Thalassia testudinum*) (Picture 2), Manatee Grass (*Syringodium filiforme*) (Picture 3) and *Halimeda* sp.. The invasive Broad-leaf Seagrass (*Halophila stipulacea*) (Picture 4) was also noted in the transects, with the dominant benthic substrate being a mud/silt material. In Transect 1, native seagrass species accounted for 85% of benthic cover, while the invasive broadleaf species accounts for 3.5% and the remaining 11.5% made up by mud/silt. Transect 2 consisted of 58.5% of the benthic cover, with the invasive broadleaf species accounting for 11% and the remaining 30.5% mud/silt. Transect 3 had

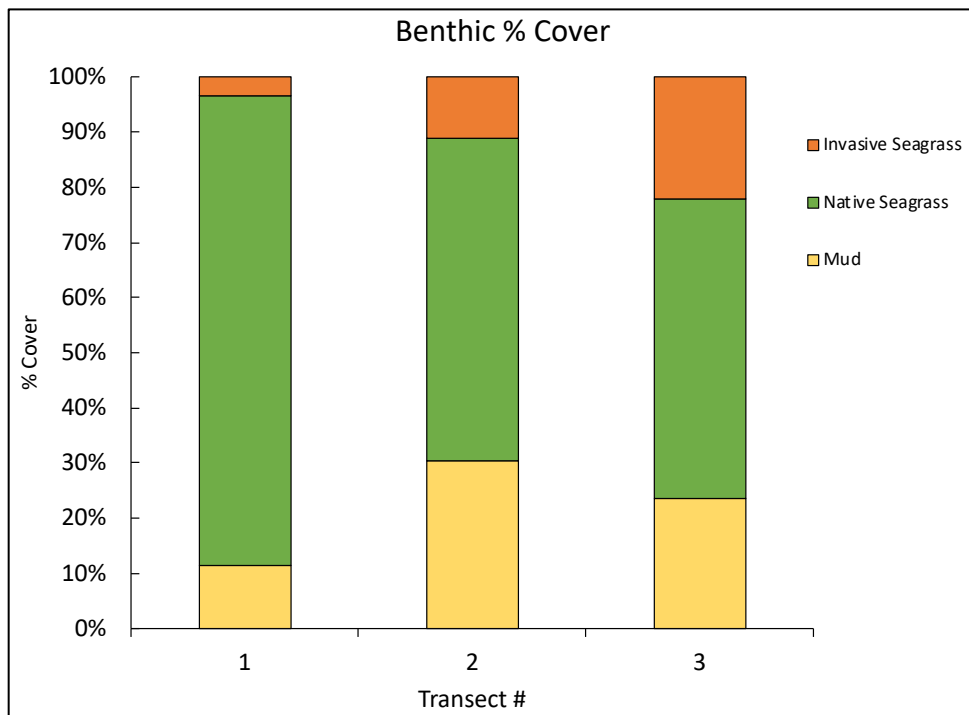
Figure 1: Benthic Substrate percentage (%) coverage

54.5% native seagrass cover, 22% invasive seagrass cover and 23.5% silt/mud (Figure 1). Overall, native seagrass species accounted for 66% of the benthic coverage in the area of interest, followed by mud/silt (21.83%) and invasive seagrass (12.17%). In all transects, seagrass blades, particularly the native species, were heavily inundated by sediment (Picture 5).

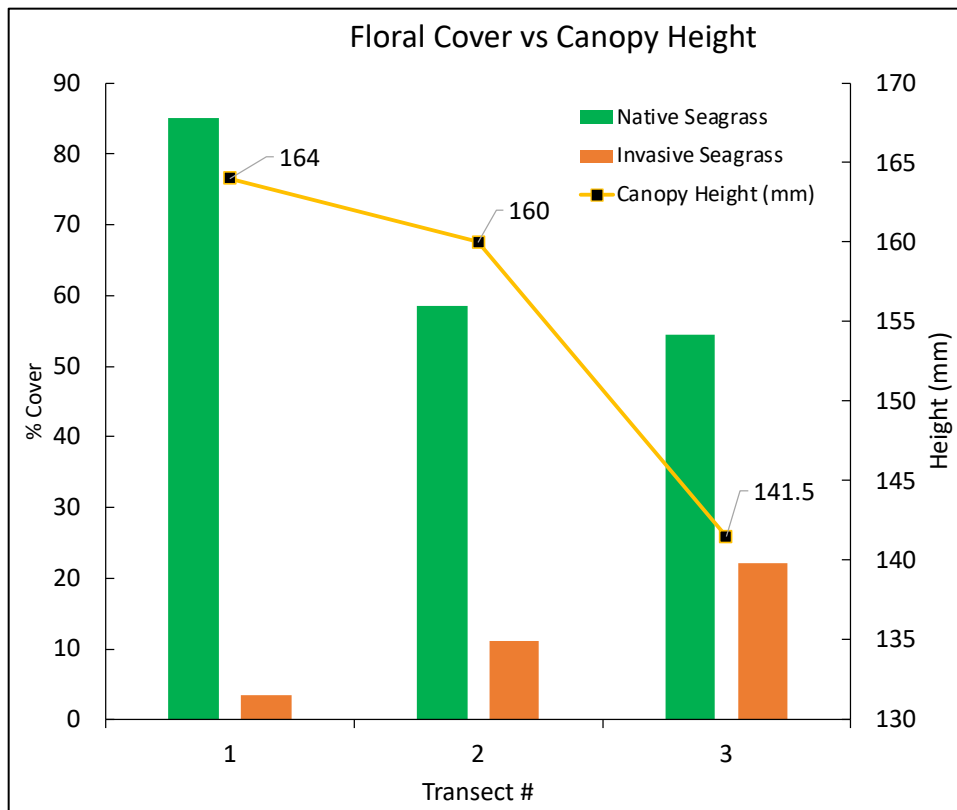
Figure 2: Seagrass percentage cover (%) and canopy height (mm).

Floral Canopy height showed variation between transects, with transects having a higher proportion of the invasive broadleaf species showing a reduction in canopy height (Figure 2). Transect 1 and Transect 2 were similar, measuring 164mm and 160mm respectively. This dropped to 141.5mm in Transect 3, where the coverage of the invasive broadleaf species increased to 22%. Average canopy height throughout the area of interest is 155.17mm. Floral species richness varied, with Transect 1 measuring 4.5 species/m², while Transect 2 and Transect 3 both measured 3.5 species/m². Overall average species richness is 3.7 species/m².

dredged area by this species. As seen in Figure 2, canopy height decreases as the proportion of invasive seagrass species increases⁵. The smaller leaves of the invasive broad-leaf seagrass are likely to have a lessened effect on reduction of turbidity within the bay. The high levels of epiphyte cover could lower the productivity of the seagrass beds by reducing the availability of sunlight to these species ¹⁵. It has been theorized that epiphyte cover can be used as an indicator for nutrient load, but no positive correlation has been found between the two ¹⁶. Cyanobacteria were observed in the spot checks (Table 1) and during the seagrass surveys. Cyanobacteria (Picture 14) can often be a result raised nutrient levels in the marine system and could be an indication of anthropogenic pollution¹⁷. Water quality test were not conducted during these surveys.

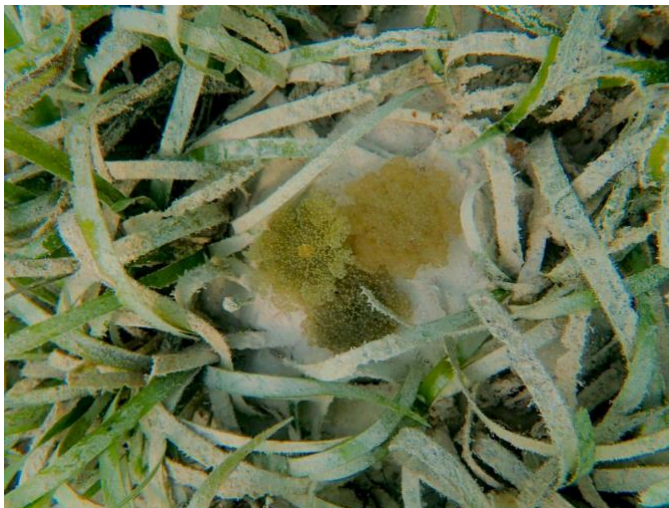
Picture 6: Upside-down Jellyfish in seagrass

Macro-invertebrates varied across transects, with the Upside-down jellyfish (*Cassiopea frondosa* and *Cassiopea xamachana*) (Picture 6), being the most dominant but only seen in Transect 2 (26/100m²) and Transect 3 (5/100m²). A single Queen Conch (*Aliger gigas*) (Picture 7) was seen in Transect 2, while 6 Cushion Sea Star (*Oreaster reticulatus*) (Picture 8) were observed in Transect 6. No Macro-invertebrates were observed in Transect 1 (Figure 3).

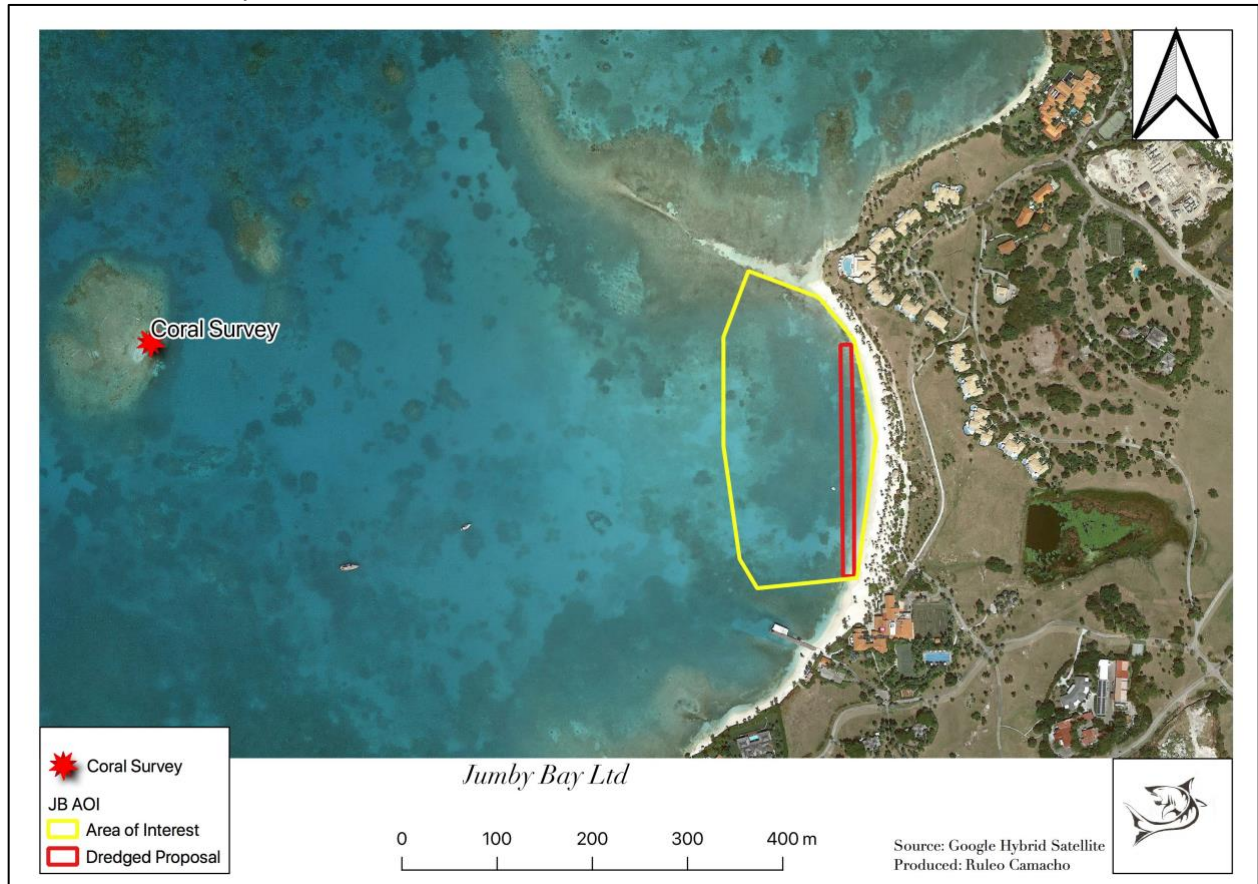
Map 4: Coral Survey Site

Coral surveys were carried out at the point specified “Coral Survey” in Map 4. This would ascertain the baseline ecological conditions of this coral reef site. T1 was carried out on the southern part of the point. The area here is algal dominated (*Picture 9*), with Dead Coral with algae (49.24%) and Macroalgae (28.90%) accounting for the majority of the benthic cover. Live coral accounted for 0.38% (Figure 4).

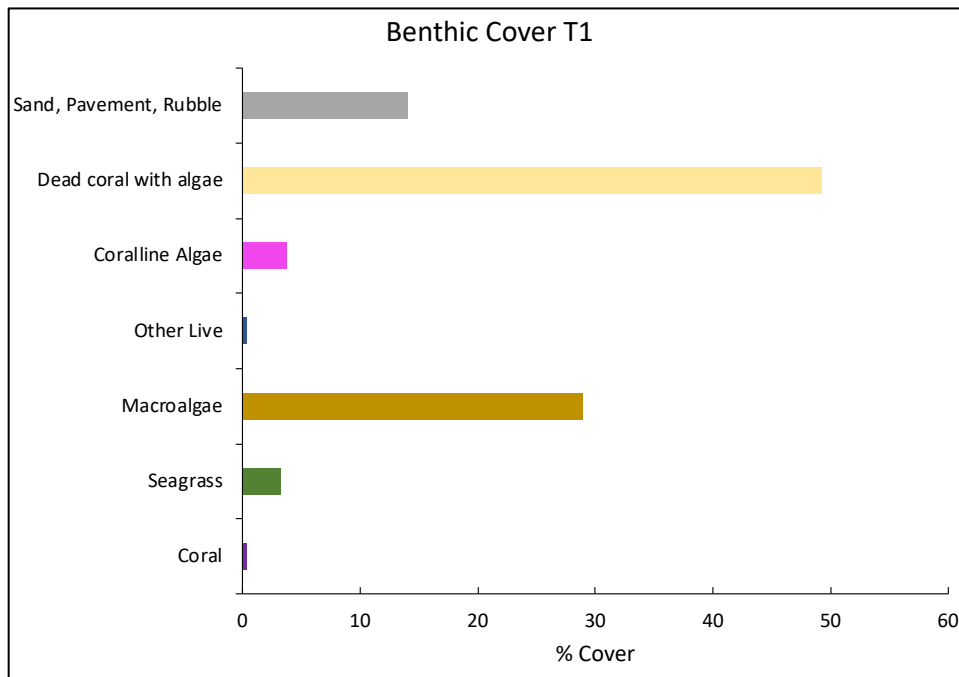
Figure 4: Coral Transect 1 - Benthic Cover

where coral cover only accounted for 0.38%, while algae (Dead coral with algae and macroalgae) accounting for 78.14%. Overall, the reef condition was comparable to what has been observed in surveys in the NEMMA regions⁴, with coral cover averaging 23.87% and algae (Dead coral with algae and macroalgae) accounting for 57.36%. The recovery of these coral reef ecosystems, particularly as conditions similar to T2 were observed at reef sites to the north (Table 1), should be prioritized and encouraged. A variety of fish species were also observed using these coral reef areas, highlighting the habitat and biodiversity support being provided by these ecosystems (Picture 19).

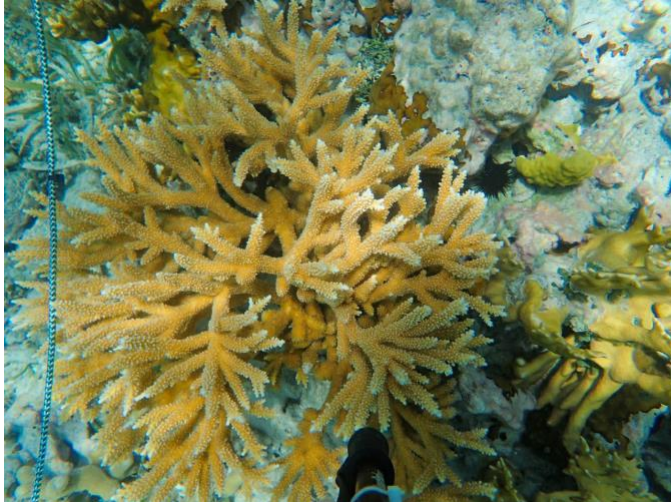
Picture 10: T2 Coral Transect picture

T2 was carried out to the northern part of the “Coral Survey” point. The dominant substrate here was live coral, accounting for 47.36% of the benthic cover (Picture 10). Dead coral with algae accounted for 28.41% while macroalgae and seagrass each accounted for 8.15% (Figure 5).

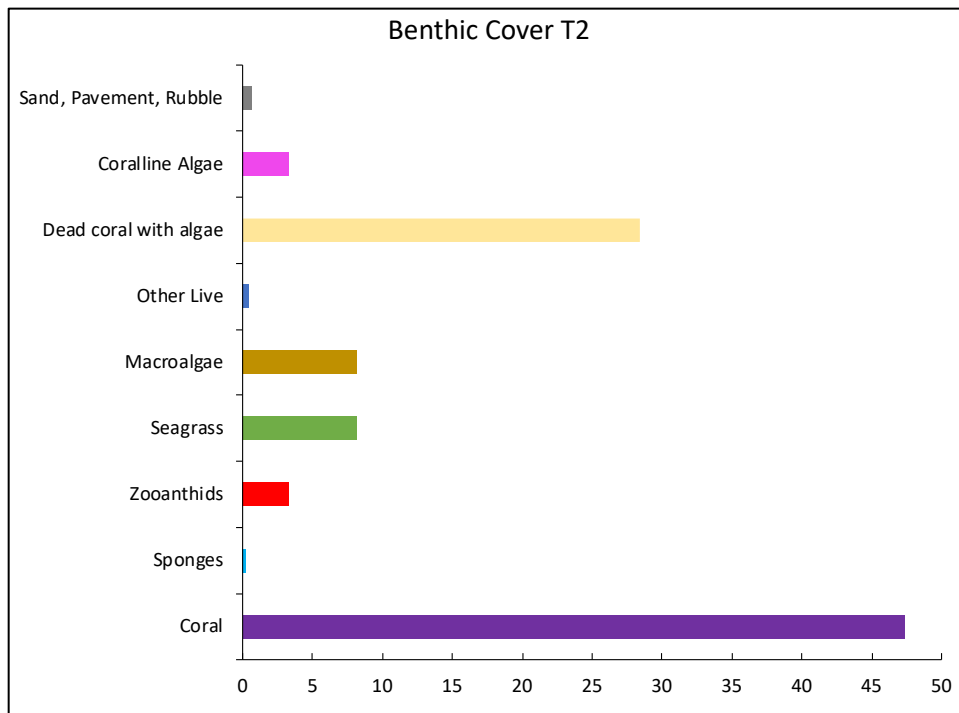
Figure 5: Coral Transect 2 - Benthic Cover

Coral Reef surveys were undertaken at one of the reef sites (Map 4) in an effort to understand the ecological conditions of the coral reef ecosystem. The entire reef ecosystem appeared to be making a slow recovery in a northern to southern direction, as areas to the north had greater health than areas to the south. This was exhibited in the results, as the transect executed to the North of the site T2 (Figure 5) had a healthier reef characteristic, with Coral cover accounting for 47.36% and algae (Dead coral with algae and macroalgae) accounting for 36.56%. This contrasted with the southern transect, T1 (Figure 4),

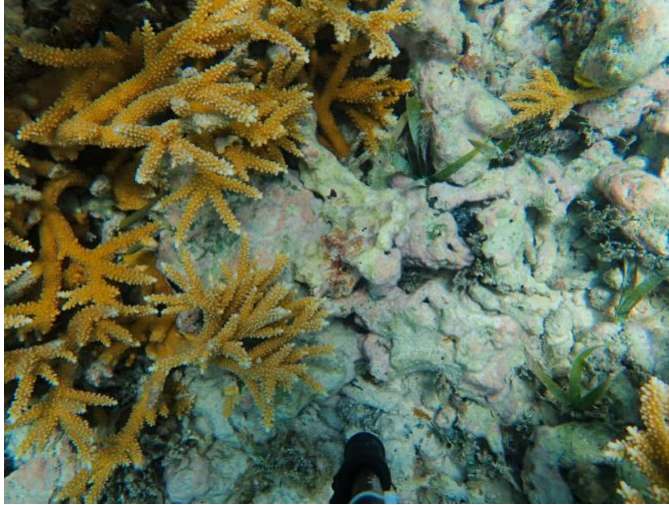
Picture 11: Coral Reef area

Averaged together, Live Coral accounted for 23.87% cover, Dead Coral with algae 38.83% and macroalgae accounted for 18.53% (Picture 11).

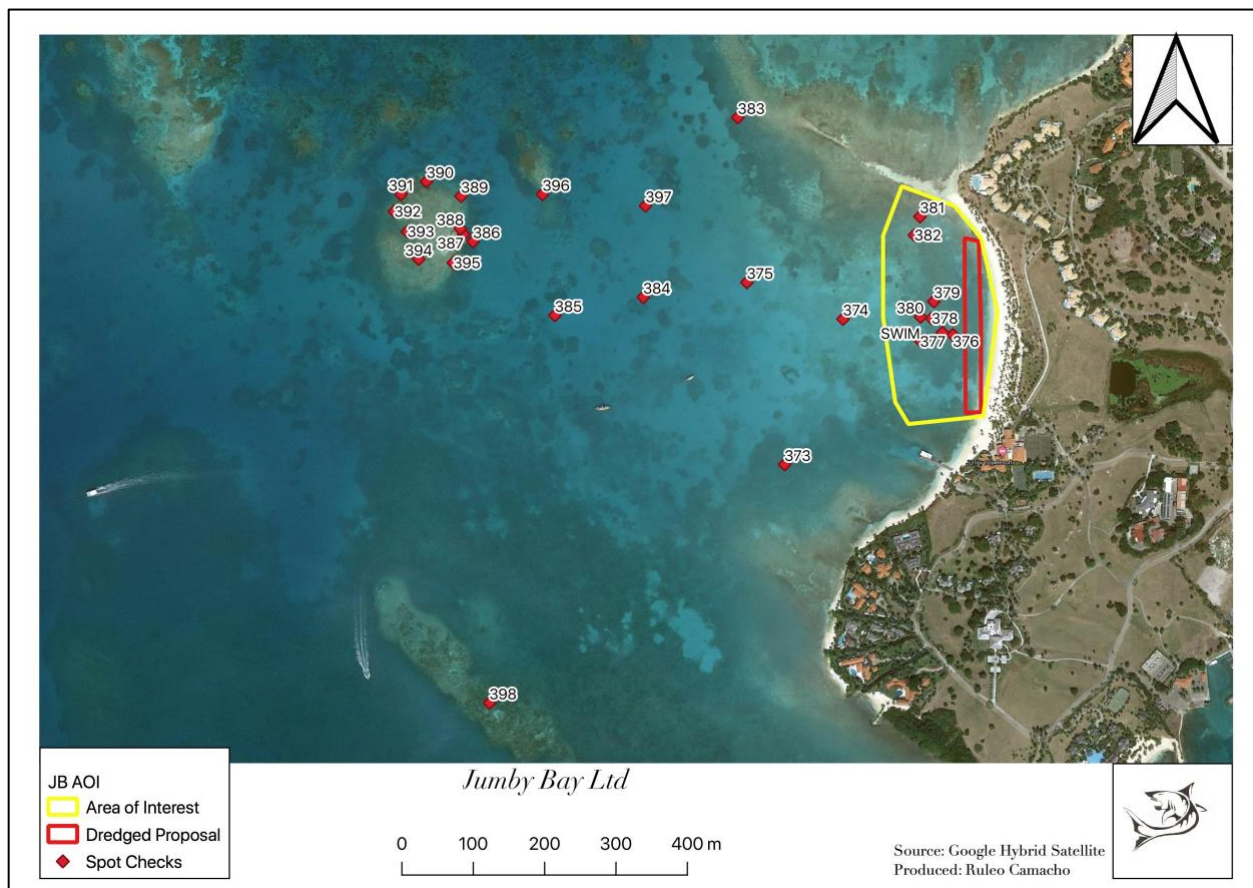
Map 5: Spot Checks

Several spot-checks were carried out to better understand the distribution of benthic marine ecosystem (*Picture 12 – data recording*). The areas are displayed in Map 5 and the data are summarized in the Table 1 & 2 below:

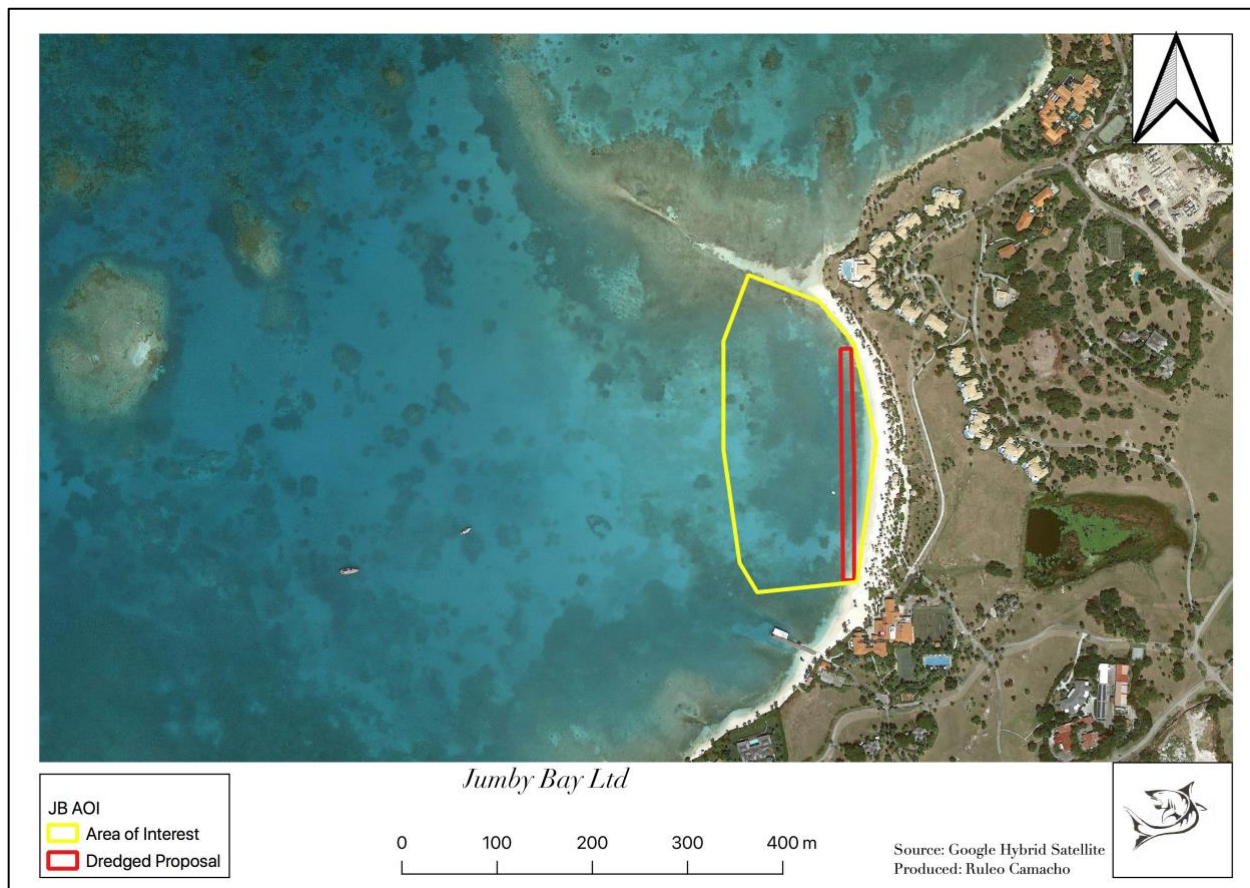
Map 6: Area of interest, and proposed site to be dredged.

The proposed activity to remove silt and replace with sand is to take place on the western portion of Long Island in the JumbyBay Bay area (Map 1). Map 6 highlights the proposed 800ft (243.8m) long by 40ft (12.2m) wide section that is proposed to be dredged (Map 6 – Red rectangle). The process of

dredging raises environmental concerns, particularly as it can result in the removal of seagrass material as highlighted in the Department of Environment's Review (REF #D.o.E 9/6 F6). There is also concern about the potential impact of the dredging on the surrounding marine environment, given its location within the North East Marine Management Area (NEMMA), an area known to be rich in marine biodiversity and recognized as a globally significant area for endangered and endemic species ¹. As such the benthic assessments highlighted in this report were carried out to address these concerns.

The proposed dredging is likely to have a significant impact on the seagrass bed ecology and the ecosystem services being provided by them. Dredging activities are likely to create an opportunity for the already present invasive seagrass species to colonize and dominate the dredged areas, as has been observed in previous areas. The proposed area for dredging is the areas currently least affected by the invasive broad-leaf seagrass species, although it is already colonizing areas further offshore. Dredging in this area will likely enhance the spread of the invasive species in this area and result in the reduction of the benthic coverage of the native seagrass species. Dredging may also result in a reduction in the turbidity of the nearshore waters, as the ability of the invasive species to capture and reduce water sedimentation is reduced when compared to the native species. Increased sedimentation and turbidity from the dredging activities can have detrimental effects on the down-stream coral reef areas, by smothering and reducing the sunlight available to these ecosystems. This is of concern, as these areas are showing significant recovery, and area averaging higher coral cover than is seen throughout the rest of the island.

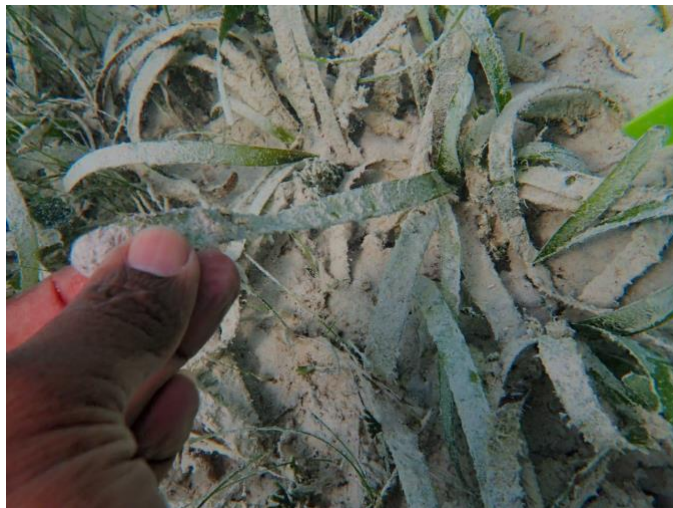
Picture 13: Turtle Grass with high sedimentation

Seagrass beds play a crucial role in the reduction of turbidity and stabilization of the surrounding habitat¹⁴. The seagrass blades observed had large quantities of sedimentation and epiphytes associated with them (Picture 13), suggesting that the ecosystem services of improving water quality is heavy at work within the Area of Interest. Possible disturbance of the seagrass beds from dredging activities is likely to increase turbidity within the area of interest. Additionally, the presence of the invasive Broad Leaf seagrass among the seagrass beds could result in a faster colonization of the

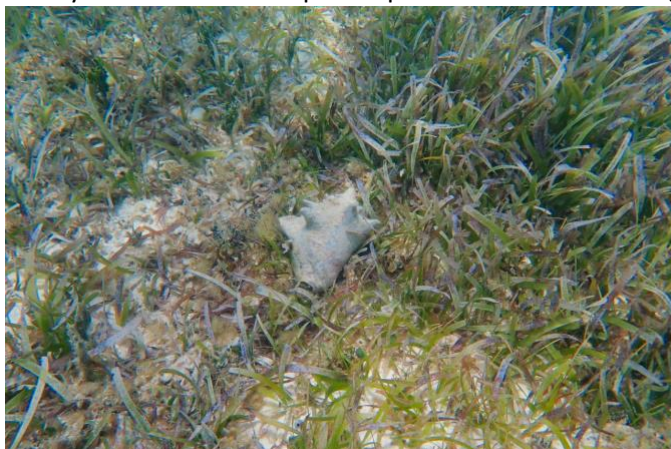
Picture 16: Juvenile conch in seagrass beds

possible impacts from the proposed activities. As seen in Table 2, the areas immediately around the AOI were predominantly seagrass beds, consisting of native and invasive seagrass species (Table 2). The area to the immediate North of the AOI had large numbers of juvenile queen conch (Picture 16, Map 5-381) associated with its seagrass beds. Queen conch are very important for the local fisheries economy and food security, and the presence of the juveniles is an indication of the nursery support being provided by the

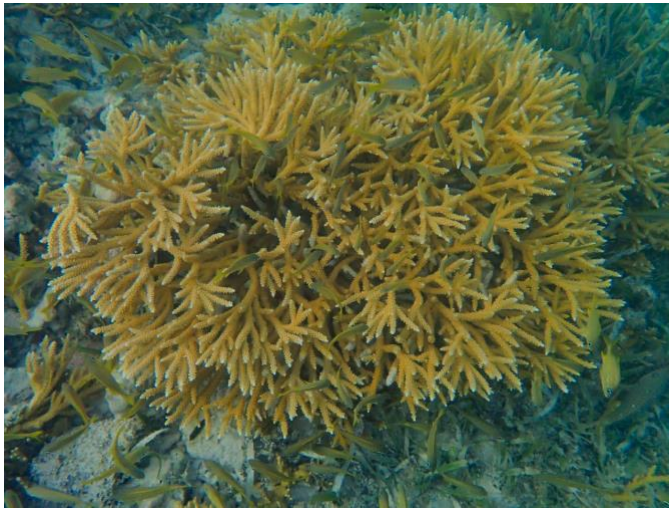
Picture 17: Fused Staghorn Coral

seagrass beds¹⁸. Further offshore, the presence of coral reef colonies was observed (Table 1). Included among these species was the Fused Staghorn (*Acropora prolifera*) (Picture 17), a hybrid of the Critically endangered *Acropora palmata* and *Acropora cervicornis* corals. This correlates with earlier observations where areas of recovery of coral reefs, aided by this Fused Staghorn coral had been observed¹⁹. It was also observed that areas further offshore (Table 1-375, 385; Map 5) where you would have expected to find open sand/mud habitats were being colonized by the invasive Broad-leaf seagrass (Picture 18). This can provide an indication of the likely impact of dredging on the nearshore areas, where the invasive is likely to colonize and dominate the native species.
