**Coastal Assessment of Proposed  
Beach Enhancement Works  
At Jumby Bay Beach  
Long Island  
Antigua**

**September 2021**

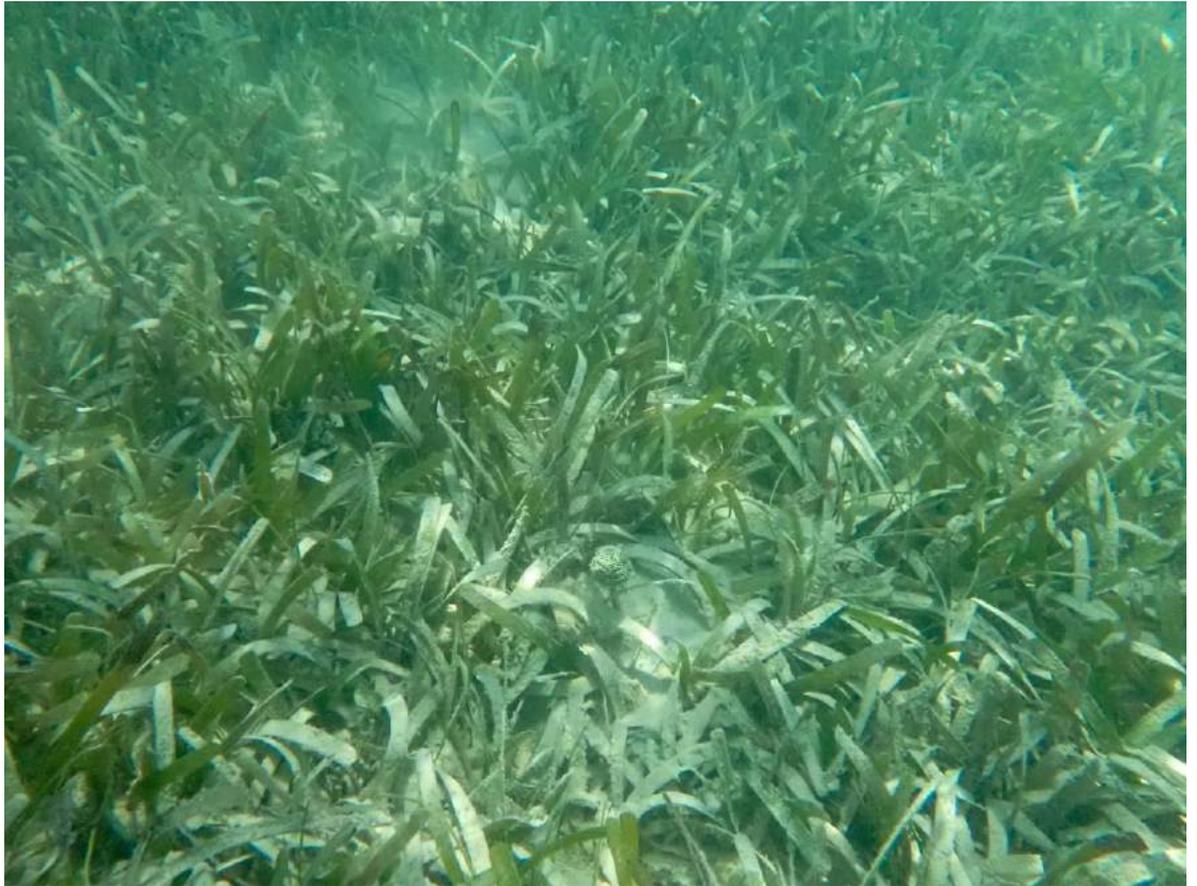
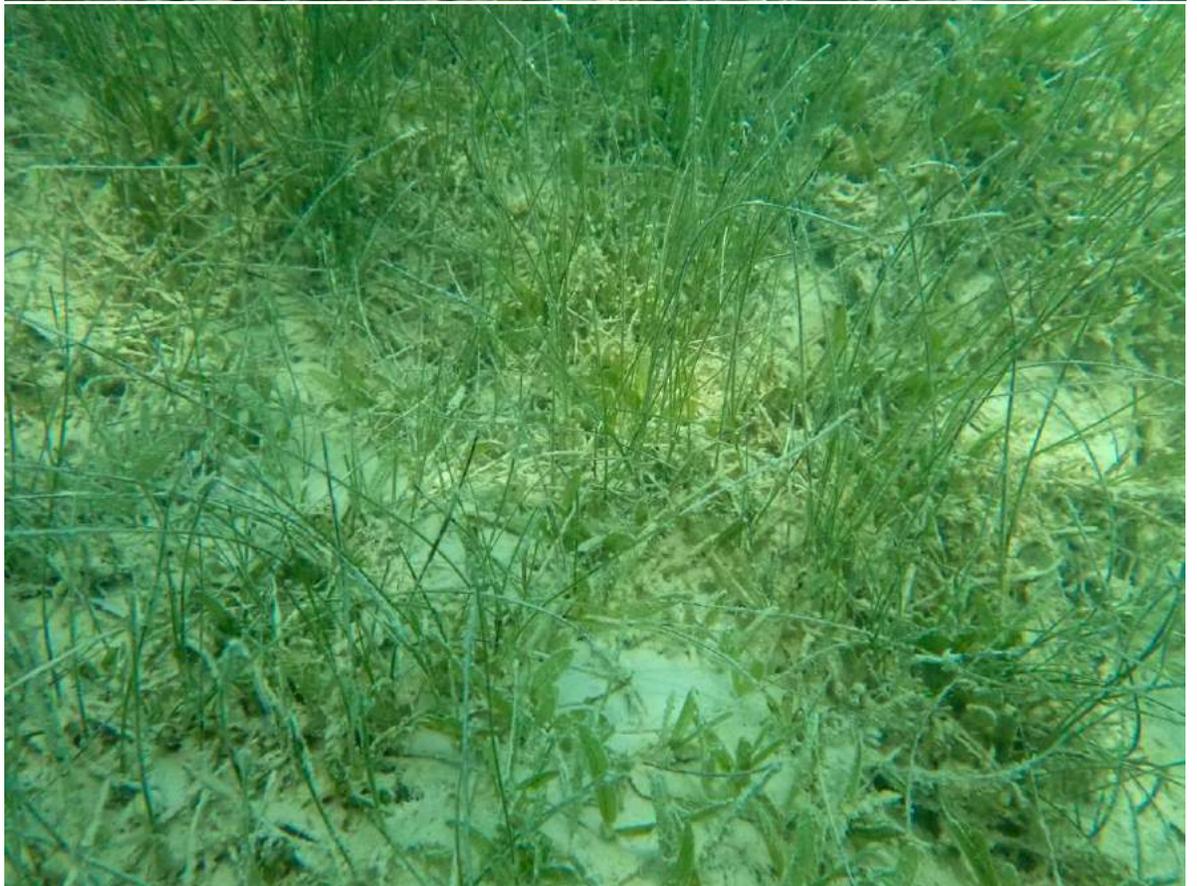
**Enclosure No3A**

Contrasting sea grass type in Bay

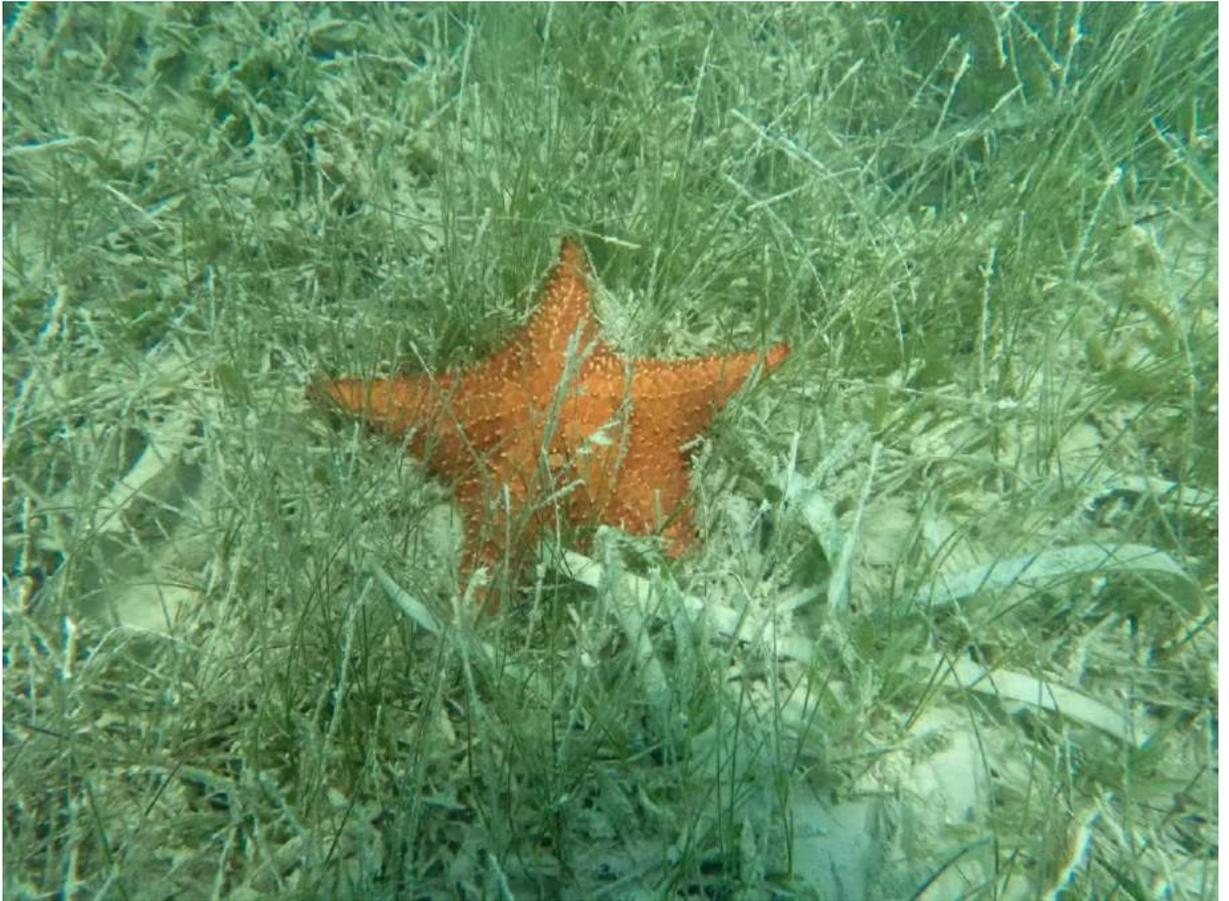
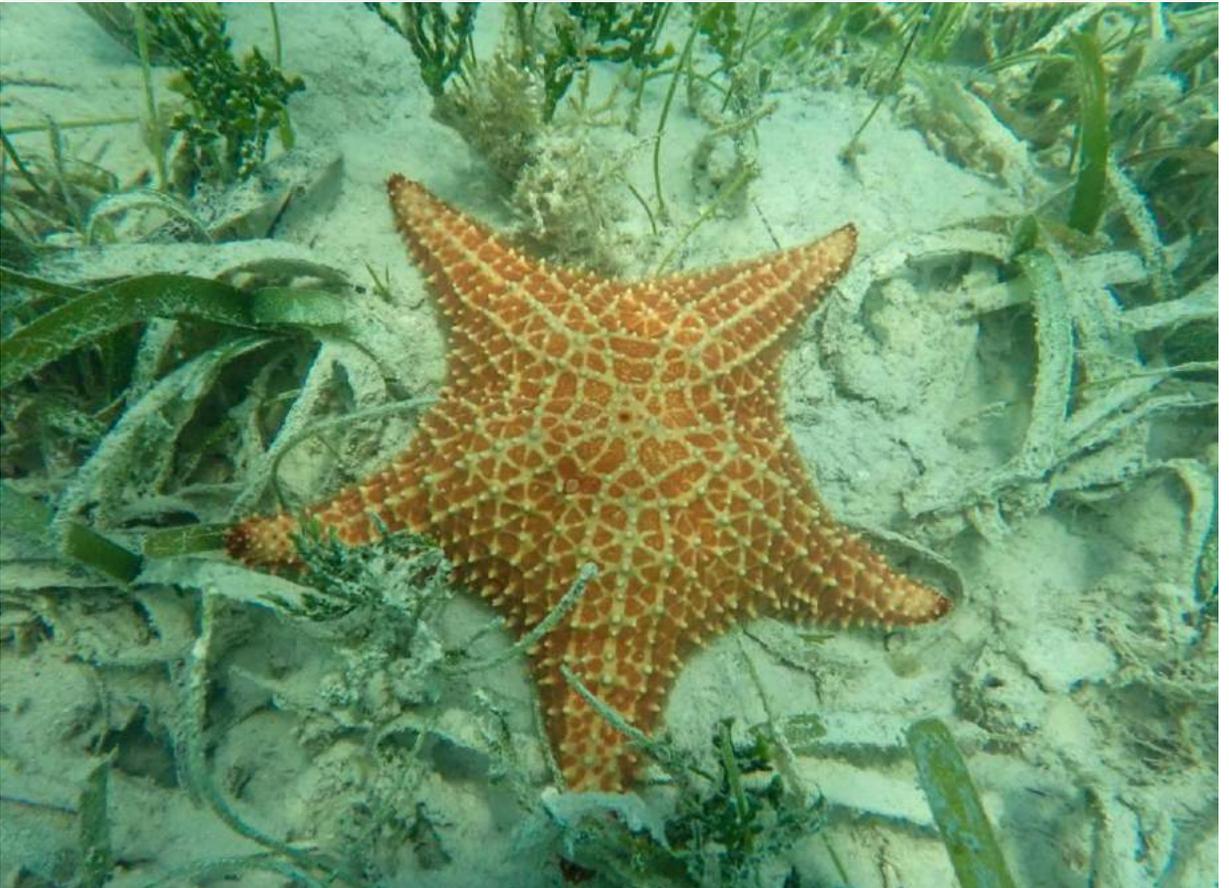
**Enclosure No3C**

Star Fish Encountered in nearshore area

- There were a few Star fish & other Sea Life observed within the area earmarked for the improvement work. It is recommended that these animals be removed by a team of Divers and be relocated outside of the affected zone.

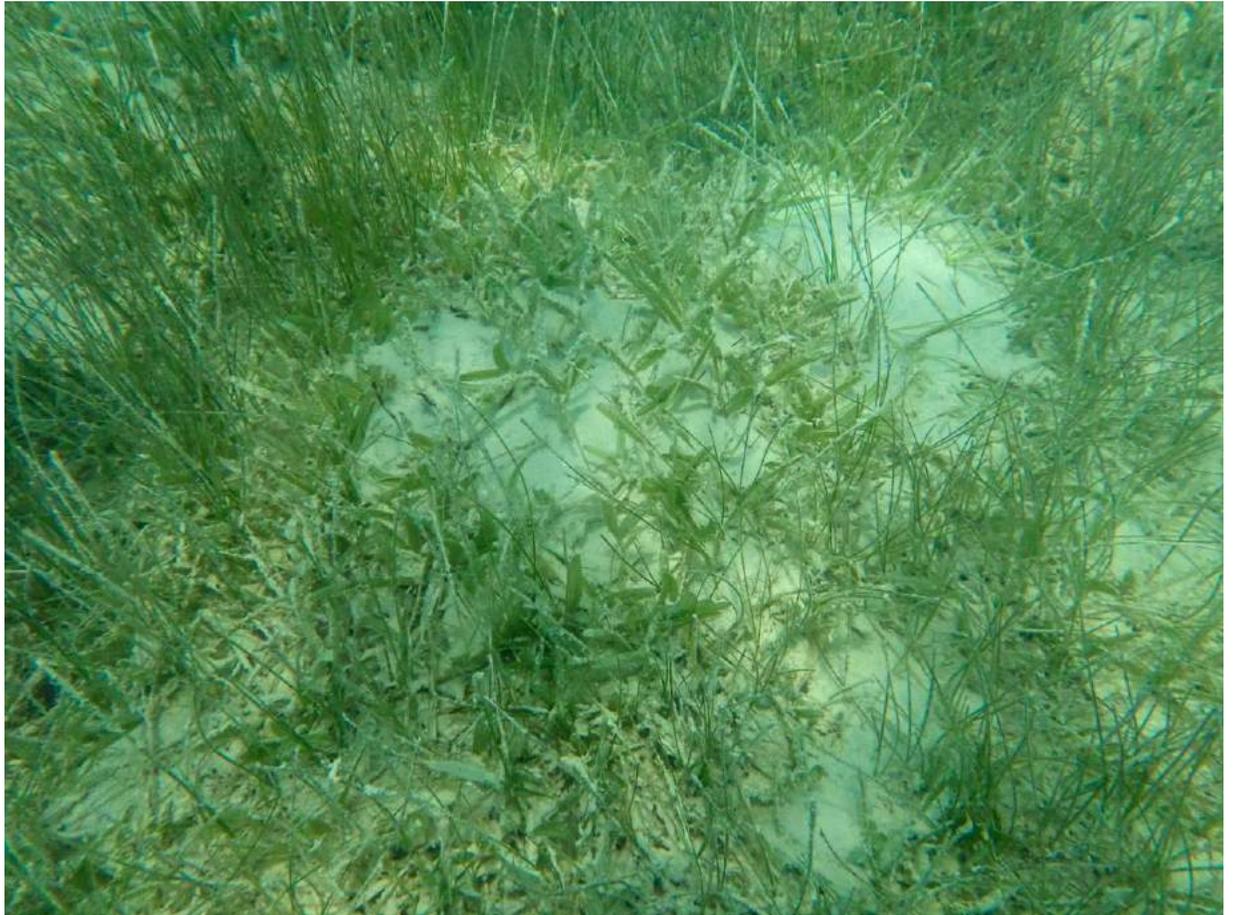
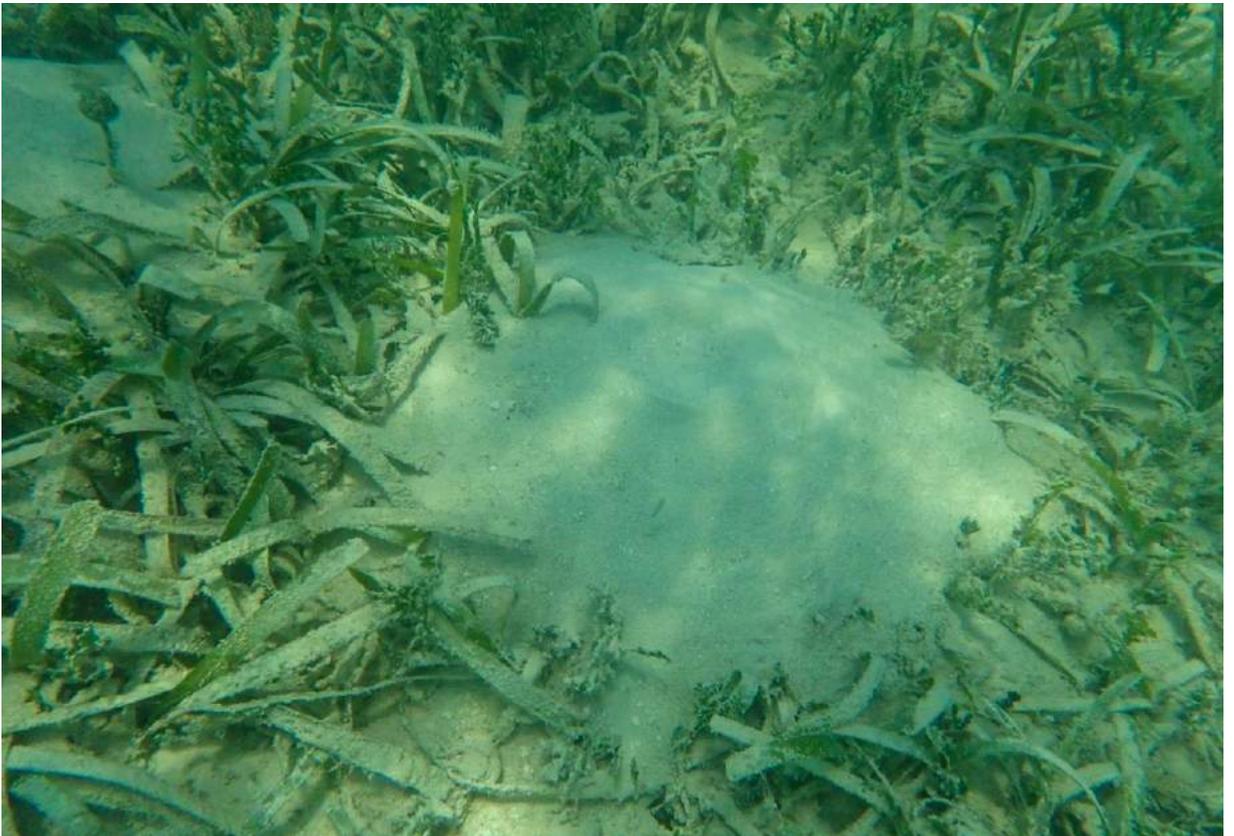
**Enclosure No.3D**

Beyond 20 ft. into the water the bottom bathymetry although possessed a mild slope downwards, was fairly irregular with irregular small undulations along the seabed with small peaks 1 ft. and low depressions 0.5 ft. above and below surrounding levels. See Enclosures Nos.3D & E. The surface sedimentology consists of a silty fine sandy with moderately dense seagrass. The sediment in reality may actually be finer than indicated by the laboratory test due to the loss in fines during the collection process.

Shallow depressions encountered along Sea Bed

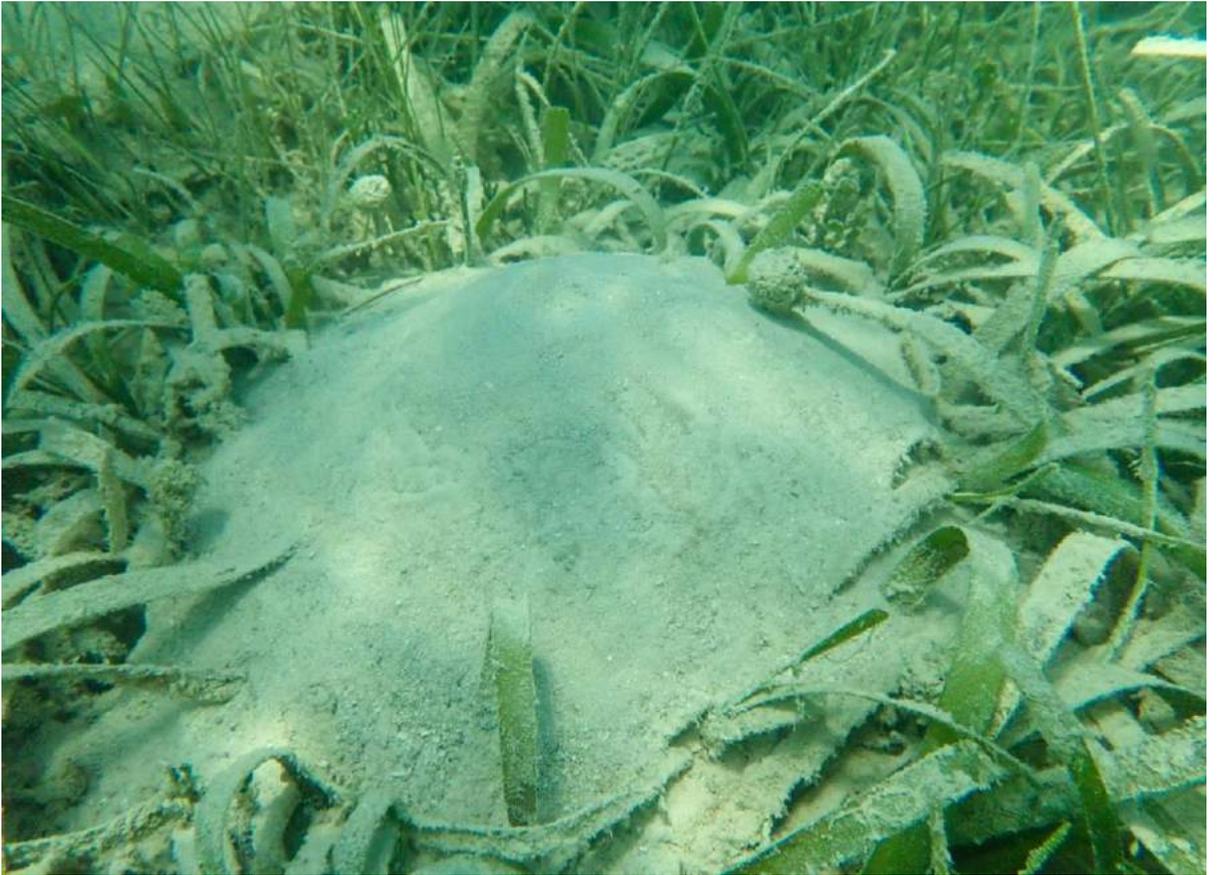
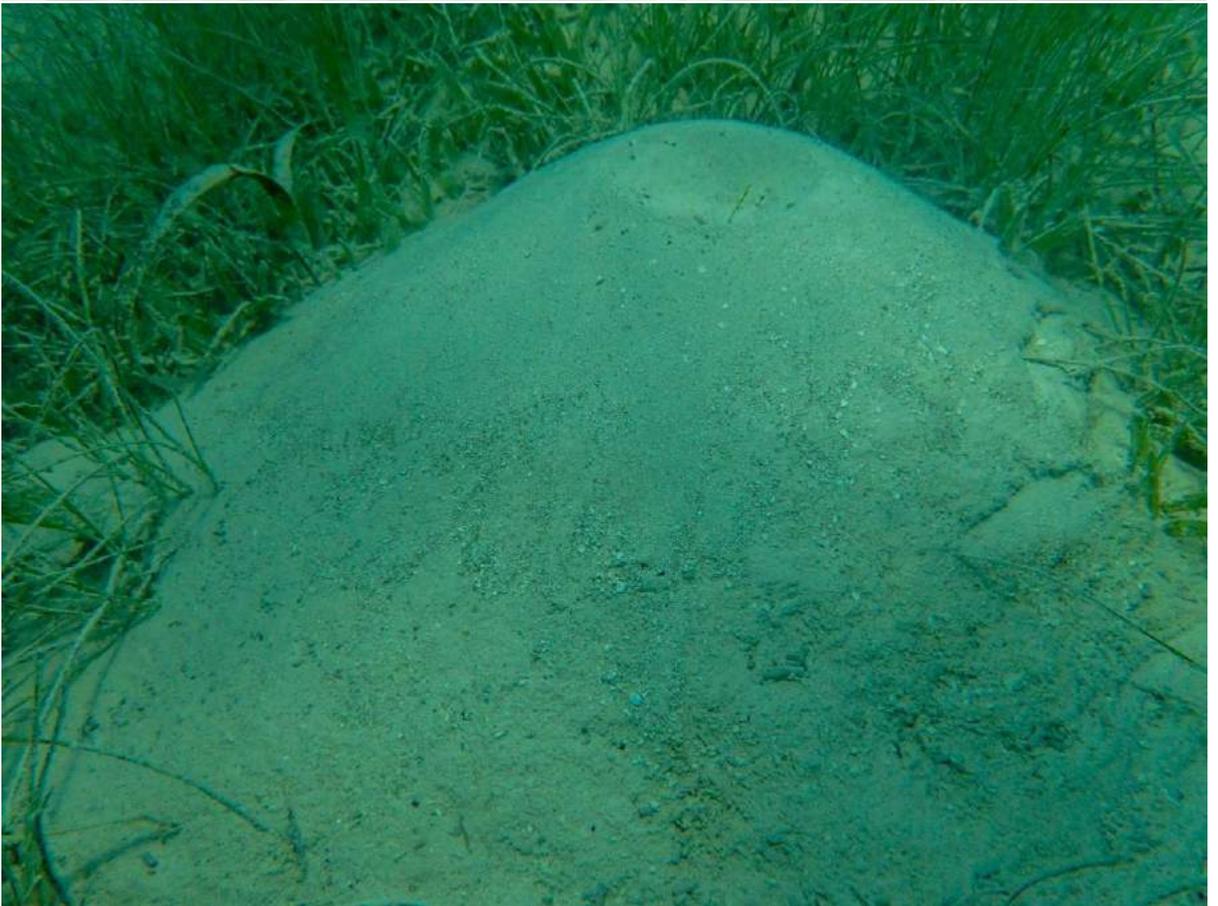
Enclosure No3E

Low mounds encountered on sea bed

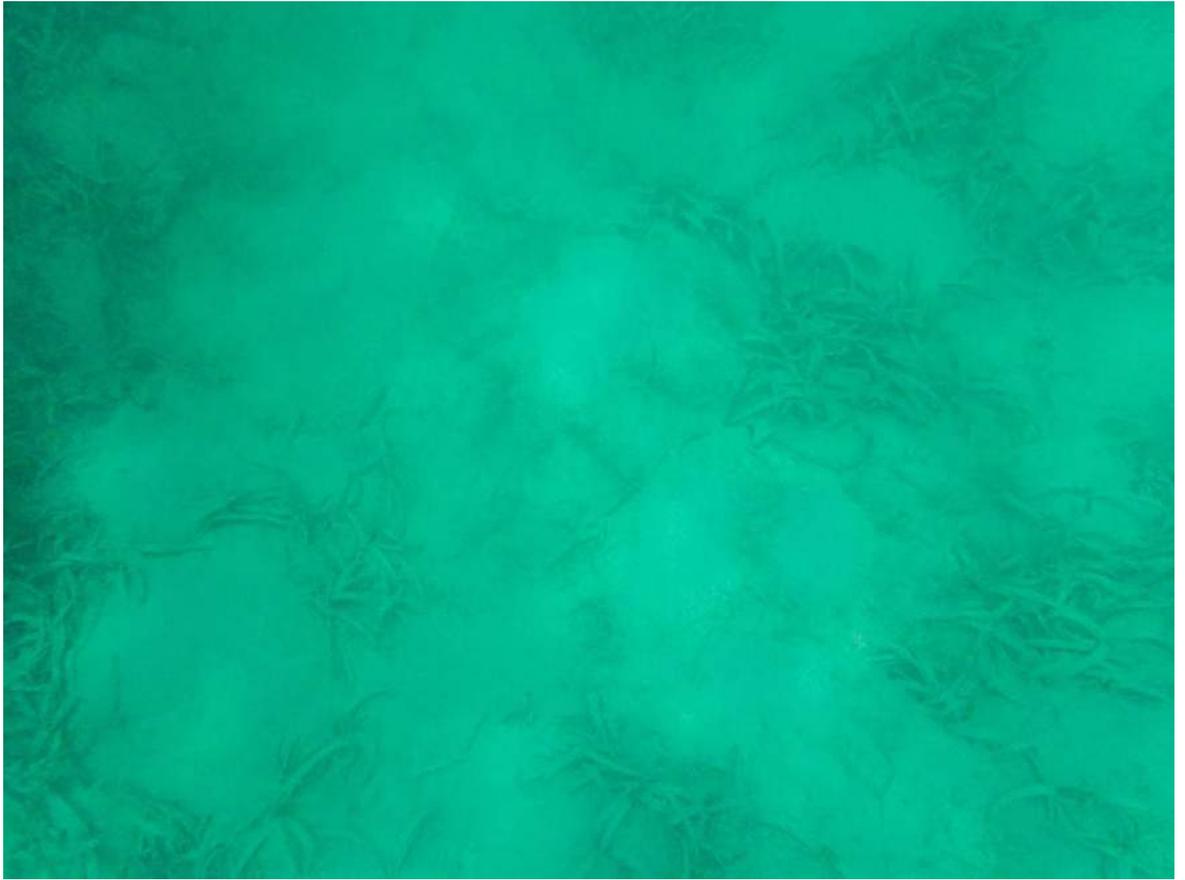
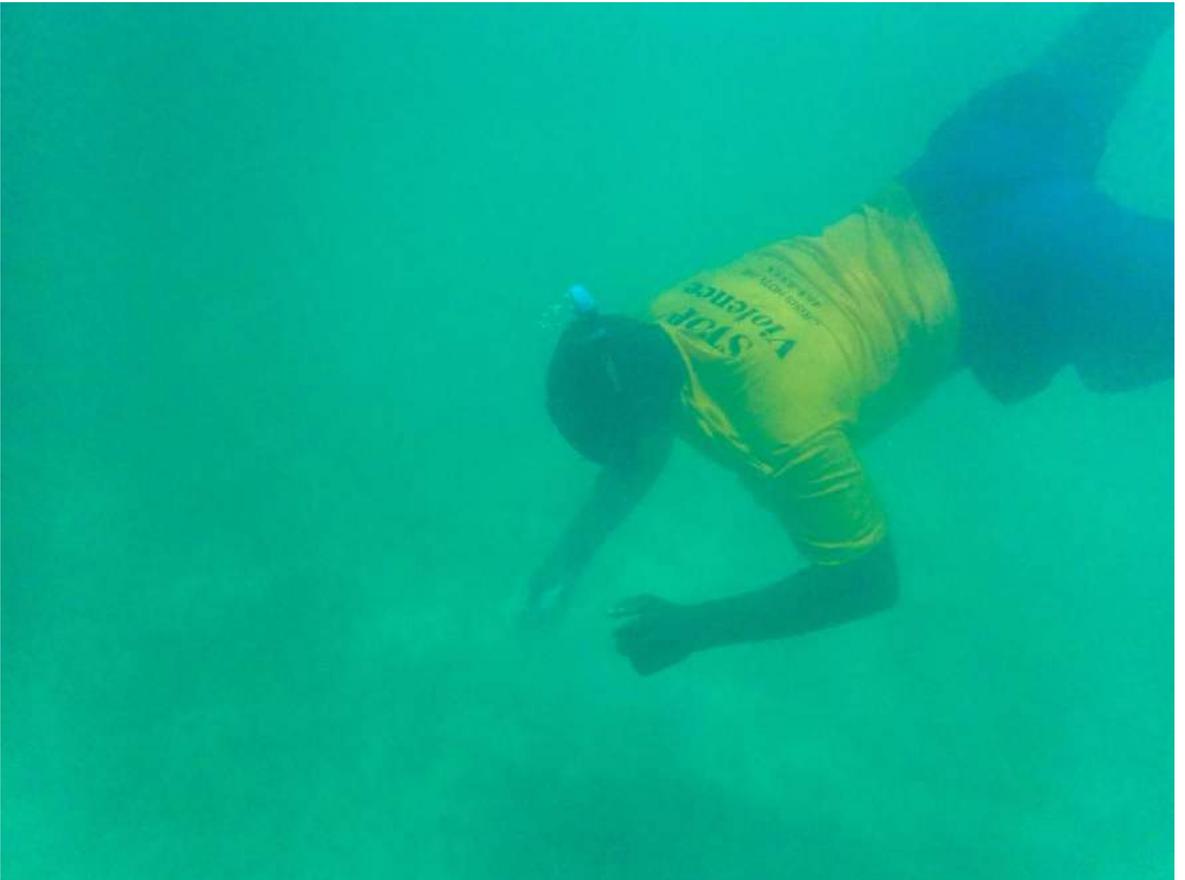
**Enclosure No.3F**

The undisturbed water appears to be very clear but readily becomes murky whenever disturbed as occurs when one walks on the seabed or even slightly disturbs the seabed while diving. See Enclosure No. 3F.

Decrease in water clarity when bottom sediment is slightly disturbed

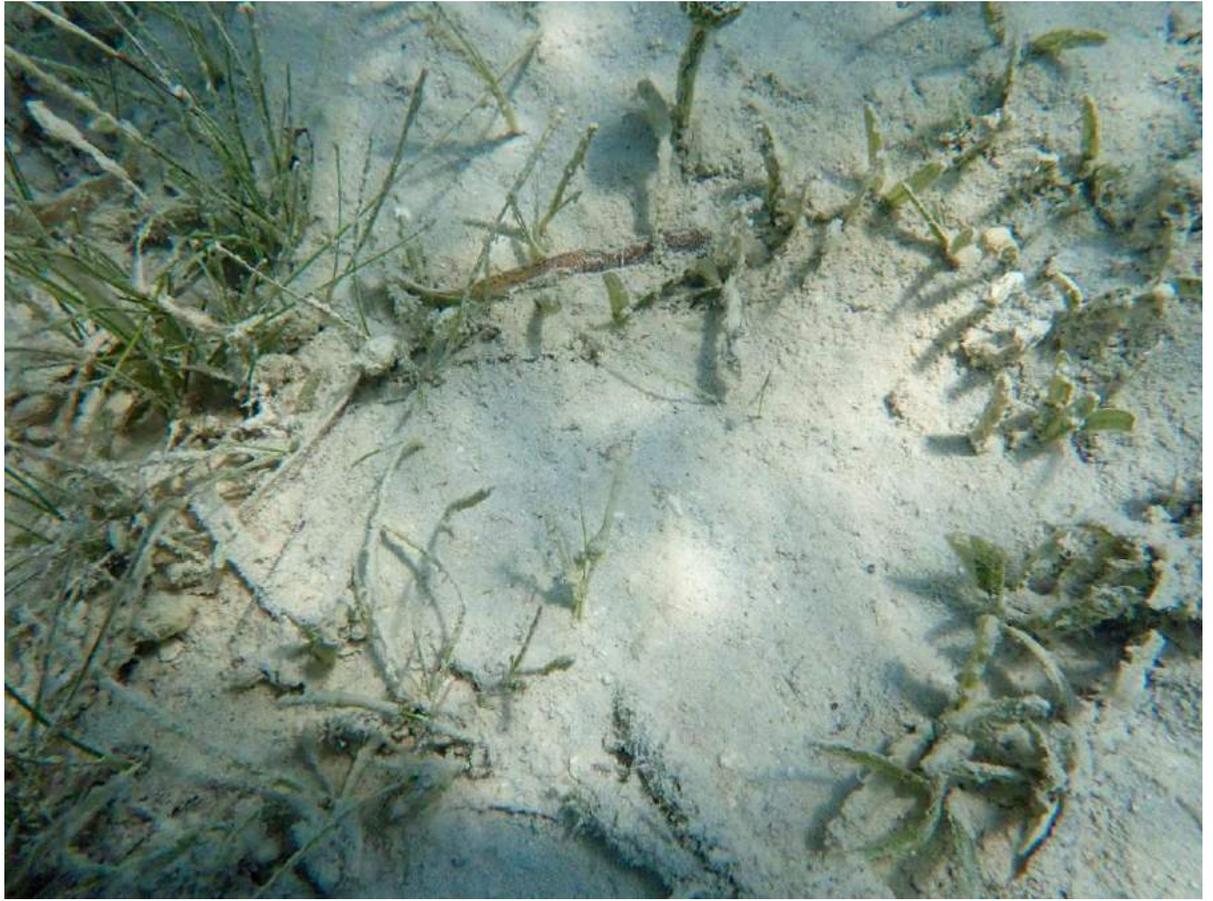
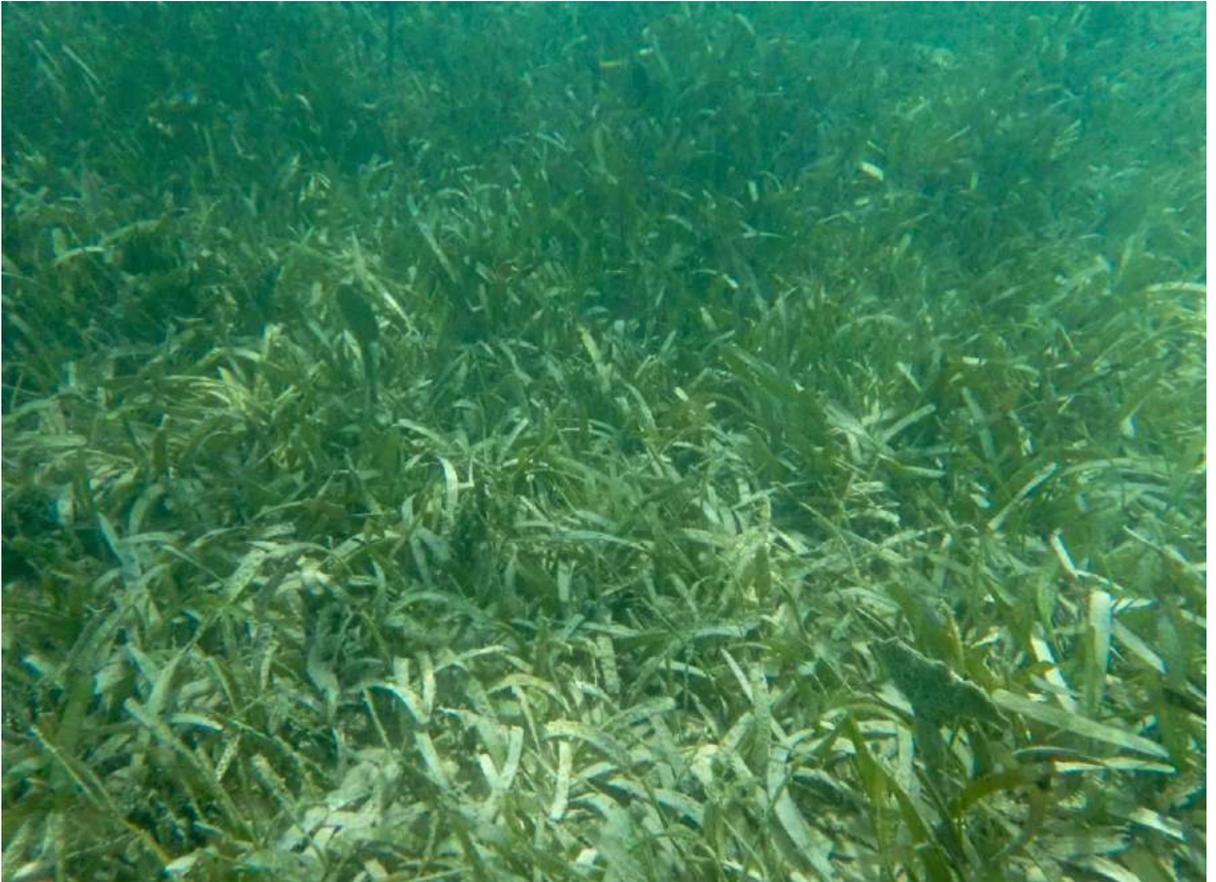
Clarity of water in undisturbed area dense & sparce seagrass **Enclosure No.3G**

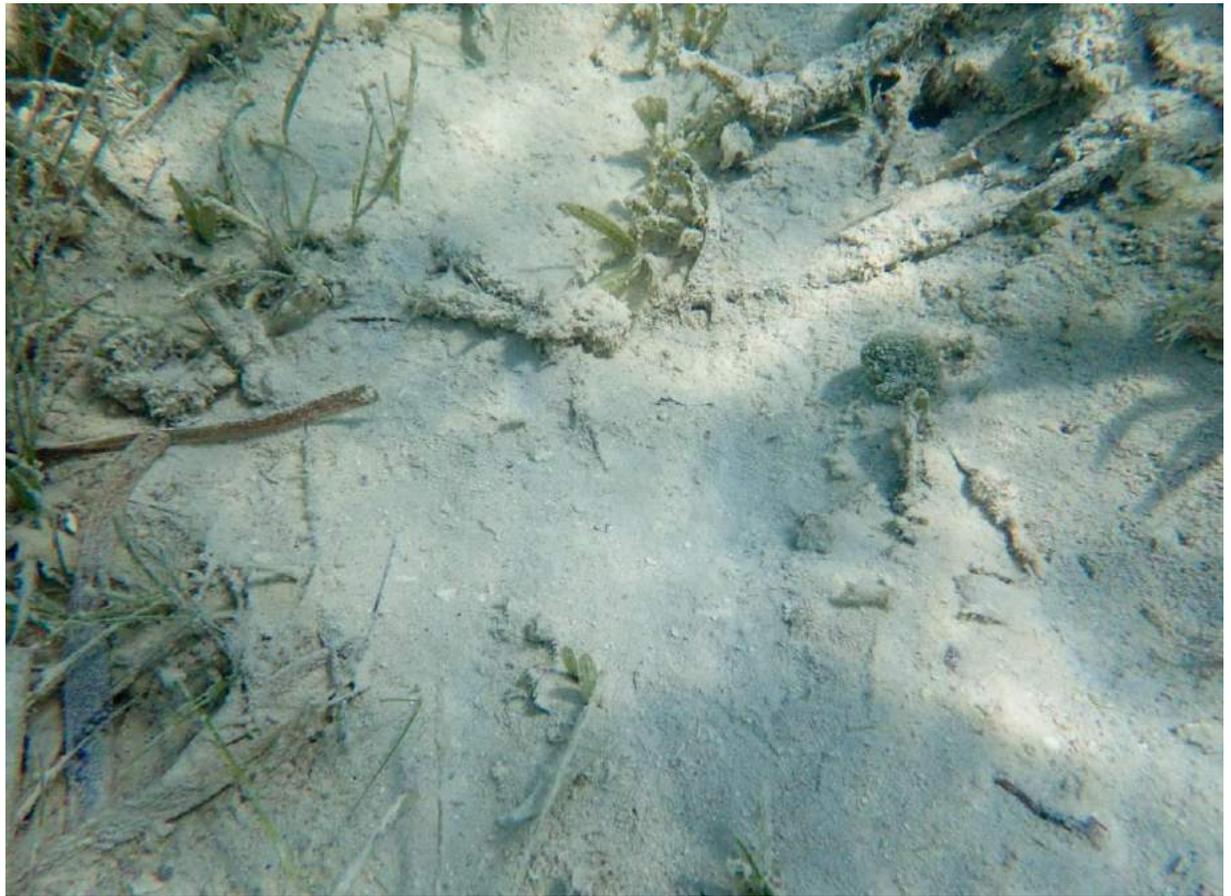
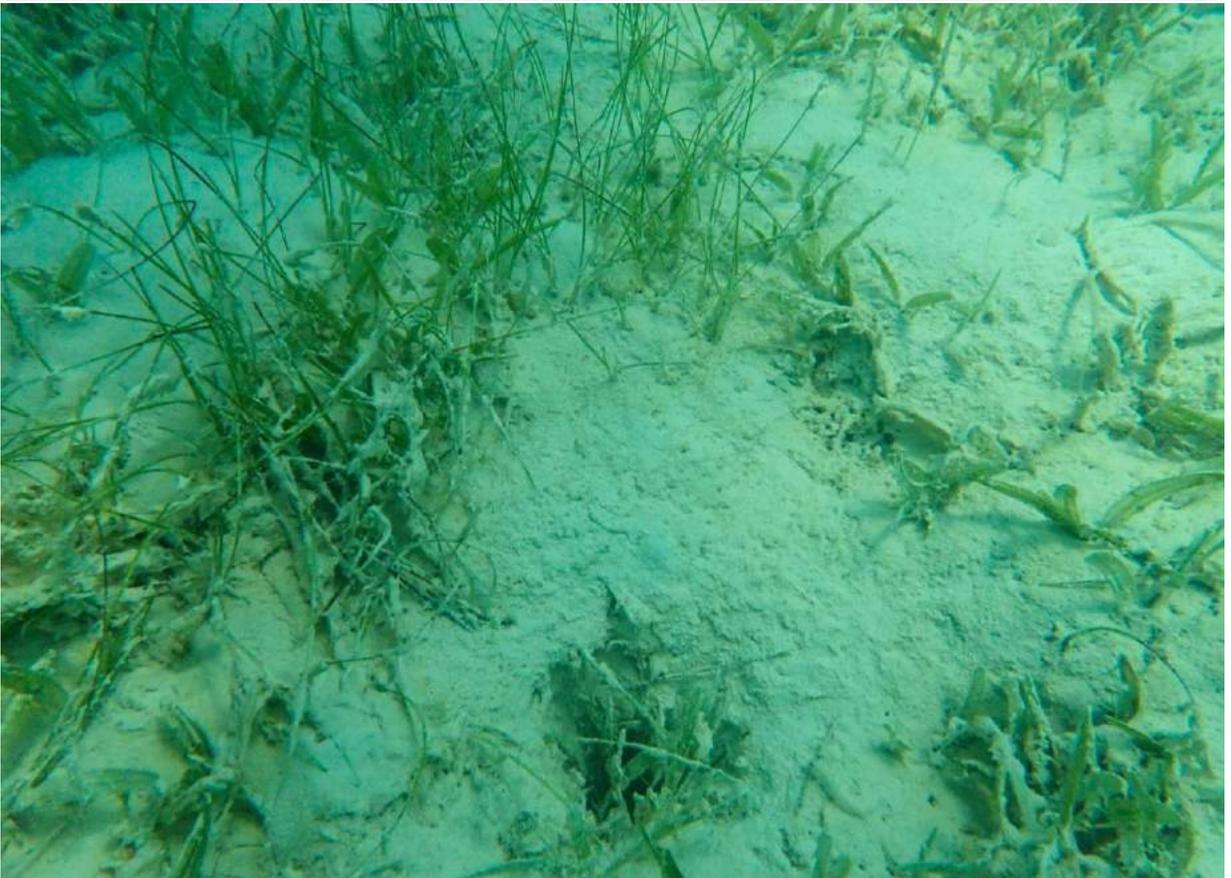
**Enclosure No. 3H**

The bottom surface may be described as mushy/ slimy with a sense on compression of the surface as one walked along the nearshore area. Appendix 1 shows the sieve analysis for 2 samples taken within the nearshore area. Further seaward the bathymetry is relatively flat with only a mild downwards slope seawards. The seabed lithology consisted of a similar fine sandy silt as encountered in the nearshore area but appeared in some areas to be finer than the material encountered further shoreward. There was however a marked reduction in the density of the seagrass. See Enclosure No.3H.

Area of Sparce Sea grass

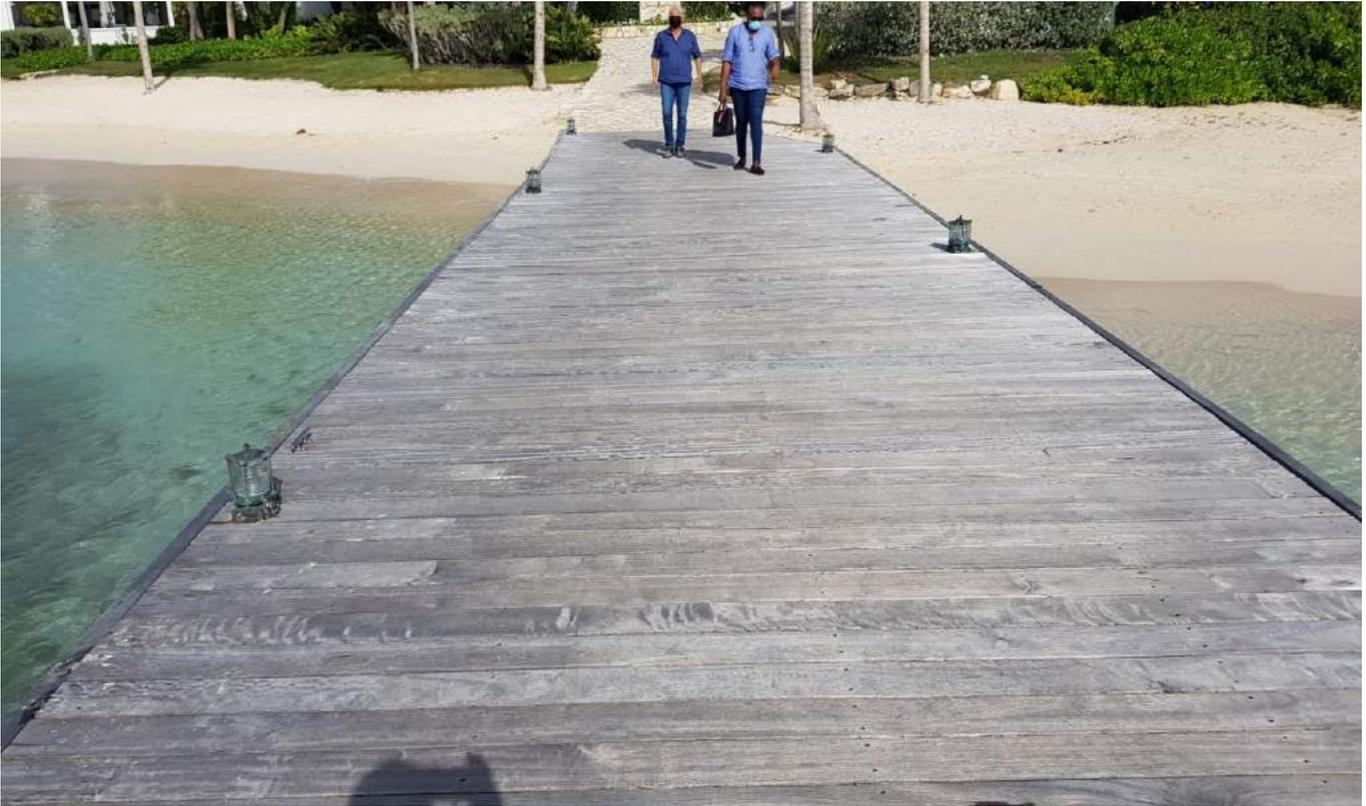
Sand is reported to accrete on the southern side of the Guest Arrival Jetty. This sand accretion is likely due to the partial blockage due to the jetty. JBIC has indicated that in the past a backhoe was used to remove the accreted sand from the shoreline and nearshore and place it on the other side (referred to in Coastal Engineering as “bypass” . The sand removal serves to maintain the water depth along the jetty. Currently the area on the south of the jetty is significantly

Guest Arrivals Jetty showing accreted on Right hand Site

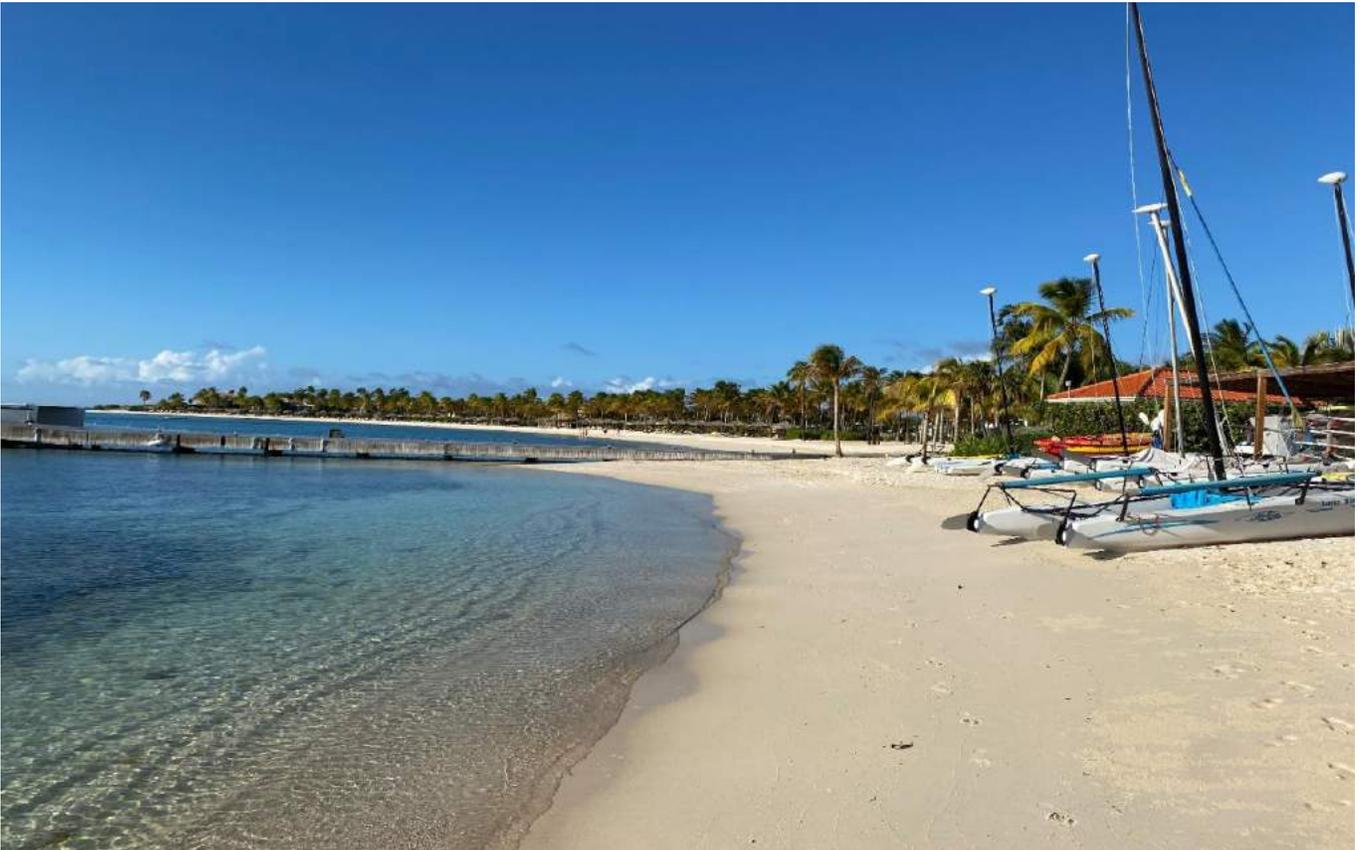
Southern side of Jetty on Jumby Bay beach where sand is to be removed

The quantity of sand to be relocated was not indicated. However based on observations on site, it is estimated that an area of approximately 100 m<sup>2</sup> is to be removed immediately along the south side of the dock. The depth of sand to be removed depends on the location and is estimated to vary from 0 up to a maximum of 1 m. The total volume of sand to bypass the jetty is estimated to be in the region of 50 m<sup>3</sup>. This is a relatively small volume.
