BATCH PLANT ENVIRONMENTAL ASSESSMENT AND BEST MANAGEMENT PRACTICES (BMP)

CCECC HEADQUARTERS COMPLEX, ST GEORGE, ANTIGUA

Submitted to the Development Control Authority
Antigua and Barbuda

March 25, 2021

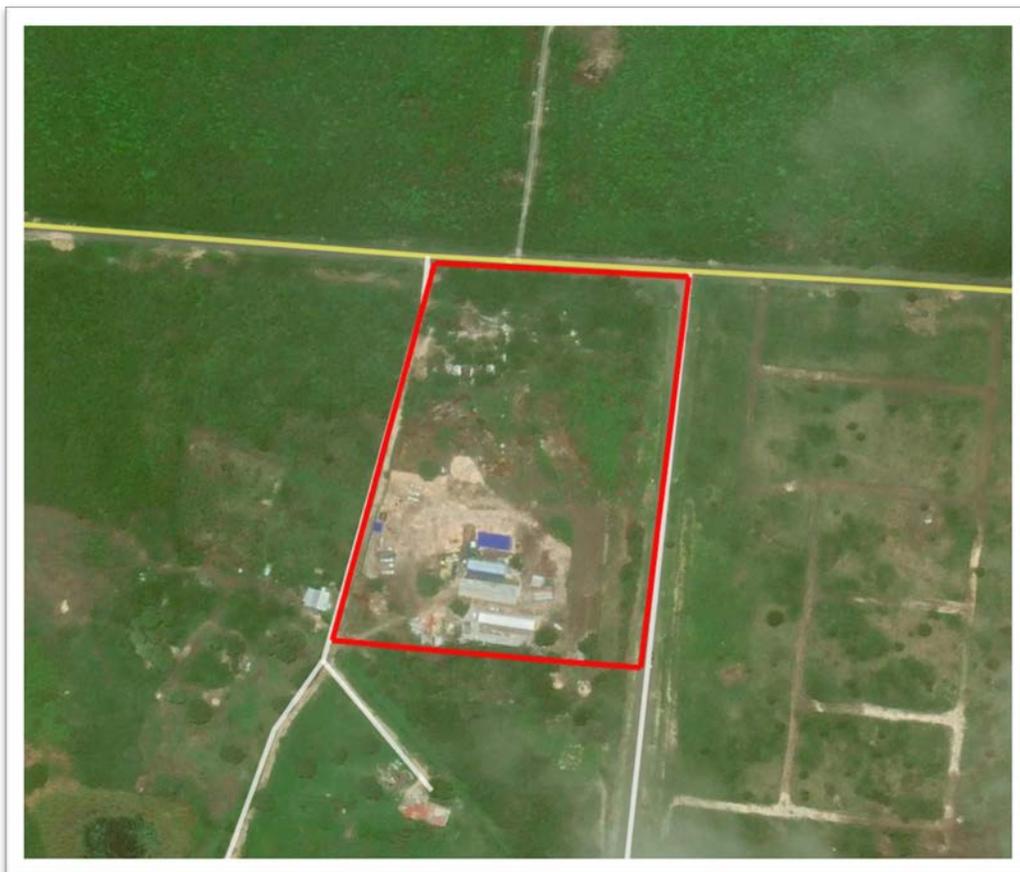
Figure 3. Area assessed by field surveys and drone imagery in March 2021.

An initial site visit was conducted on February 10, 2021. A landscape and vegetation survey was completed on March 1, 2021, and covered 2 acres (0.8 ha). These assessments were supported by drone imagery carried out on March 11, 2021, covering 11 acres (4.5 ha) (Figure 3). Remote sensing via Google Earth was used to assess historical, as well as current land use.

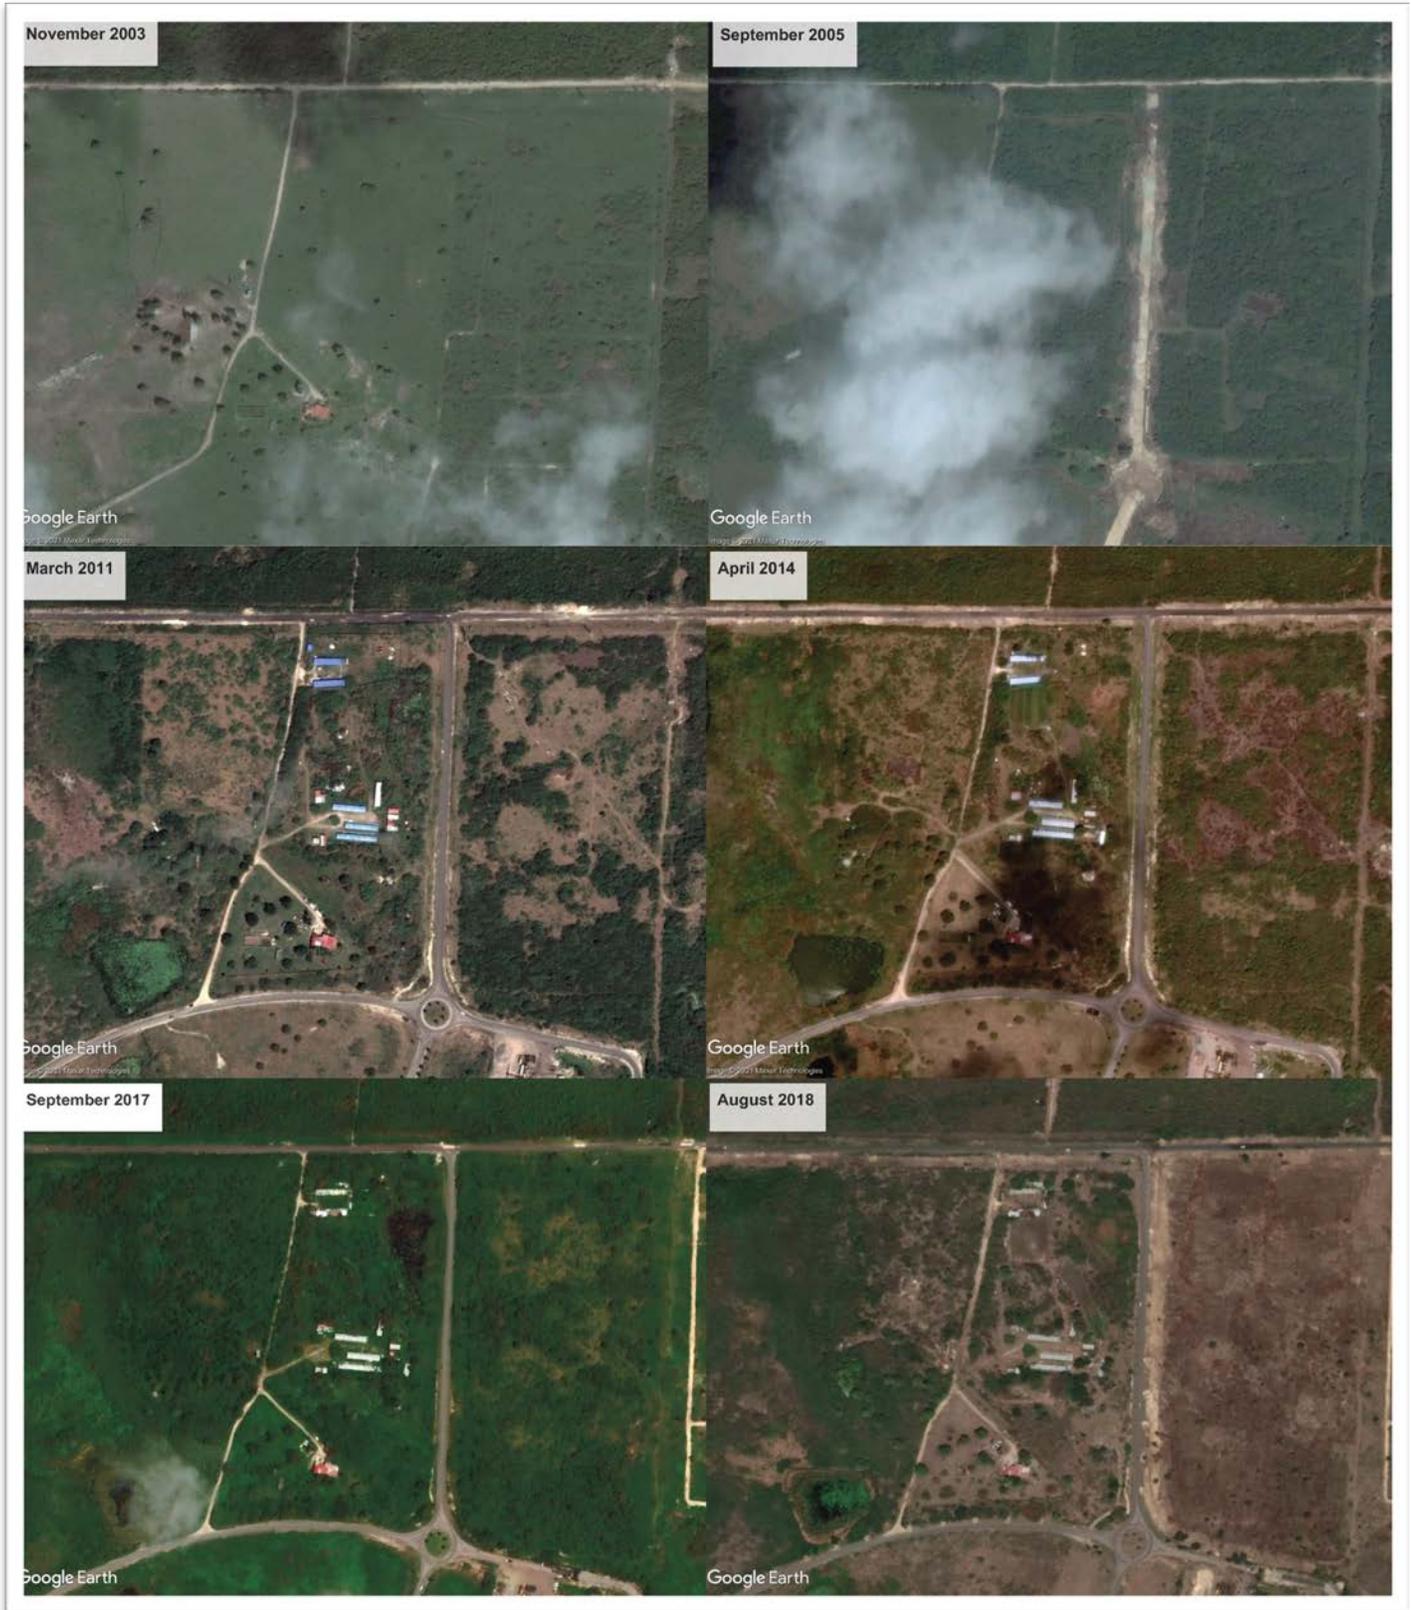
Historic aerial imagery of the site obtained via Google Earth shows that the area has been disturbed and developed several times prior to being acquired by CCECC for their headquarters construction. In 2003, the site was a grass-dominated field with few trees, suggesting that the site was cleared prior to this time since the surrounding area is tree-dominated.

By 2005, small trees and shrubs were growing on the site. However, much of this area was later cleared to construct several buildings on the site between 2005 and 2011. These buildings still exist on-site today. Areas of cultivation visible in satellite imagery from 2014 are overgrown in imagery from 2017 and are cleared of vegetation in imagery from 2018.

Figure 4. Aerial imagery of project site, 2003 – 2018, showing several cycles of clearing, building, and overgrowth.

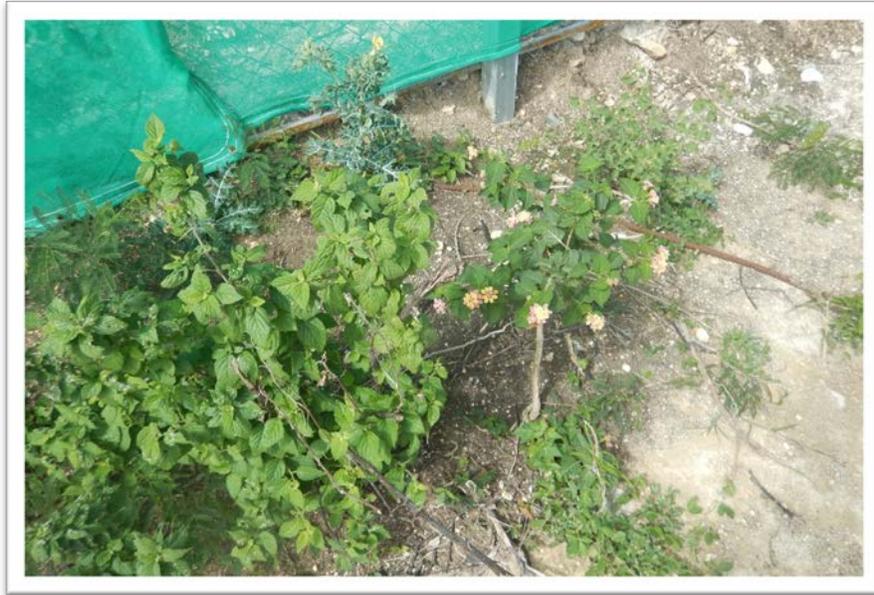
Figure 6. Photograph of *Lantana camara* and *Sonchus asper* observed on-site (March 1, 2021).

During the field surveys, plant species and assemblages on the site and adjacent to the west roadway were identified, and their condition evaluated. The site is dominated by opportunistic and, in some cases, exotic invasive, plant species. This is likely the result of the historic land disturbance noted earlier. Most plants identified on-site are adapted to exploit freshly disturbed habitats and are commonly found in marginal habitat and edge zones. No sensitive vegetation species were observed on-site. Sensitive species are those species that are listed as threatened or endangered by the IUCN Red List, protected per the Antigua and Barbuda Environmental Protection and Management Act (EPMA) 2019, or are regionally endemic (as determined by Pratt et al., 1997). A list of plants observed by the field biologist on the site and the adjacent roadway is provided in Table 1. Photographs of the most common plant species are provided in Figures 6 and 7. No birds or wildlife were documented using the site during the assessment.

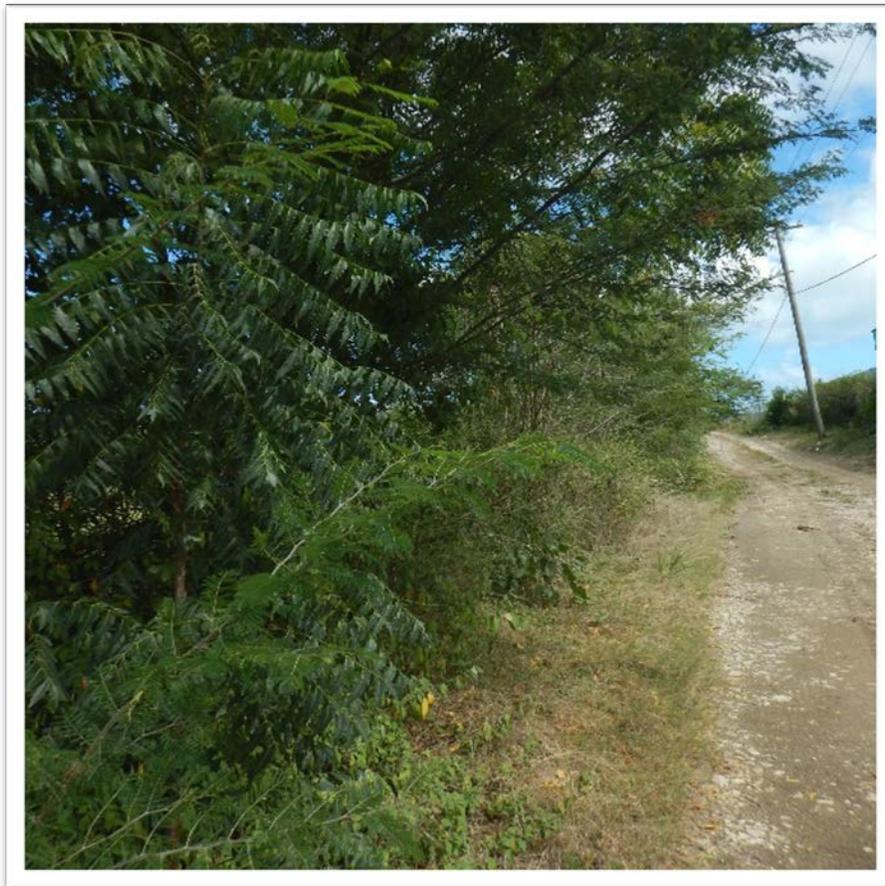
Figure 7. *Azadirachta indica* and *Tamarindus indica* observed along west roadway near CCECC site (March 1, 2021).

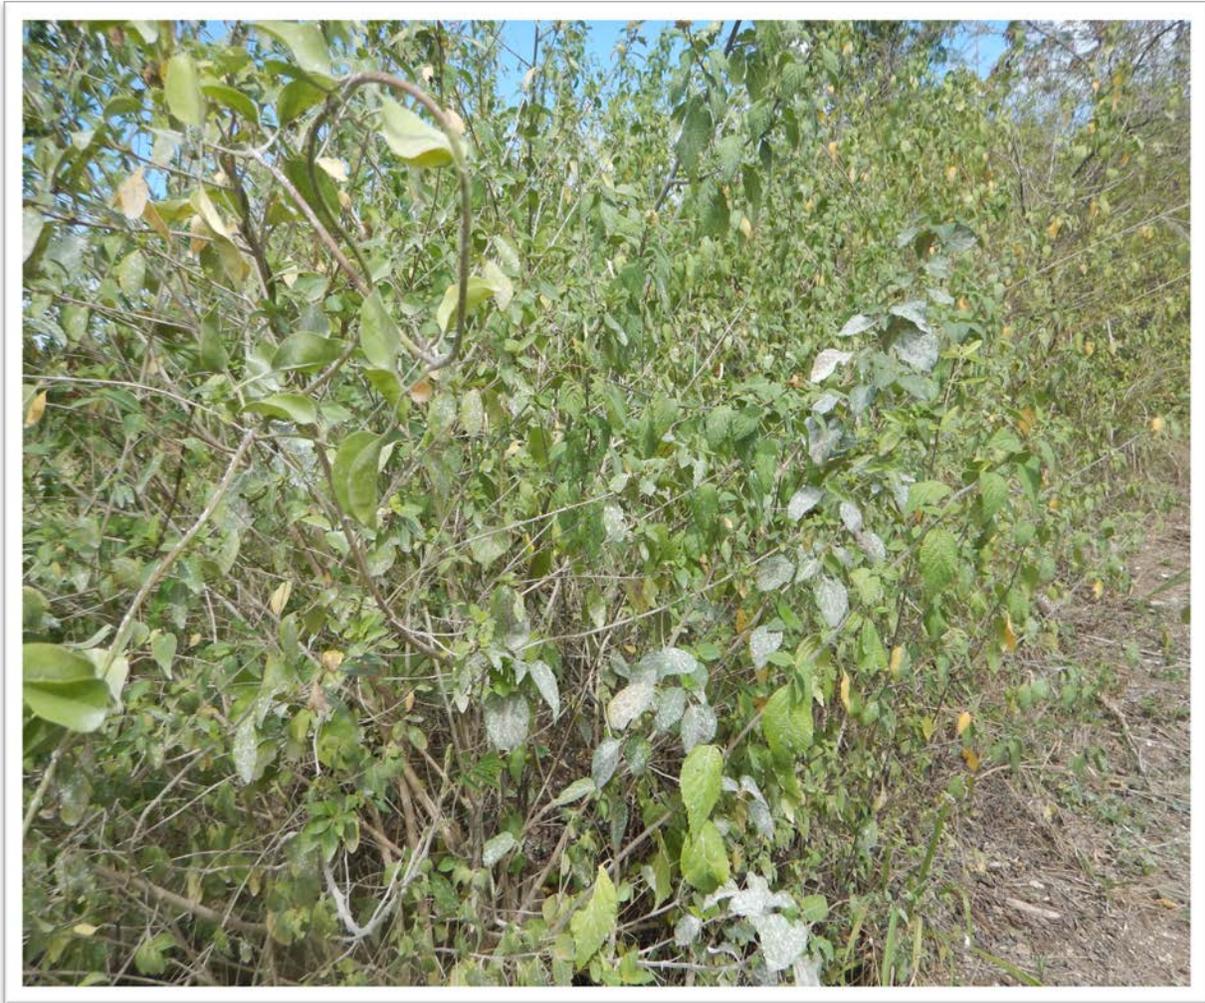
During the survey and in one area along the west side road, there was evidence of track-out on roadside vegetation (Figure 10). However, this was a localized observation, and the finding of only one such incident indicates that, as long as concrete-truck traffic remains light and mostly on-site, this is not likely to be a significant contributor to air (dust) pollution or vegetation pollution off-site.

Figure 10. Example of track-out concrete splattering observed along west side road outside project site, (March 1, 2021). This is not expected to be a main concern during construction due to infrequent off-site travel.

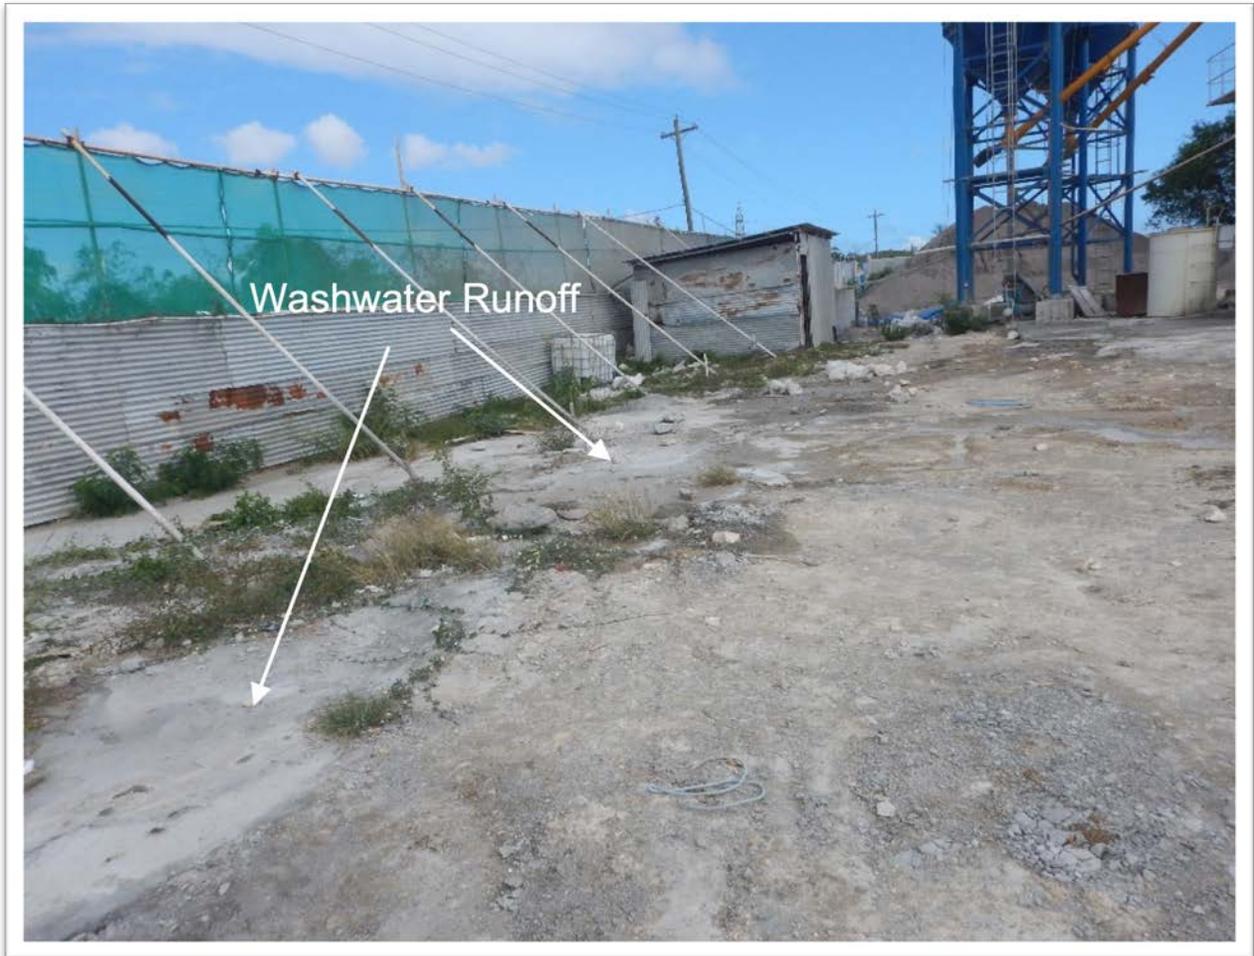
This offers the best BMP solution to waterborne pollution management. During the site visit in March 2021, the biologist observed evidence that washout water is being discharged onto the bare ground in batch plant area between the plant and the access gate (Figure 12). Although concrete washout is not directly being discharged into waterways or groundwater, it could reach waterways via runoff or percolation.

Figure 12. Photograph of visible washwater runoff (Observed March 1, 2021).

The biologist alerted CCECC to this issue. In follow-up discussions with CCECC, they proposed moving concrete washout to an area that drains to an existing open tank on-site (Figure 13). As long as the tank is contained and water does not percolate into groundwater or soil, this appears acceptable.

As a BMP, we recommend that concrete washout be collected in an impermeable basin, where water and solids can be separated to be recycled on-site. The basin should be able to retain washout water with sufficient freeboard to avoid overflow during a 20mm rain event. Examples of concrete washout areas are shown in Figure 14 below. A simple concrete washout area can be constructed using hay bales and an impermeable plastic liner. Prefabricated options made of metal or vinyl are also commonly used. Water and solids can be separated by natural settling, or a filter bag can be used.

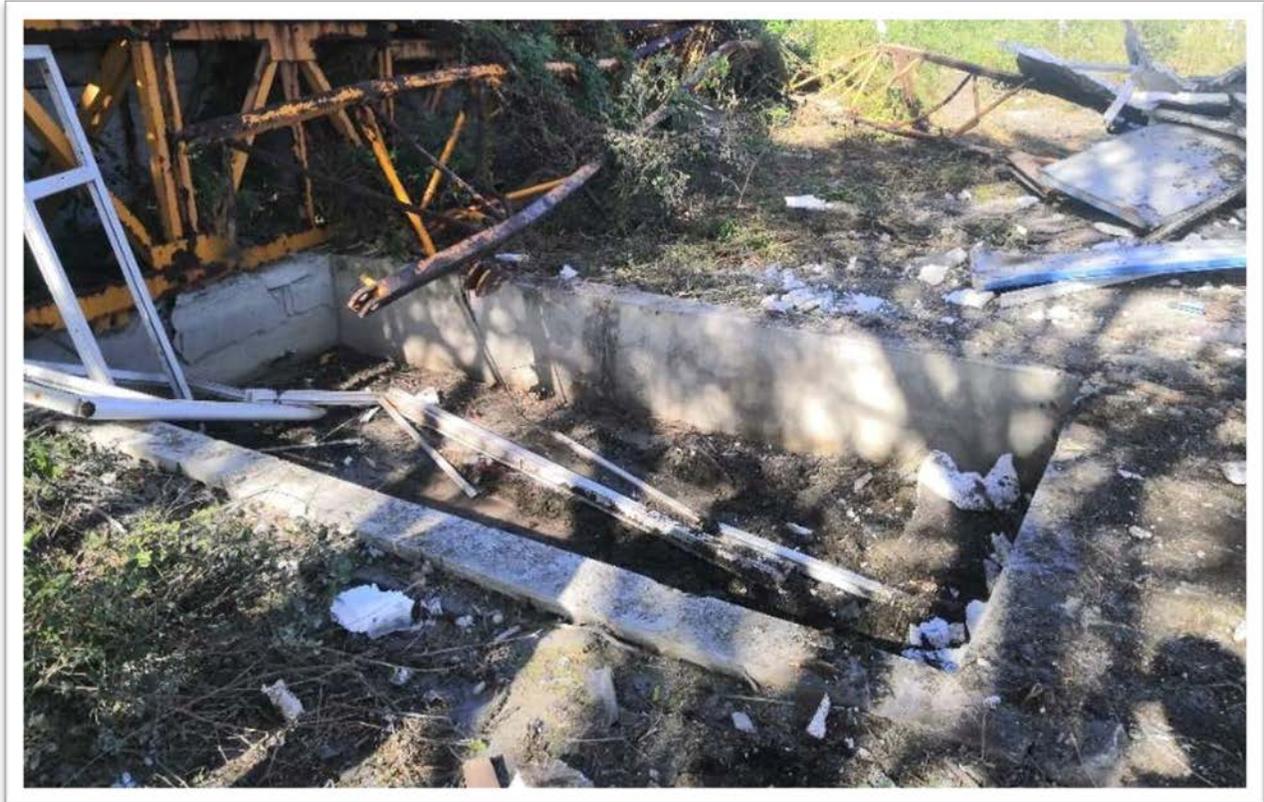
Figure 13. Existing tank proposed to retain truck washwater.

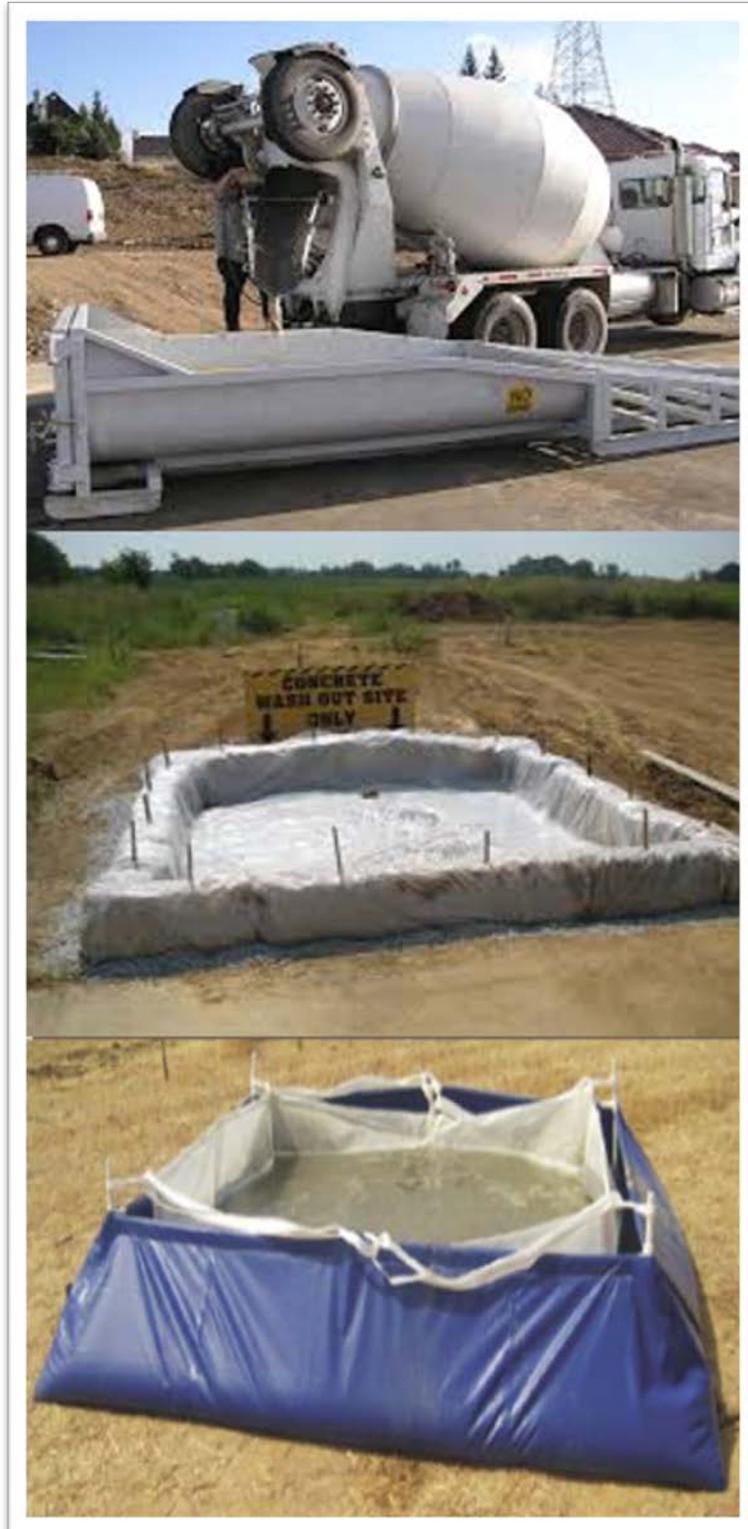
Figure 14. Examples of concrete washout areas. Top: Roll-off metal container. Middle: Washout area constructed from hay bales and an impermeable plastic lining. Bottom: Vinyl washout area with filter bag to separate water from solid materials.

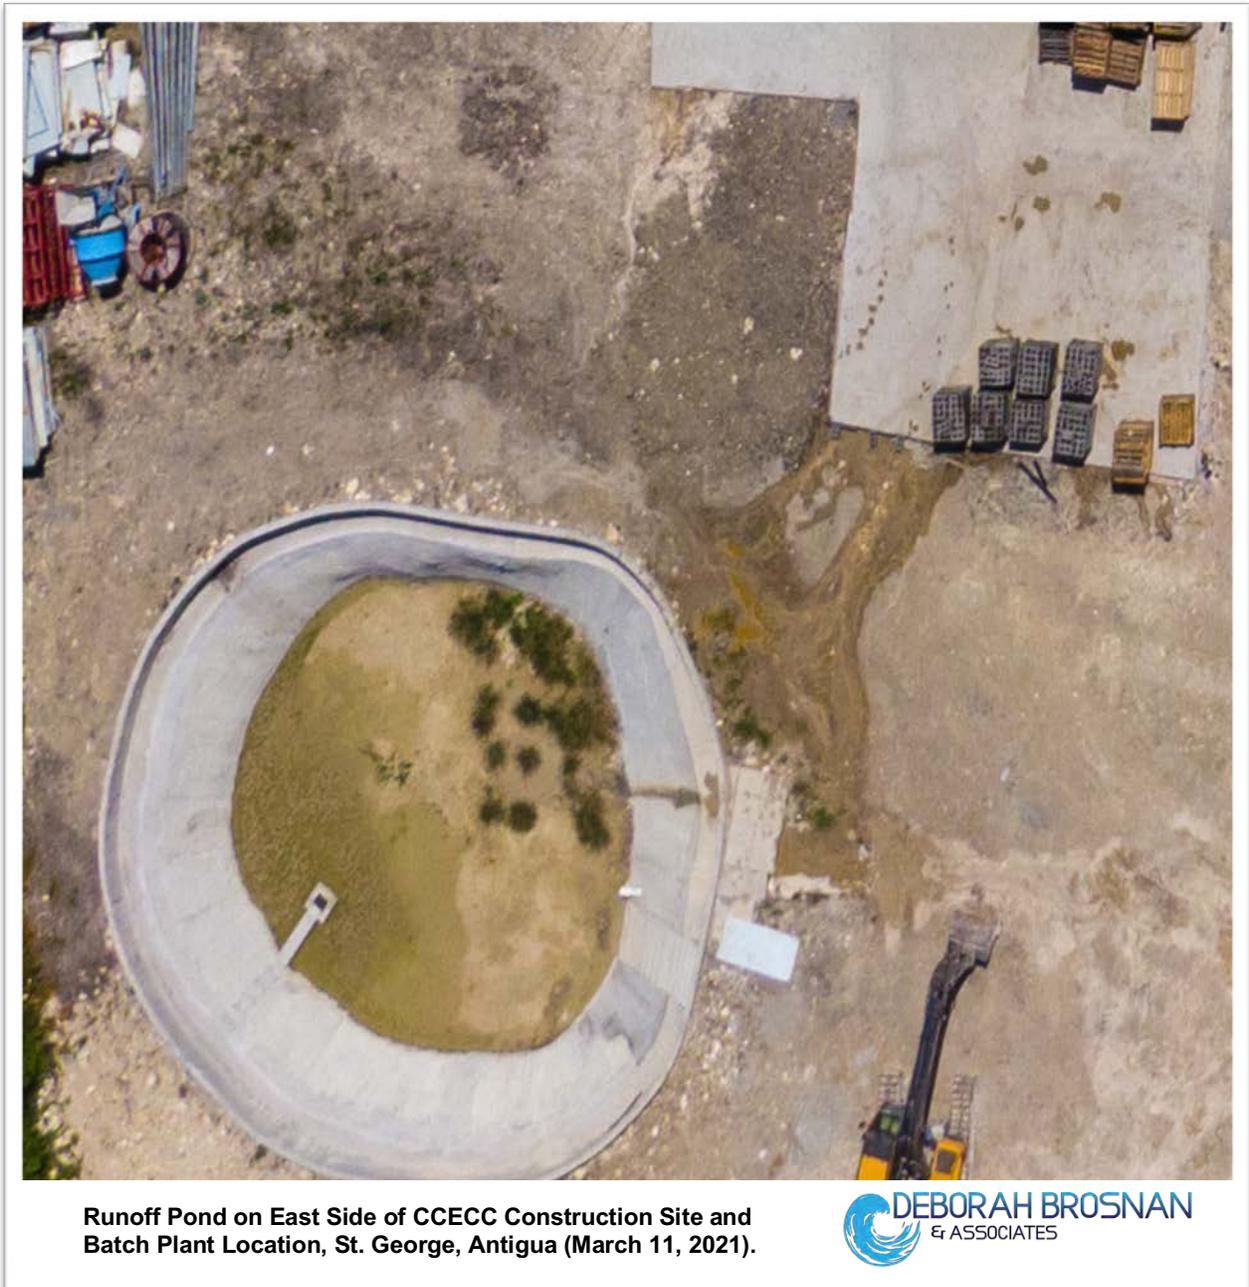
Figure 15.

A constructed pond with impermeable sides is located on the east side of the site. The pond was partially wet when observed in March 2021, and it appears to be receiving runoff from an existing concrete pad that may be used to wash equipment (Figure 15). A grassed swale is recommended to convey drainage from the concrete area to the pond; this would trap sediment and impurities and improve the overall quality of the runoff water.

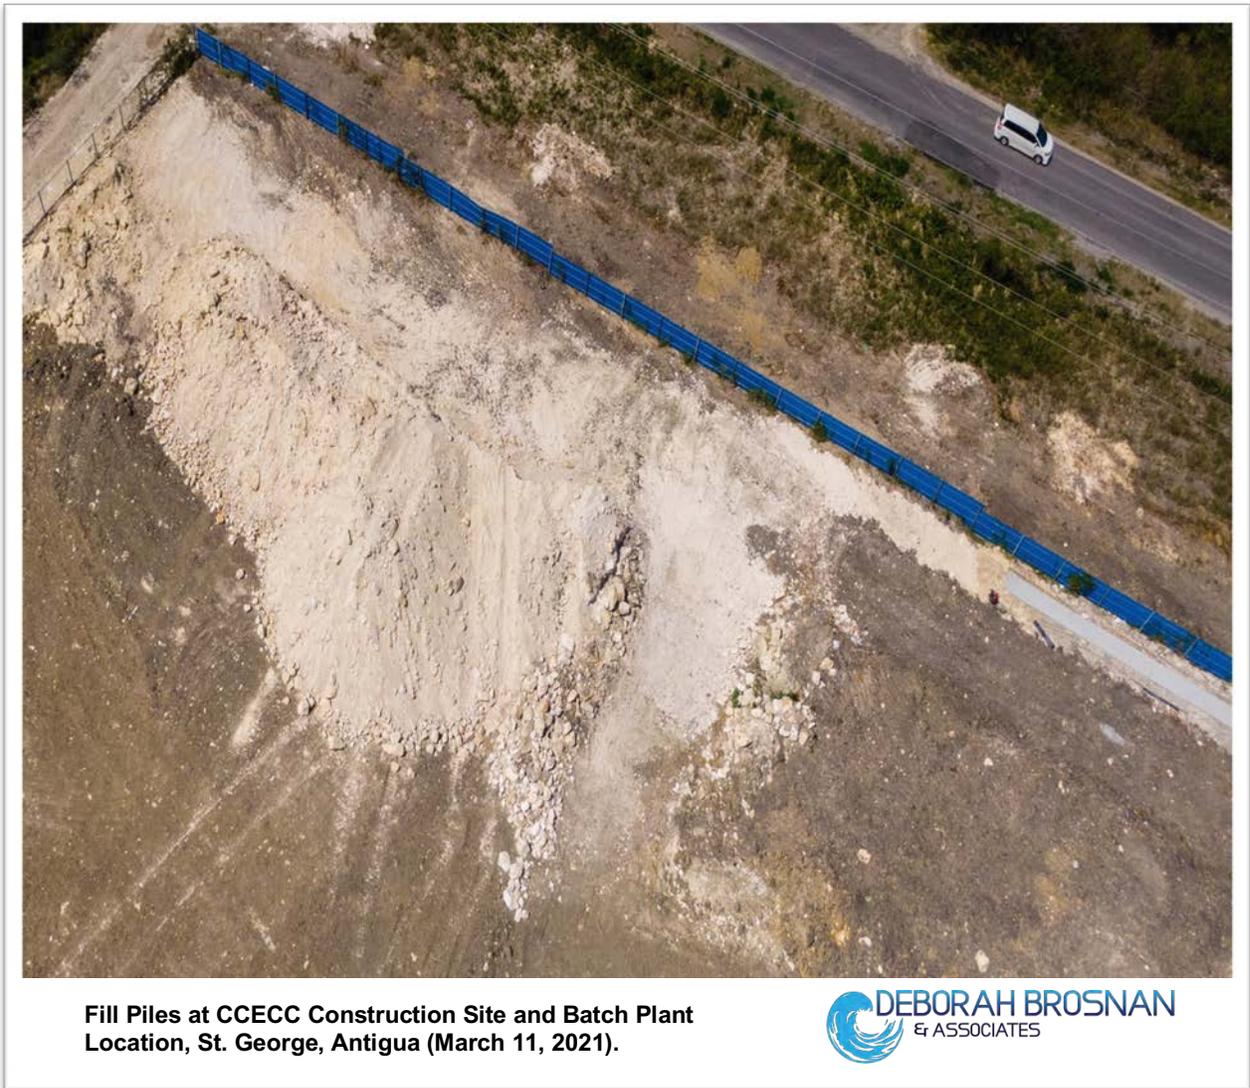
Figure 16.

Based on observation of the site, erosion control is not a major concern with the batch plant operation. However, there are piles of loose fill on-site in the construction area (Figure 16) that may be washed away during heavy rains or storms. These loose fill piles can be protected from erosion during heavy rains via a silt fence and impermeable covering (Figure 17). This will also stop sediment-laden runoff from spilling out of the site.

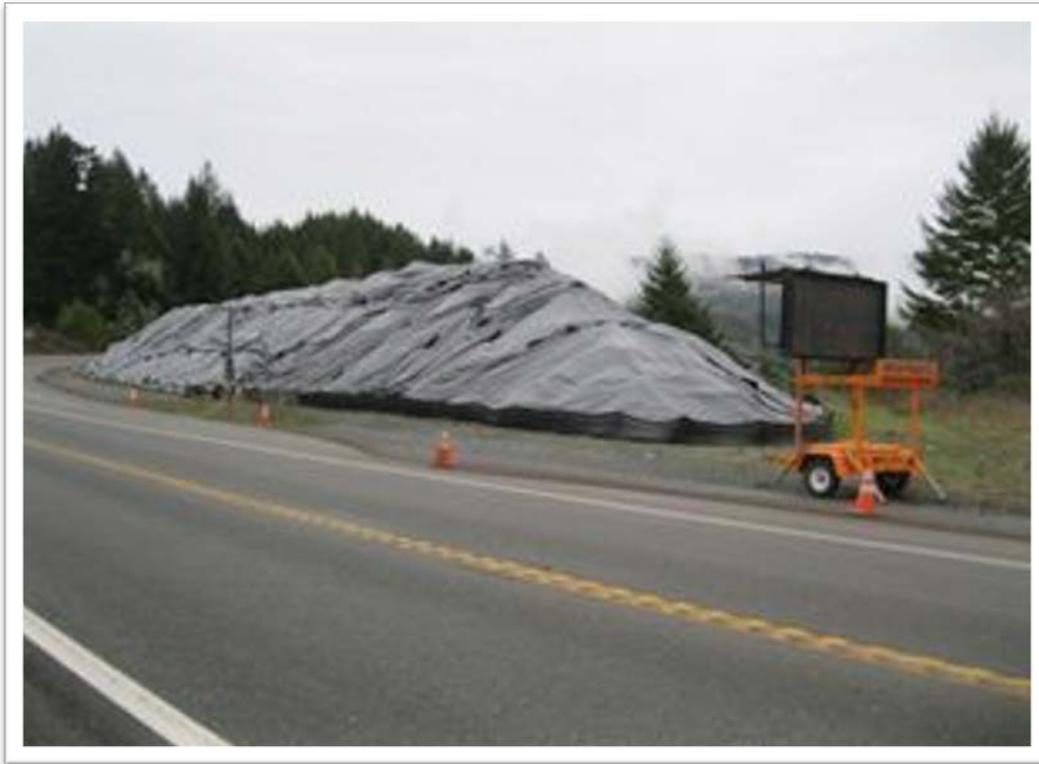
Figure 17. Example of fill pile protected with cover and silt fence to prevent material from running off in rains or blowing off during wind storms.

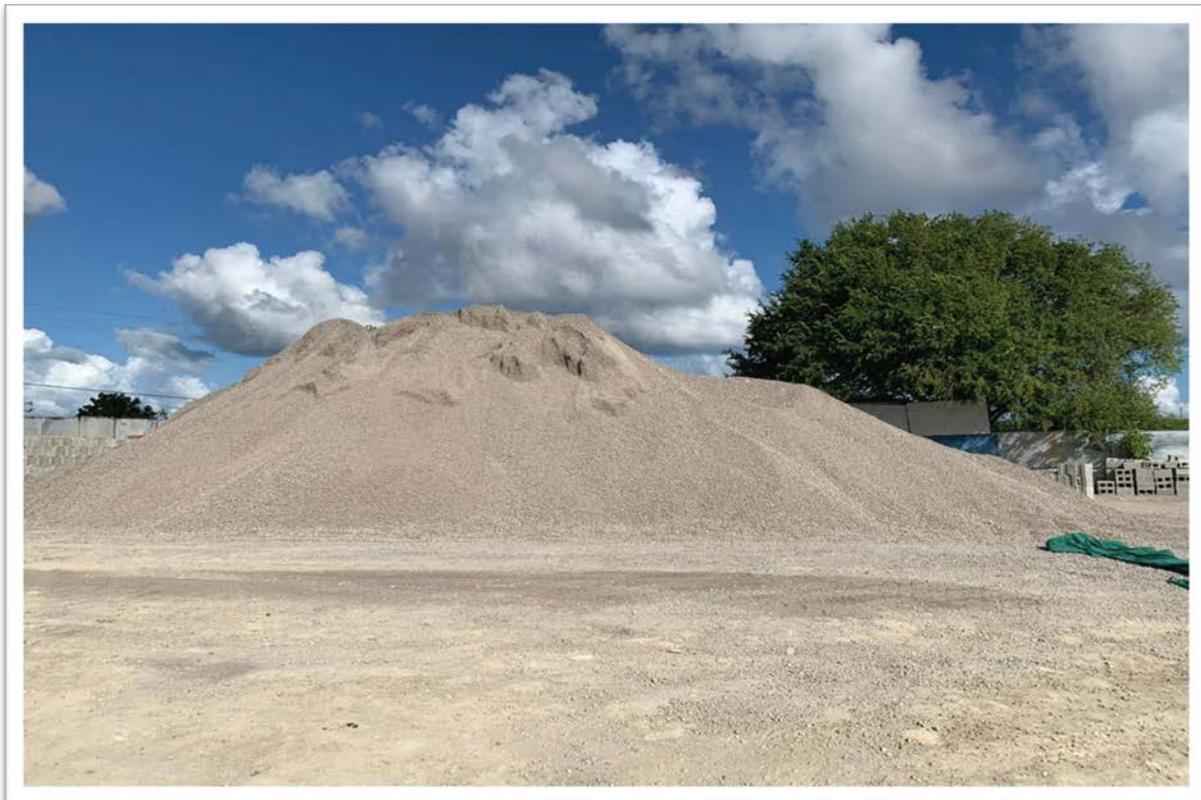
Dust is a common issue on construction and concrete batching sites. Particulate matter from unvegetated soils can be made airborne by vehicle and equipment movement and winds. Wind action can also pick up dust from unprotected aggregate piles. Dust becomes easily airborne at material transfer sites, as well. Filters on the cement silos and dust screens downwind of the batch plant are being used on-site to control dust currently. The stockpiles on-site are partially protected from the wind by low walls (Figure 18). The cement silos are replenished by closed trucks. During the two site assessments, vegetation on and adjacent to the site was relatively free of dust from the batch plant.

Figure 18. Aggregate stockpile on-site.

The dust control systems on the batch plant should be maintained and filters replaced, as needed. To further control dust, loads of raw materials (e.g., sand/aggregate) should be covered while being transported to the site, and the top layer of material should be damp for transport.

To minimize wind-driven dust movement around the coarse aggregate stockpiles, full enclosures should be built around the stockpiles. Until such time as these enclosures are built, regular spraying of the coarse aggregate stockpiles should be conducted for dust suppression, and stockpile height should be limited to reduce dust creation. Additionally, regular wetting of the batch plant grounds should be conducted to suppress dust, particularly during the drier months.

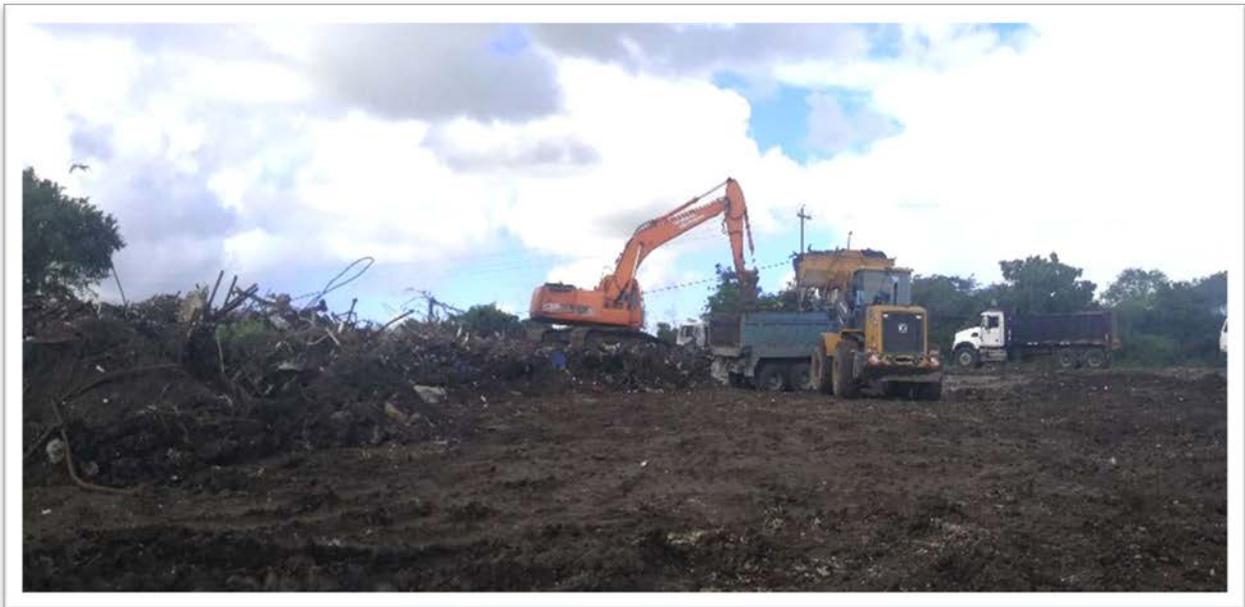
Figure 19. Disposal of construction waste at Cooks Landfill.

Solid waste on Antigua is disposed of at Cooks Sanitary Landfill in the Five Islands area. Construction waste and refuse from previous development should be removed to Cooks Landfill following the completion of construction (Figure 19). Waste concrete from testing or spills should be recycled on-site. Hazardous materials (paints, oil, diesel, etc.) should be stored separately from construction waste on-site and disposed of properly at Cooks Landfill.
