Environmental and Social Impact Assessment Report for the Paradise Found Development, Barbuda

Submitted to: Mr Darren Flanagan
For Paradise Found LLC

19 May 2023

Smith Warner International Limited Unit 13, Seymour Park, 2 Seymour Avenue Kingston 10, Jamaica, WI

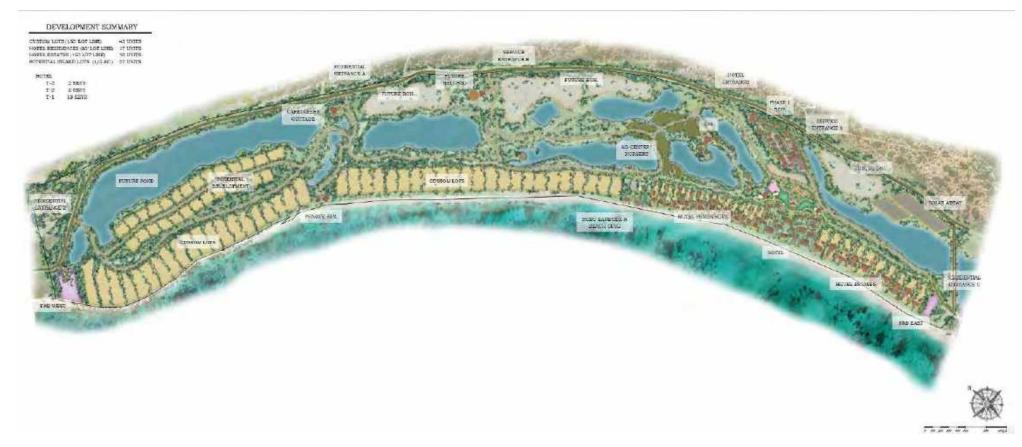
Figure 2.2 Development plan

As shown in Figure 2.2 this development will include the following facilities:

- Nobu Beach Inn Clubhouse
- Guest Villas
- Arrival Area
- Beach Bar
- Nobu Restaurant / Satellite Restaurant
- Sales Village
- Spa
- Tennis and Kids Club
- Farm and Nursery
- Logistics and Staff Center, and
- Home Sites.

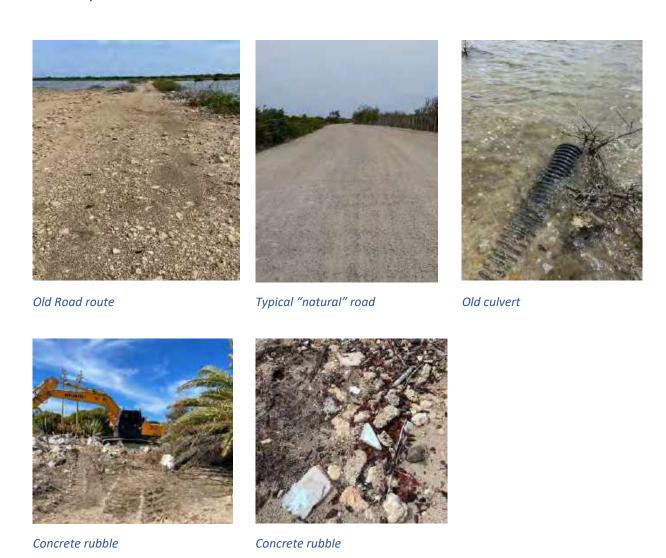
Figure 2.4 Existing road that crosses the salt pond at the south end of the property

Phase 2 of the road realignment will involve improving and rehabilitating the old existing road that crosses the salt pond at the south end of the property (see Figure 2.7). Currently neglected and dilapidated, this road previously provided access to Coco Point and Princess Diana Beach, and the new road realignment will maintain access to Gravenor's Bay, Coco Point and Princess Diana Beach. The road in this area has existing pipes and culverts underneath that have been damaged because the pipes were uncovered and vulnerable to the elements. In recent years, this road section has been a dump site for construction waste and other debris to stabilize the roadway (see photographs in Figure 2.4). Paradise Found intends to remove all the construction waste and rubbish from the location, re-establish the road, add littoral shelves for planting mangroves and install culverts to assist with the flow of water in and out of the salt pond.

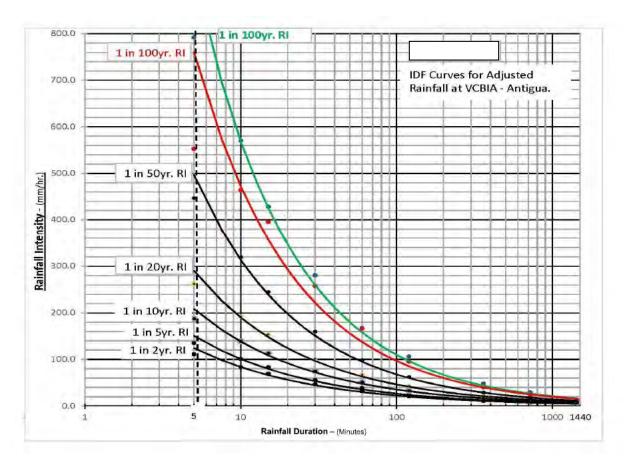
Figure 2.8 IDF Curves for VC Bird International Airport Antigua

that do not occur as runoff. The average rainfall intensity, *i*, used in the formula is the rainfall intensity for the *Tc* of the catchment for the storm design frequency occurrence. These may be obtained from Intensity-Duration-Frequency curves such as are shown below for the VC Bird International Airport, Antigua.

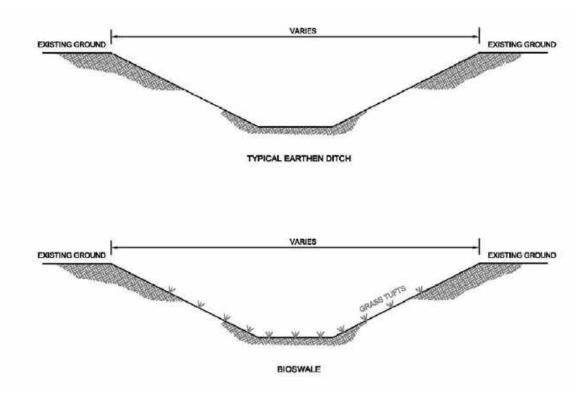
Figure 2.10 Cross-section of typical earthen ditch (top) and bioswale (bottom)

This sub-section describes the likely construction methods for earthen drains, paved drains, buried pipe drains and culverts. For bioswales or earthen drains (Figure 2.10) the alignment will be prepared by clearing and grubbing (see Section 2.3.1) and excavation or filling (see Section 2.3.2). The drain itself will then be trenched using a backhoe or an excavator. Surplus material from trenching will be managed as described in Section 2.3.2.

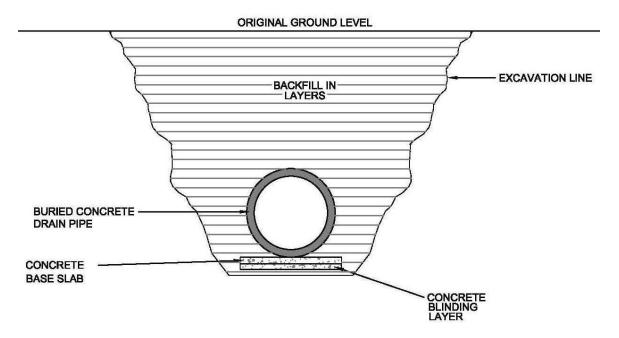
Figure 2.11 Cross-section of a buried concrete pipe drain

For French drains (buried pipe drains) (Figure 2.11) the precast concrete or PVC pipes must be imported to the site by ship and brought to the site on flatbed trucks. Trenches will be dug along the design alignments using backhoes or excavators, and the pipes lowered into the trenches using HIAB units (concrete pipes) or by hand (PVC pipes). Backfill will then be placed to the sides and over the pipes in layers, with each layer being compacted to the required density using whackers.

Buried drainpipes will be pressure tested in place after they are installed. Given the size and type of the pipes on this development, it is unlikely that chemical treatment of the hydrostatic test water will be required. As a result, the water will not be significantly contaminated after use and can be disposed directly to surface drains. However, if chemicals (such as anti-rusting agents) are mixed into the hydrostatic test water, it will be considered contaminated and cannot be discharged directly to surface drains after use.

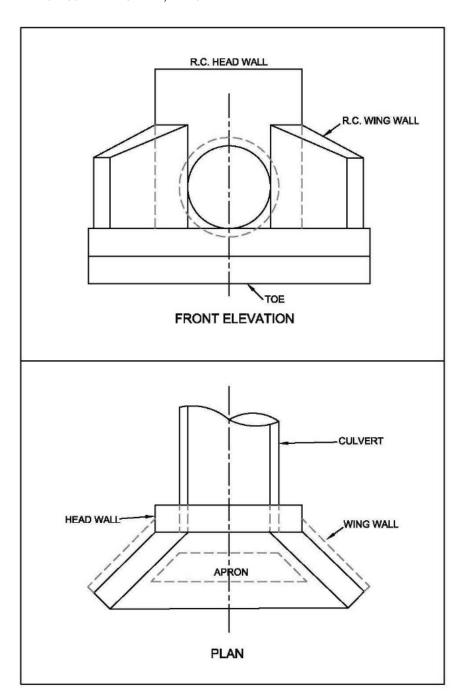
Figure 2.12 Front elevation and plan of the end of a culvert

Culverts will be constructed of HDPE pipes and installed using the same methods as just described for buried pipe drains. In addition, a head wall with wing walls and apron (Figure 2.12) will be constructed at each end of each culvert using methods as described in Section 2.3.6. Since water flows through culverts by gravity rather than under pressure, there is no need for hydrostatic testing when construction is complete.

Reinforced concrete structures on this development will include building foundations and floor slabs, manholes and head walls on culverts. These may be constructed of premixed concrete or mixed-on-site concrete. In either case, formwork and reinforcing steel will be brought to the site in flatbed trucks. Reinforcing steel will be cut and bent to the required lengths and shapes. Formwork will be installed to receive the concrete and reinforcing steel placed within the formwork. Concrete will then be placed into the formwork and compacted using vibrators.

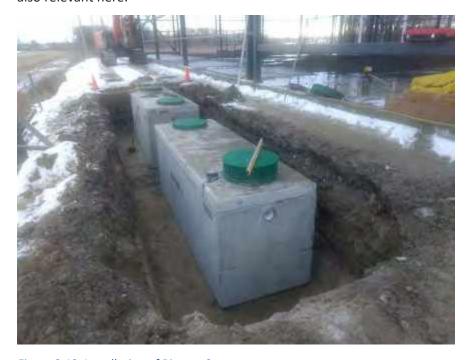
Figure 2.13 Installation of Bionest System

Wastewater treatment plants of this type are shipped to site in shipping containers, completely assembled for smaller units and in parts for larger units. The units will be formed from poured concrete and will be sized to treat the anticipated wastewater volumes from the development. Units are to be located completely underground, allowing landscaping (i.e., native grass, plants, etc.) or parking atop (Figure 2.13). The units will be transported to the site by road. Smaller units will be ready to install and connect to the incoming plumbing. Larger units will require some on-site assembly. Tanks and piping on these units are normally pressure tested at the factory before shipping, so in the case of fully assembled units there is no need for repeat hydrostatic testing on site. However, for units that are assembled on site it will be necessary to conduct hydrostatic testing after assembly. The volume of water required for hydrostatic testing of wastewater treatment plants will be significantly more than what is required for testing of piping, and the comments on potential contamination of surface water in Section 2.3.4 are also relevant here.

The Bionest technology is certified to NSF (National Sanitation Foundation) Standards 40 & 245 to not exceed maximum averages of 25 mg/L of cBOD, 30 mg/L of TSS and a 50% Total Nitrogen removal. It also has certification under BNQ (Bureau de Normalisation du Québec) Class III and V for more stringent average effluent criteria of 15 mg/L of cBOD, 15 mg/L of TSS as well as disinfection of less than 200 CFU (colony forming units) of fecal coliform. The product also carries the CE mark which demonstrates it has met European product directives.

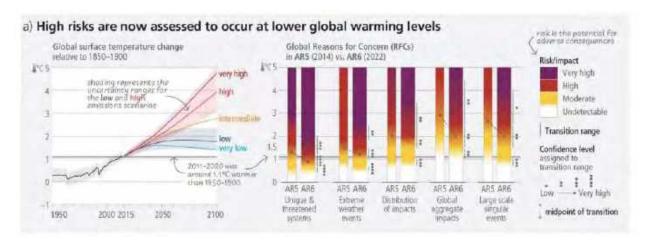
Figure 4.1 Increase in risk from IPCC's AR5 to AR6 reports for given global surface temperature change scenarios³.

Figure 4.1 indicates that between AR5 and AR6 new research has revealed that the risk/impacts for various "Reasons for Concern" have increased for the same level of global warming or put another way, moderate to high risks/impacts are now predicted to occur at even lower global warming levels than previously expected. Looking at extreme weather events, the newer science (2022 vs 2014) has revealed that high risks will occur at 1.5°C warming, whereas in the AR5, these were predicted to occur above 2°C.

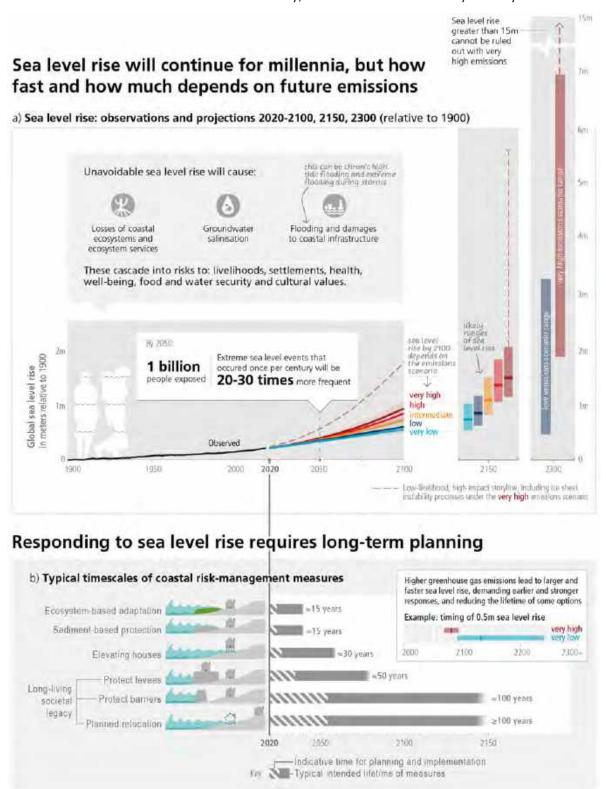
Figure 4.2 Summary of risks from sea level rise over the next century (IPCC 2022)

this trend will continue well into the next century and beyond. AR6 includes the following figure, which summarises the risks until the end of the century, and an assessment of the years beyond:

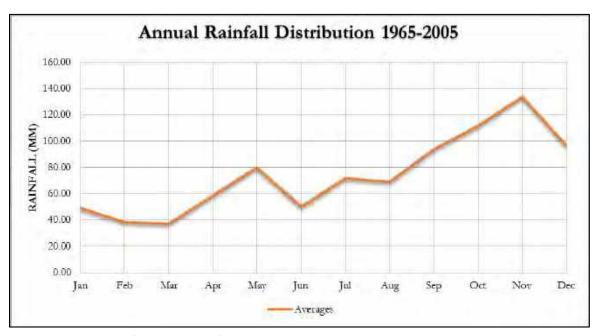
Figure 4.3 Annual rainfall distribution for the period 1965-2005

Rainfall trend graphs were plotted using available long-term precipitation data (Figure 4.3 and Figure 4.4). Barbuda has a dry season from January to April and a primary wet season from August through to November. The wet season coincides with peak tropical storm activity. The largest recorded value for the Coco Point station was in November 1999 where 483mm of rainfall was recorded. This was due to Hurricane Lenny passing south of the island.

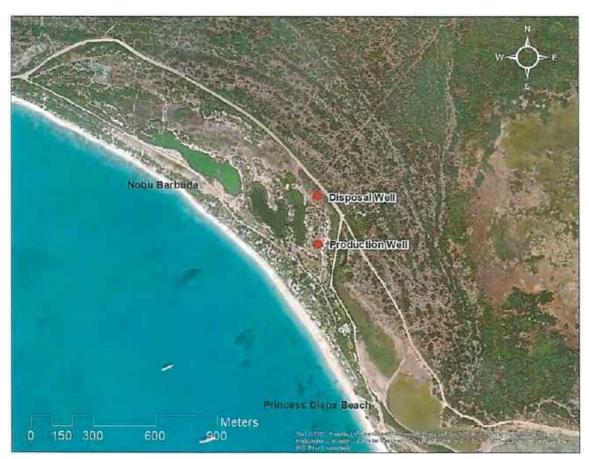
Figure 4.5 Locations of disposal and production wells

Evaluation of the yield productivity of the source water well was based on the results of a constant rate test. This test involved the pumping of the well at a continuous constant rate of 286 USgpm, for a period of six (6) hours, after measuring its initial non-pumping water level and monitoring the pumping water level at regular intervals. On the cessation of pumping, the recovery of the water level was monitored for one (1) hour.

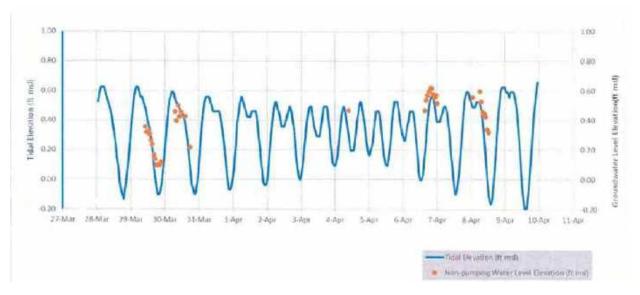
Figure 4.6 Tidal and well water level fluctuations

- The non-pumping water level in the source water well fluctuated in sync with tidal fluctuations, indicating that the Highland Limestone Aquifer is in direct hydraulic continuity with the sea. This is illustrated in Figure 4.6 below.

- The non-pumping water level in the brine disposal well fluctuated in sync with tidal fluctuations, indicating that the Highland Limestone Aquifer is in direct hydraulic continuity with the sea, as shown in Figure 4.6, below.

- This relatively high productivity of the brine disposal well no doubt reflects the interception of conduit flow permeability at a depth of 37.2m (122 ft bgl) (36.3m below msl / -119 ft msl), indicated by the loss of drilling circulation at that depth.

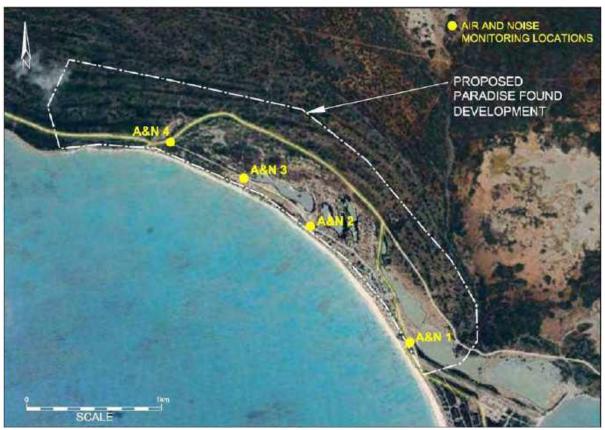
Figure 4.7 Air monitoring locations

These locations were selected based on the site boundaries and existing and proposed activities within the area. A&N 1 and A&N 4 respectively are representative of the northern and southern boundaries of the site and A&N 2 is representative of the nearest sensitive receptor, which in this case was a house with occupants who could be affected by particulate matter. A&N 3 was also selected, as construction works were on-going near this area.

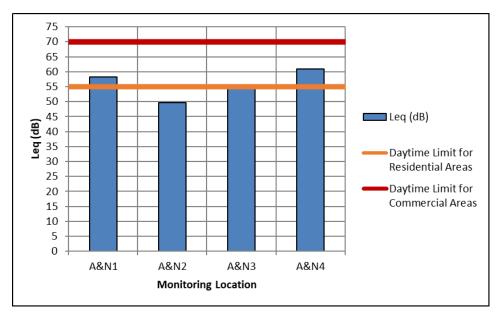
Figure 4.8 Ambient noise monitoring results & comparison to recommended daytime limits

Figure 4.8 compares the daytime L_{eq} values recorded at each monitoring location to the World Bank Group's Noise Guidelines. The figure indicates that daytime L_{eq} values recorded at the four monitoring locations were below the daytime limit for commercial areas. However, L_{eq} values recorded at A&N1, A&N3 and A&N4 were at, or slightly above, the daytime limit for residential areas.

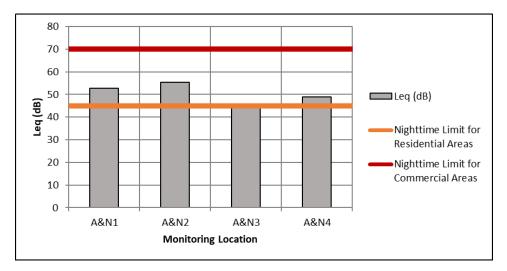
Figure 4.9 Ambient noise monitoring results & comparison to recommended nighttime limits

Figure 4.9 compares the nighttime L_{eq} values recorded at each monitoring location to the World Bank Group's Noise Guidelines. Similar to the daytime, nighttime L_{eq} values recorded at all four monitoring locations were also below the limit for commercial areas. However, L_{eq} values recorded at A&N1, A&N2 and A&N4 were slightly above the nighttime limit for residential areas.

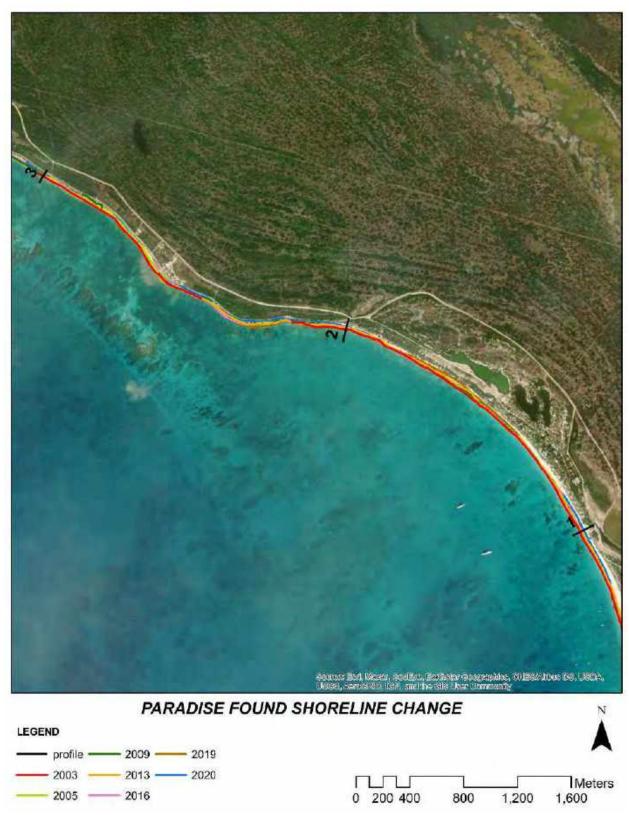
Figure 4.10 Paradise Found shoreline change

Figure 4.10 to Figure 4.14 shows that the shoreline fluctuates. Between 2003 and 2005 the shoreline eroded 15-20m but then accreted almost to the 2003 shoreline by 2009. There was again erosion between 2009 and 2013 and the 2016 shoreline seems to enjoy a wider beach than the 2013 shoreline. Between 2016 and 2020 the shoreline shows signs of erosion of 45m to 47m. This is likely because of recent hurricanes (Irma and Jose 2017) and tropical storms that passed within 300km of the site. It should be noted that the fluctuations observed might have been just from seasonal variations rather than over a period of years as just a single point in time for a year is being observed. It would require a longer period of imagery to determine a long-term trend in shoreline change and to say whether the erosion seen between 2003 and present is an ongoing trend. This analysis, however, illustrates that the beach does vary by up to 45m seasonally or annually.

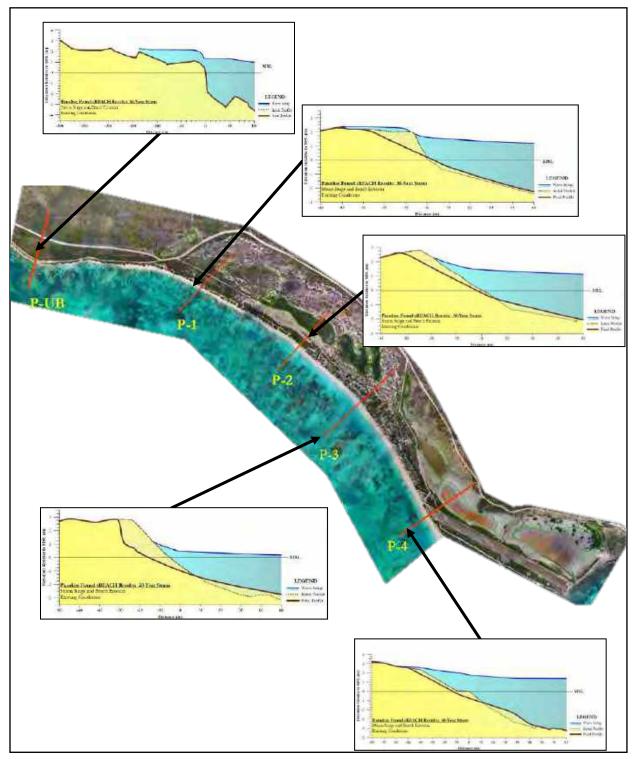
Figure 4.14 Plan with profile lines and beach erosion for a 50-year event

Nearshore wave conditions were extracted from the selected MIKE 21 plots and used to assess beach erosion for each storm event. Five profile lines were chosen for analysis with four being on the sandy section of the site and one on the rock coast. The numerical model tool, sBEACH, which simulates cross-shore beach change was used.

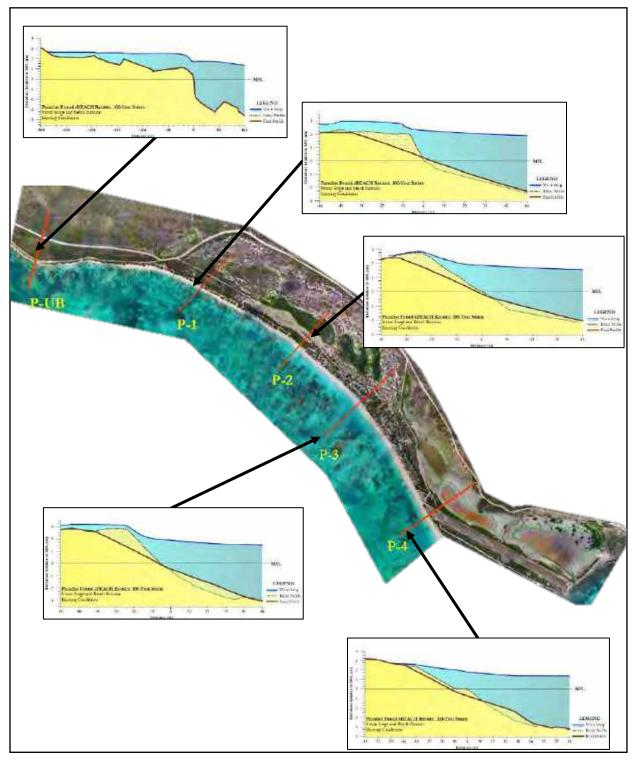
Figure 4.15 Plan with profile lines and beach erosion for a 100-year event

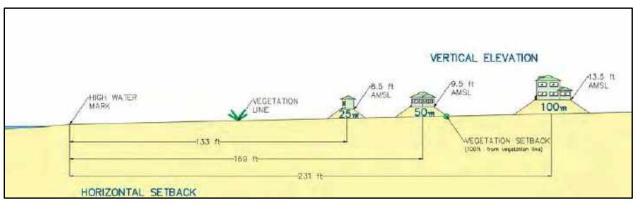
Figure 4.16 Final setback values relative to the vegetation setback line (units of measurement shown in feet)

The regulatory vegetation setback line mainly coincides with the 50-year setback line and does not exceed the 100-year setback line. Figure 4.16 shows the recommended distances for each return period.

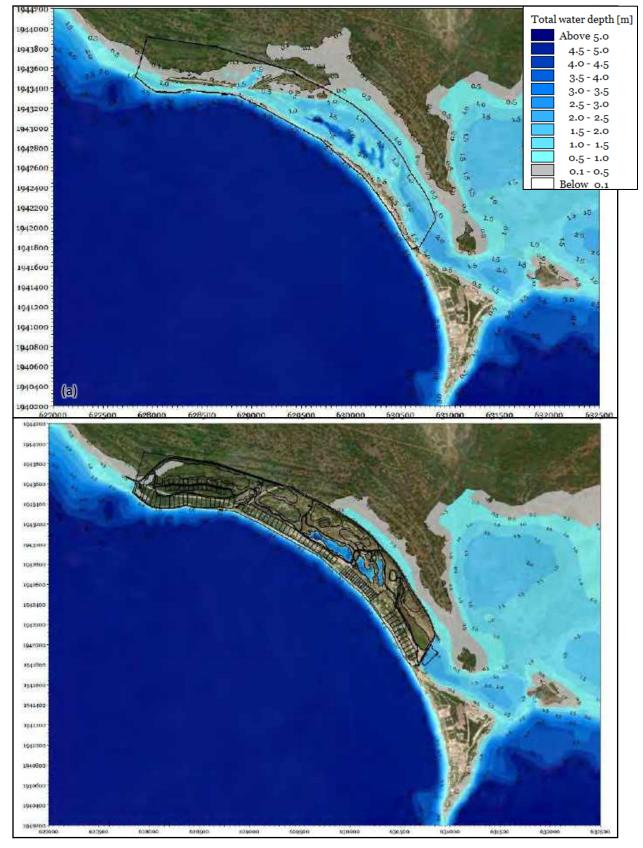
Figure 4.17 Storm surge comparison pre-development (top) and post-development (bottom) for the 50yr storm

Figure 4.17 below shows the 50-year storm event pre- and post-development. The proposed master plan would introduce a dyke behind Pond 1 and then raise the berms; modelling has shown that this would prevent inundation on site from static storm surge.

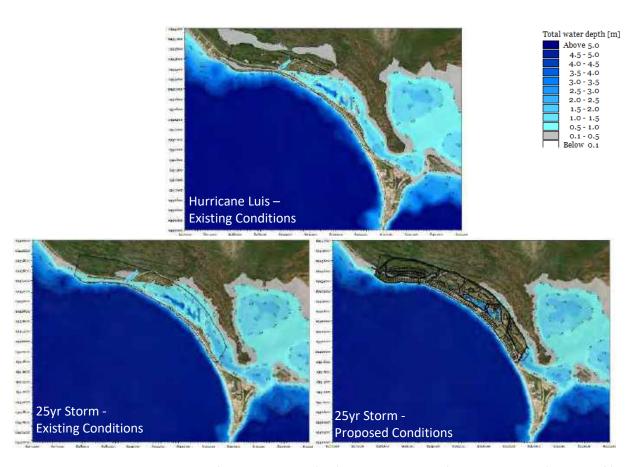
Figure 4.18 Storm surge comparison for Hurricane Luis (top) and 25-year event (pre-development (bottom-left) and post-development (bottom-right))

The simulations for the various return periods were done assuming the event happens during a high-tide situation. The simulations of Hurricane Luis and Hurricane Irma were done with the actual tide conditions that occurred during the storms. Based on the statistical analysis, the waves from Luis were found to be slightly higher than from the 25-year event, however the simulated water level (storm surge) was less. Luis therefore showed storm surge levels even less than the 25-year hurricane. The plots below show storm surge for Luis as well as the pre- and post-development scenarios for the modelled 25-year event.

For the pre-development scenario, the water elevation is shown above existing ground level, whereas for the post-development case, it is shown as being above the proposed finished ground levels. The following are key observations from the analysis:

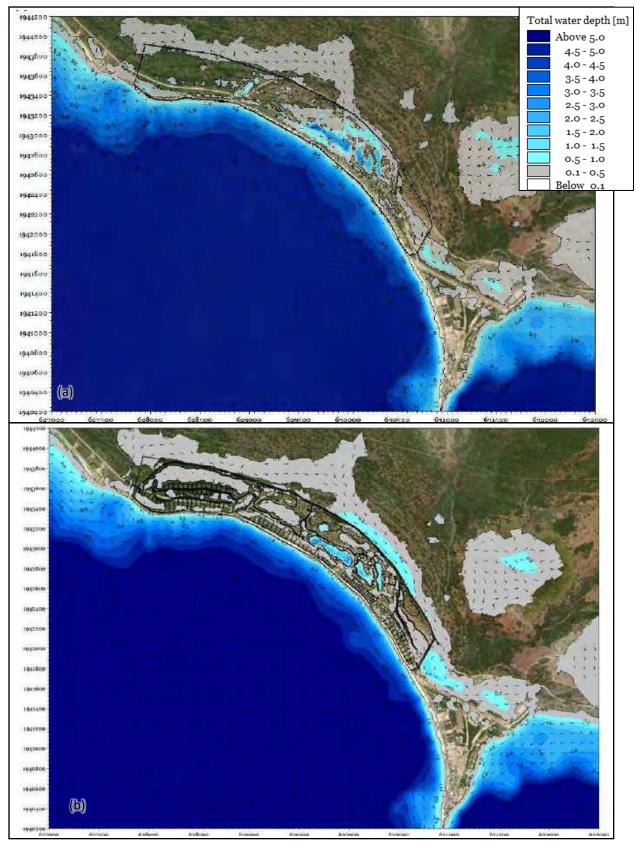
Figure 4.19 10yr flood map for existing and post-development scenarios

The results of all return period testing show that the aerial extent of flooding increases with greater return periods in those noncritical areas.

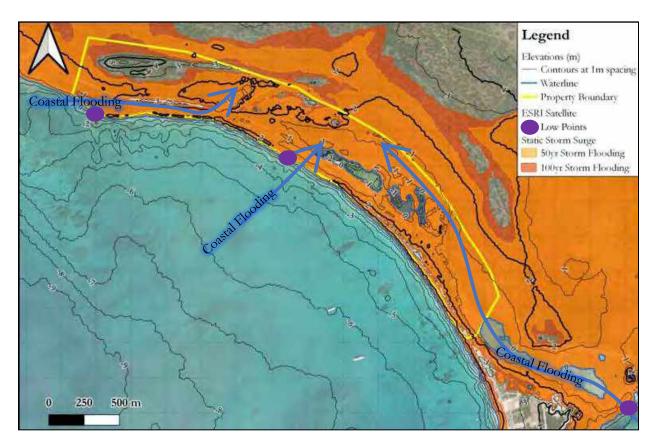
Figure 5.1 Main conclusions from the baseline study that guided coastal and drainage design

A major concern for this project is the potential for coastal and overland flooding, which was highlighted in the *Baseline Conditions Report – October 12, 2022* (attached as Appendix B). A summary of the findings from that analysis is presented in Figure 5.1. The baseline conditions show that coastal flooding is a threat from three low points on the property, the greatest of which is the low salt ponds to the south. These ponds act as an avenue for storm surge from the south-east to progress onto the project property. Statistically, wave conditions from this sector were higher than what would be experienced on the property's beach. These surge levels and extents were therefore used to guide the finished elevations of proposed roadways, beach dunes and property.

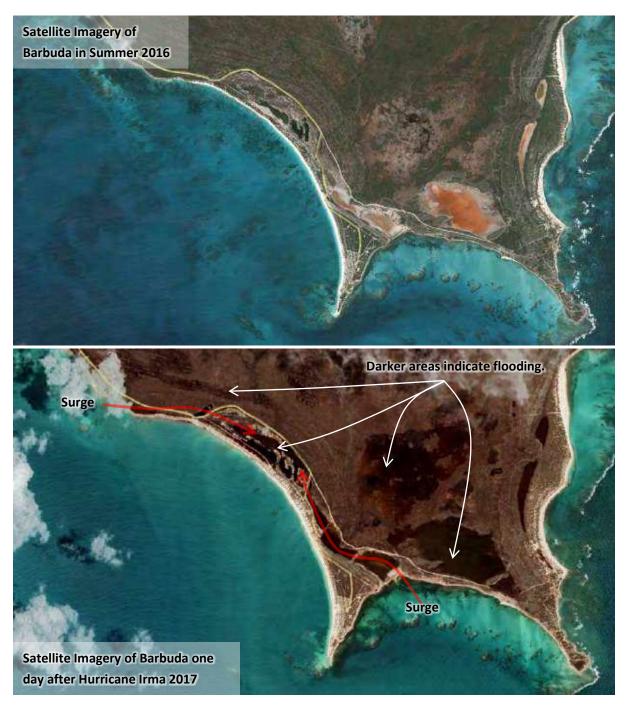
Figure 5.2 Satellite imagery of Barbuda in summer 2016 (top) & the day after Hurricane Irma 2017 (bottom)

Figure 5.2 is a comparison of Google Earth images taken in 2016 and on the day after Hurricane Irma hit Barbuda. The dark areas in the lower image indicate flooding. These areas correspond with zones that were flooded in the hurricane simulations shown in Figure 5.1.

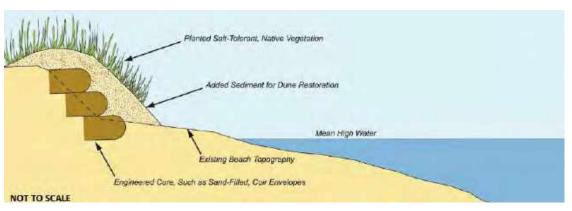
Figure 5.3 Engineered core dune¹⁵

The dune construction is recommended to be an engineered core sand dune to limit the erosion potential during high energy events. These could be a core of smaller quarried armour stones wrapped in a geotextile fabric; or sand-filled coir envelopes, or geotubes. It is likely that the sand-filled coir envelopes, or the rock wrapped core, will be used for this application. A typical example of this is shown below in Figure 5.3.

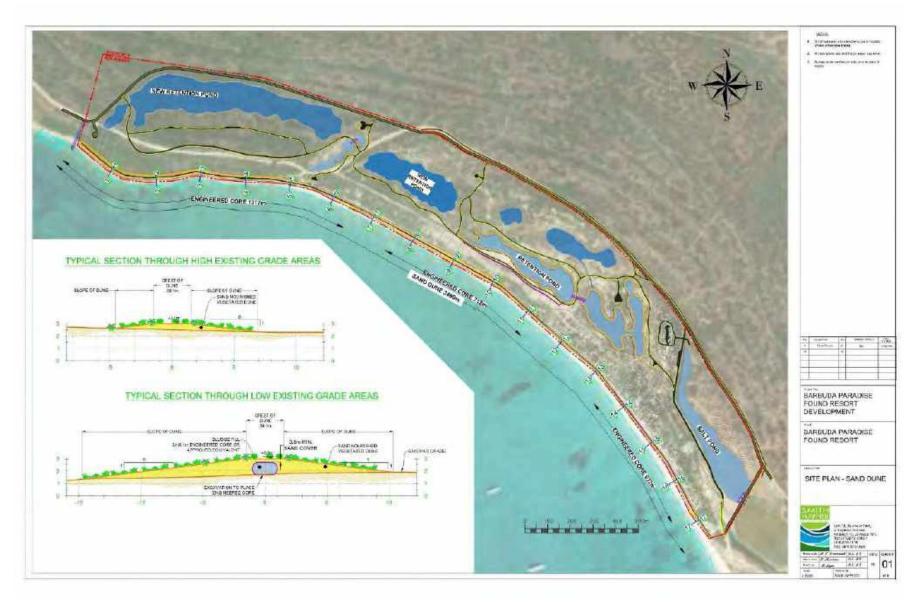
Figure 5.4 Plan and cross-sections of proposed vegetated sand dune (shown in plan in orange)

From the topography collected and presented in the baseline conditions report, the south-eastern section of the property had a high sand dune that stopped the inundation of the land behind. This dune was used as a model for the lower beach sections to the north. Based on the 99th percentile waves and 100-year storm waves, dune plans and cross-sections were developed and are shown in Figure 5.4 and in Appendix D. The plan allows for overtopping onto the site while keeping the surge below the finished floor elevation proposed for the buildings (3.35m above MSL).

The sand dune will be located along the phase-two private lots. Although it would be most desirable to have all coastal elements implemented at the same time, the nature of construction costs typically encourage the use of phasing. Since the lot will be developed in the second phase of the construction, it is anticipated that the bulk of the dune construction works will occur during the second development phase.

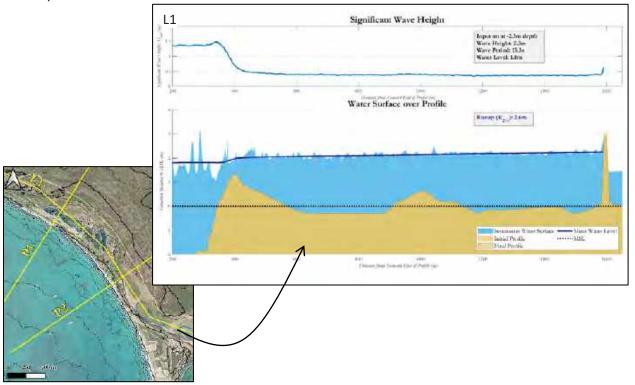
Figure 5.5 Model results for wave run-up and wind setup at the southern boundary with the concept in place

Figure 5.5 shows the model results for a profile that runs through the road to determine if the road is overtopped. The results indicate that the elevation of the road would provide a satisfactory protection in a 50-year storm.

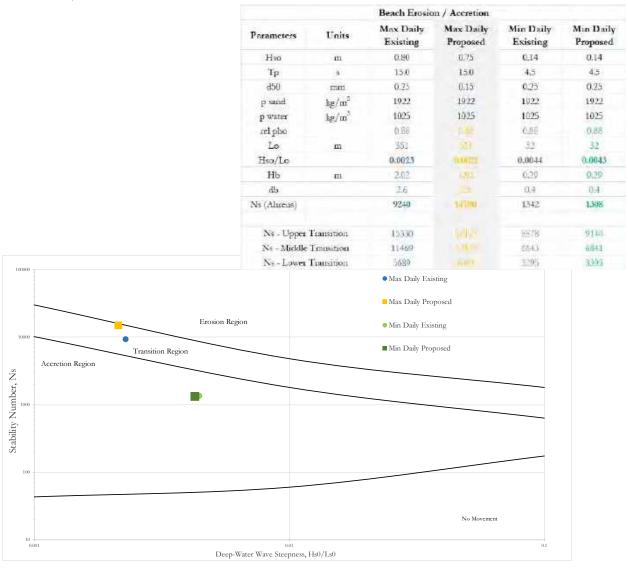
Figure 5.6 Sediment erosion and accretion zones (Ahrens & Hands); spreadsheet in inset

The wave parameters during swell events are represented by wave conditions exceeding 12 hours per year (99.86th percentile), and these were used to assess the stability of the beach. These wave conditions were up to a wave height of 0.75m and wave period of 15.0s at the toe of the beach nourishment. The tendency for the beach to accrete, erode, or be in a transitionary zone under the input conditions, is illustrated in Figure 5.6

The critical conditions show that the beach fluctuates naturally under existing conditions. The *in-situ* beach sediment is fine with a mean grain size of 0.25mm. Material that is used to nourish the beach should have a similar grain size distribution and have a low silt content (less than 0.5%). Higher silt content will result in cloudy water as the waves gradually clean the sand and can create a hardened surface over time. Other characteristics, such as carbonate content and colour are generally aesthetic, and are subject to preference. From tests done, the minimum grain size to keep the beach in at least a transient state is 0.15mm. If a fine sediment is placed on the beach, there is likely to be a high probability of erosion. In summary, a D50 grain size of 0.25mm is recommended to keep the beach in an accretionary zone.

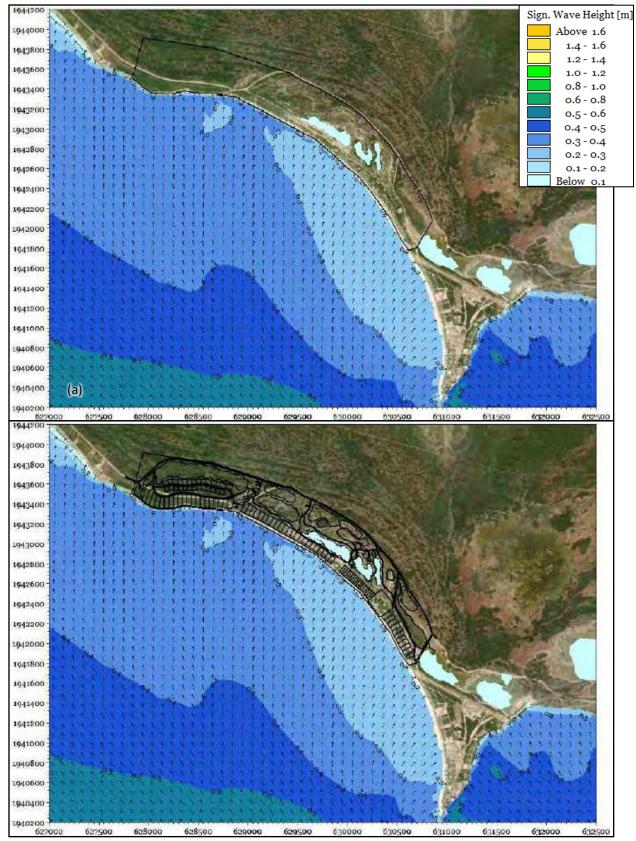
Figure 5.7 Comparison of mean annual waves results (a) under existing conditions and (b) with the plan in place

Figure 5.7 depicts a comparison of mean annual wave heights under existing and proposed conditions. Figure 5.8 shows the wave results for conditions exceeded 12 hours out of the year to represent a swell condition. Overall, the findings indicate that:

- There is no appreciable change in operational waves between the existing and proposed conditions. This is due to all works being confined on land within the property boundaries. Under operational conditions, the concept plan would provide an additional dune to the northern section of the property, which is more exposed to waves.
- In the more extreme condition of the 99.86th percentile waves, the wave heights range from 1m to 1.2m at the shoreline. As with the operational waves, the northern section of the beach is exposed to higher waves. These wave conditions may generate significant scour on the sandy beach, and this is addressed in the following section.

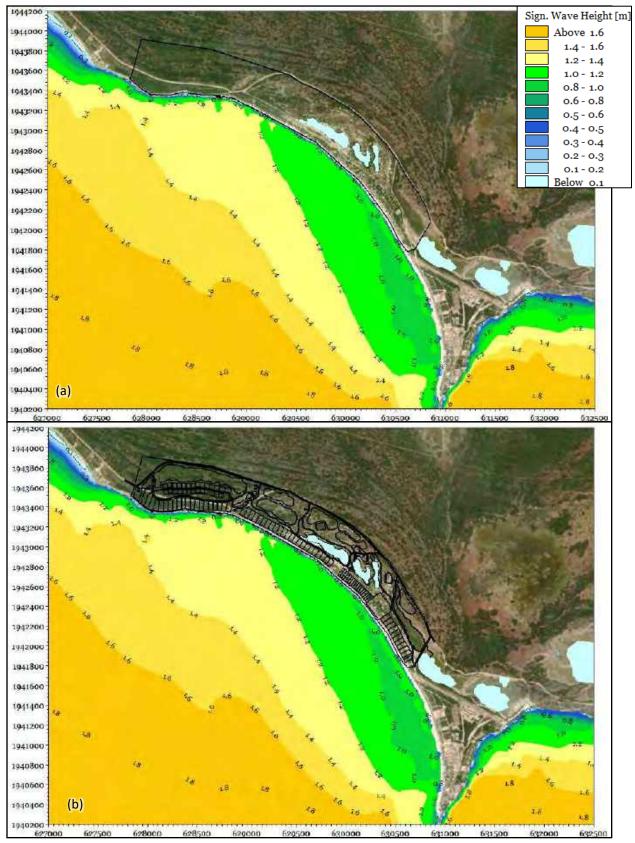
Figure 5.8 Comparison of wave heights statistically exceeded 12hrs per year (a) under existing and (b) proposed

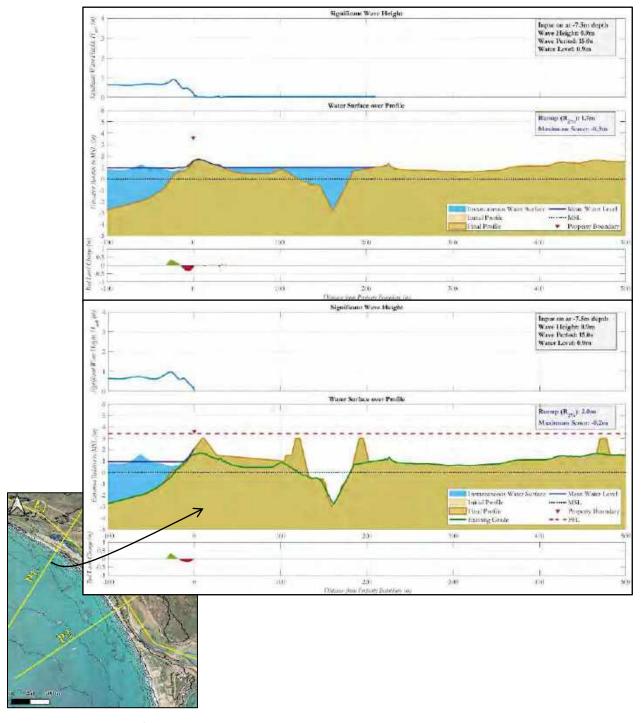
Figure 5.9 Comparison of erosion scour during 99.86th percentile wave conditions

High energy swell waves cause significant erosion on sandy shores. To capture the effects of a swell wave, forty-two years of wave data was assessed using exceedance statistics. A wave condition that is exceeded for only twelve hours per year was chosen and simulated at high tide. To account for possible climate change impacts, sea level rise was added to the simulation, and this was found to be 0.74m. Key results were plotted along a profile in the low vulnerable area to the north.

In the existing case, there was up to 0.3m of scour along the beach profile (Figure 5.9). The face of the dune was eroded and deposited around the waterline, which led to a temporary widening of the beach. In proposed conditions, there was less scour of around 0.2m on the dune face. The eroded sediment from the dune was deposited by the waterline. Erosion/accretion zones were reduced for the proposed conditions from 75m to about 50m.

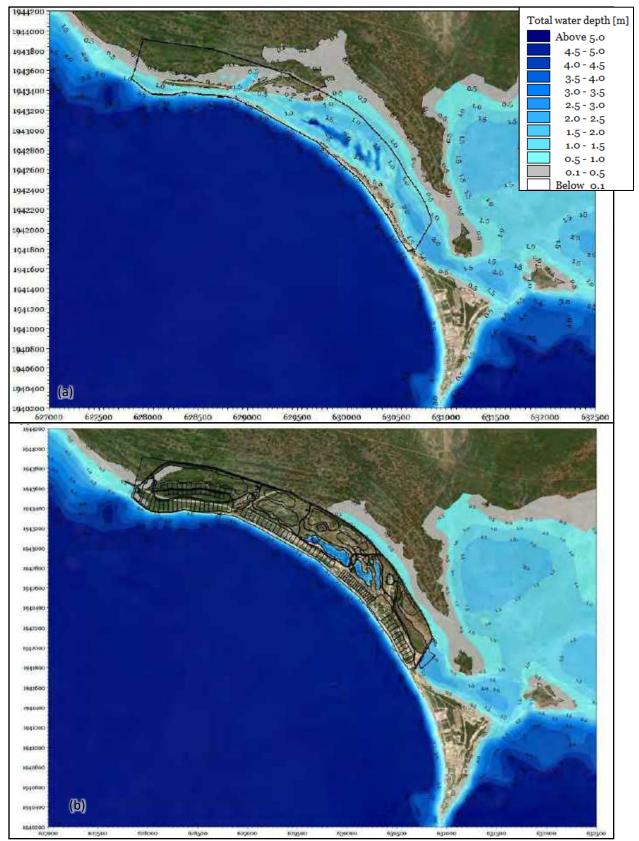
Figure 5.10 Comparison of 50-year storm simulation results for water depths (a) under existing and (b) proposed

Inundation results are shown in Figure 5.10 as water depths across the area. For the existing condition almost all areas slated for housing are shown to be inundated with up to 1.5m of water. In proposed conditions the surge is blocked by the extended dune and perimeter road. Inundation outside of the property is seen to be similar in both existing and proposed conditions. Properties to the south of Paradise found also did not see a significant change in coastal flooding as a result of the implemented works.

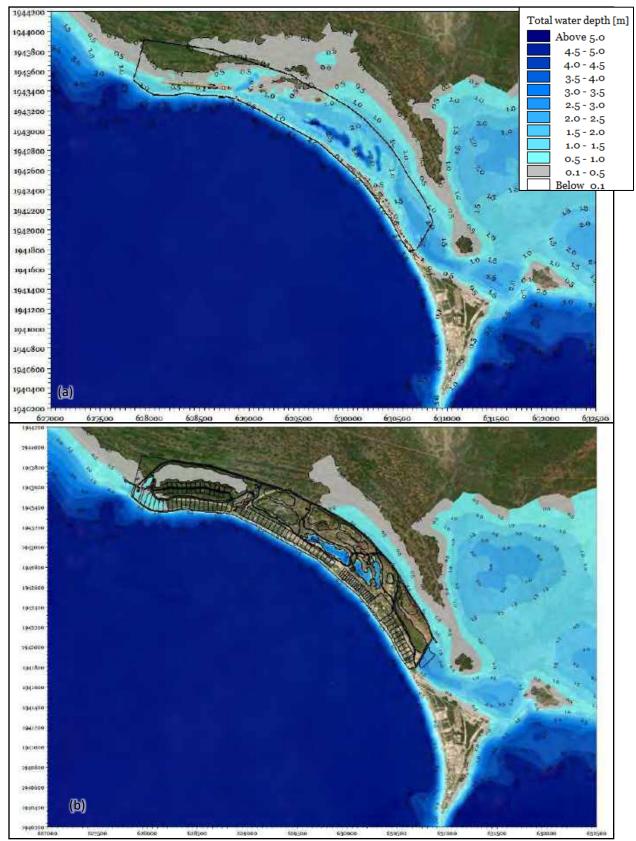
Figure 5.11 Comparison of 100-year storm simulation results for water depths (a) under existing and (b) proposed

Inundation (Figure 5.11) covered almost all of the project site with water depths of around 2m in pond 1. Once again, the south-eastern surge breached the southern property boundary and propagated 3km

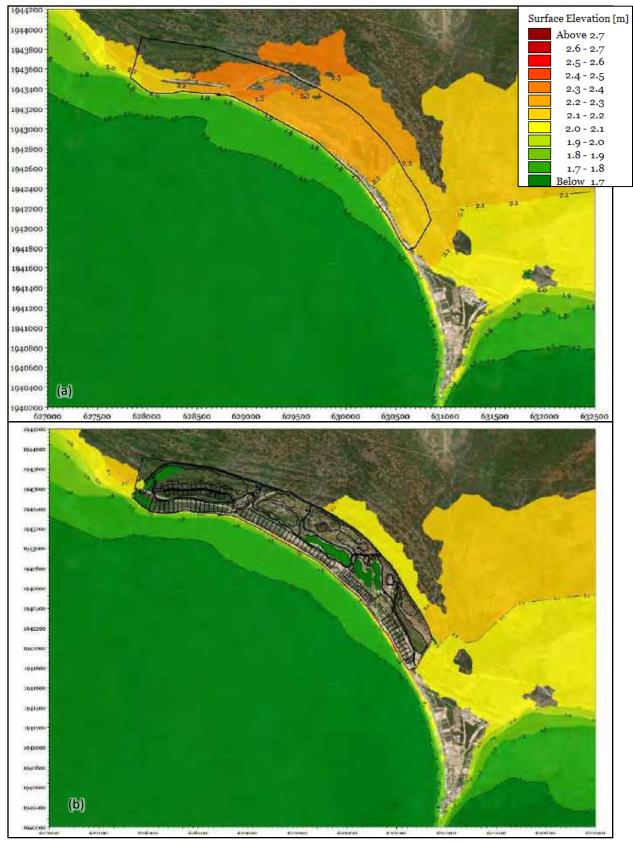
Figure 5.12 Comparison of 50-year storm simulation results for water elevations for (a) existing and (b) proposed

Storm surge extents and elevations are compared in Figure 5.12. As with the inundation mapping, the site was mostly not flooded by static storm surge under proposed conditions. Coastal flooding from the west was well handled with the extended dune in place. The static surge levels at the shoreline were computed to be up to 2.3m, which was higher than in existing conditions. These higher surge levels are related to the ground being elevated in the proposed concept. However, the higher surge levels did not produce higher inundation depths. A small area south of the perimeter road had a decrease of 0.1m in surge elevation which is likely linked to a reduced area for wind setup. Storm surge for areas outside of the property were not worsened by the perimeter structures.

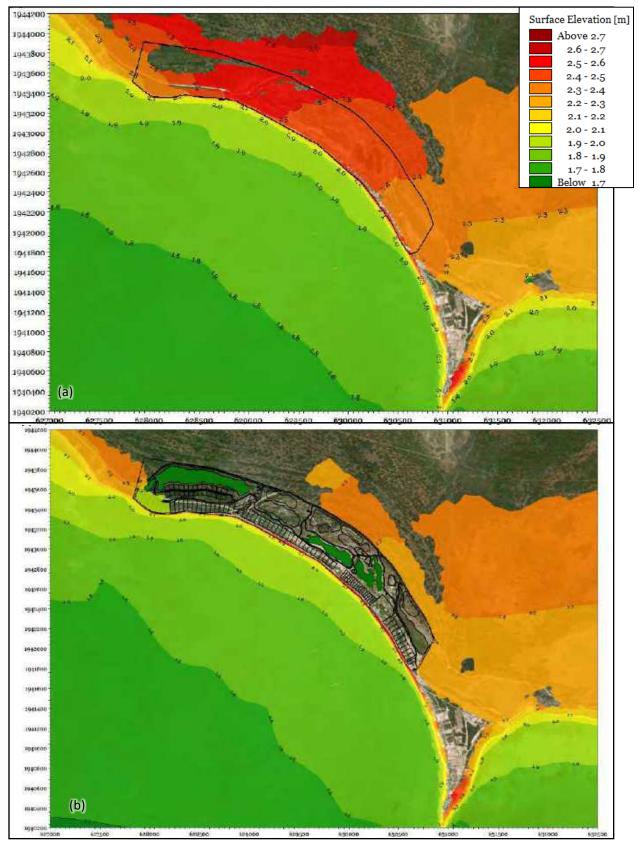
Figure 5.13 Comparison of 100-year storm simulation results for water elevations for (a) existing and (b) proposed

Storm surge elevations relative to mean sea level are plotted in Figure 5.13 for the 100-year event. The existing result (top inset) shows surge levels up to 2.6m above mean sea level. The property and green areas to the northeast had surge levels between 2.3m and 2.5m above mean sea level. This result further shows that the surge and winds from the south-east heavily influence the surge levels on the property. An easy way to see this is to notice that the surge contours run parallel to the coastline in Gravenor's Bay.

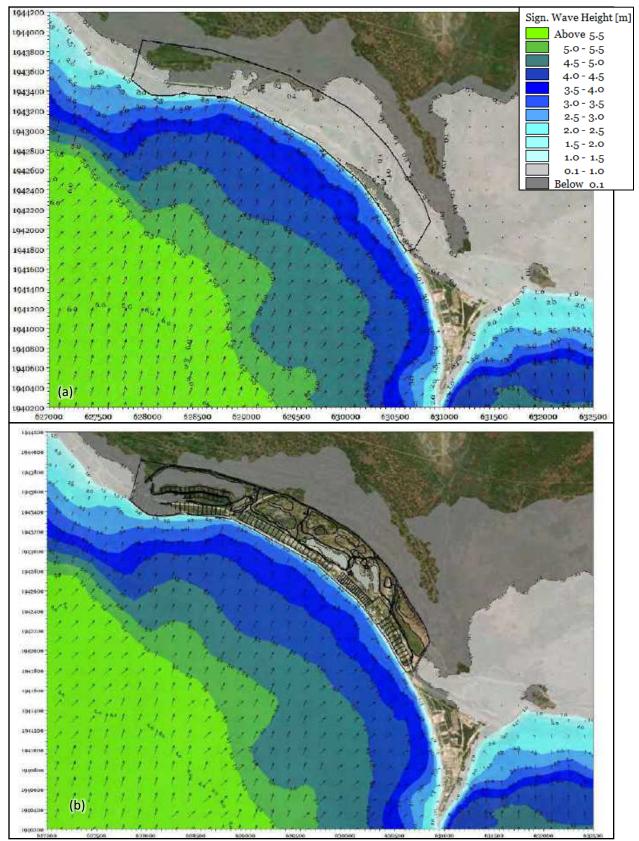
Figure 5.15 Comparison of 100-year storm simulation results for storm waves (a) existing and (b) proposed

Under proposed conditions wave heights were reduced with the property and to the north. The easement breach to the north had small waves below 0.1m. Wave heights outside of the property were still generally below 0.1m with some areas even showing a reduction in wave height. The wave heights just to the south of the property were between 0.1m and 0.4m. The reduction in wave heights is also related to a smaller wetted area for wave growth.

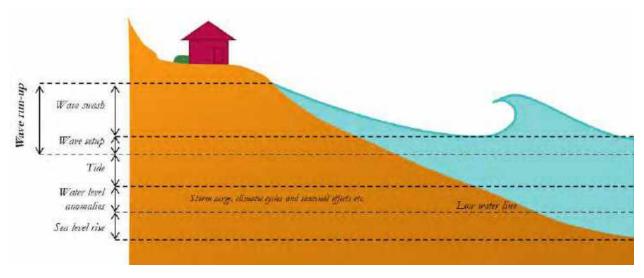
Figure 5.16 The water level components that contribute to coastal flooding

Wave run-up transpires when a wave breaks, allowing a portion of its remaining energy to travel up the face of the beach. The elevation reached by the run-up depends on the characteristics of the "swash zone" – the area where the wave interacts with the beach. If this zone consists of a smooth, impermeable surface, a higher run-up is likely. In contrast, the presence of a rough, armoured stone slope or a vegetated surface can reduce the run-up.

Due to the localized variability of wave run-up and its dynamic nature, storm surge computations in numerical models typically do not incorporate wave run-up. However, it is calculated and employed in the design of coastal structures. Both the static and dynamic components of storm surge are combined to determine the final inundation levels, ensuring a comprehensive assessment of potential flooding risks.

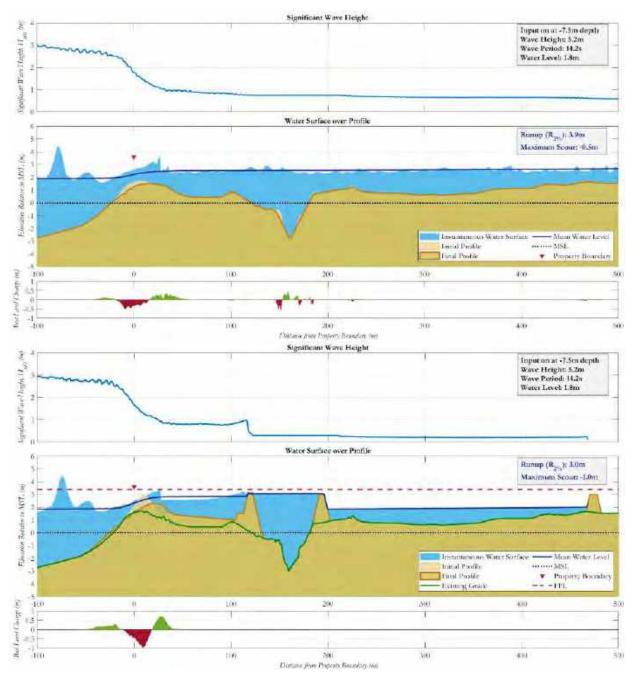
Figure 5.17 Wave runup results for the 100-year storm on the property for existing (top) and proposed (bottom)

Wave runup levels are shown in Figure 5.17 for the 100-year event.

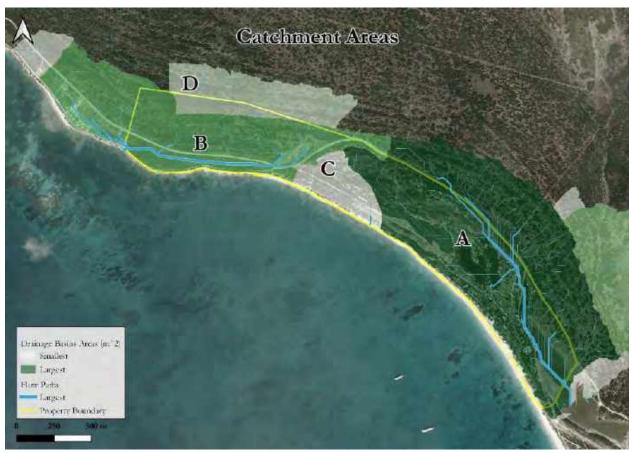
Figure 5.18 Catchment areas for the project site overlain on satellite imagery [© ESRI]

The data for the island catchment area had several gaps and was not at a fine enough resolution to allow for processing in the model or further division into sub-catchments (Figure 5.18). This is a significant limitation in the hydraulic analysis, as flows can be dramatically altered based on the slope over which they move. Not having a detailed DEM creates gaps and inaccuracies over the catchment area and means the resulting flows can be taken as an estimate only.

Based on the results of the catchment analysis, there are four catchment areas and drainage paths on the property. The largest catchment is Catchment A, which covers ponds 1, 2 and 3 and has an area of 1.4km². Pond 1 is the collection point for Catchment A and acts as the final point for discharge in this area. The northern half of the property drains to a low point near to the property boundary in Catchment B. This catchment has an area of 0.83km². Catchment C is located along the centre of the property's beach front. The catchment is smaller than the others with an area of 0.14km². This area drains towards the sea. The fourth catchment (D) has an area of 0.32km² which flows from the 6m ridge.

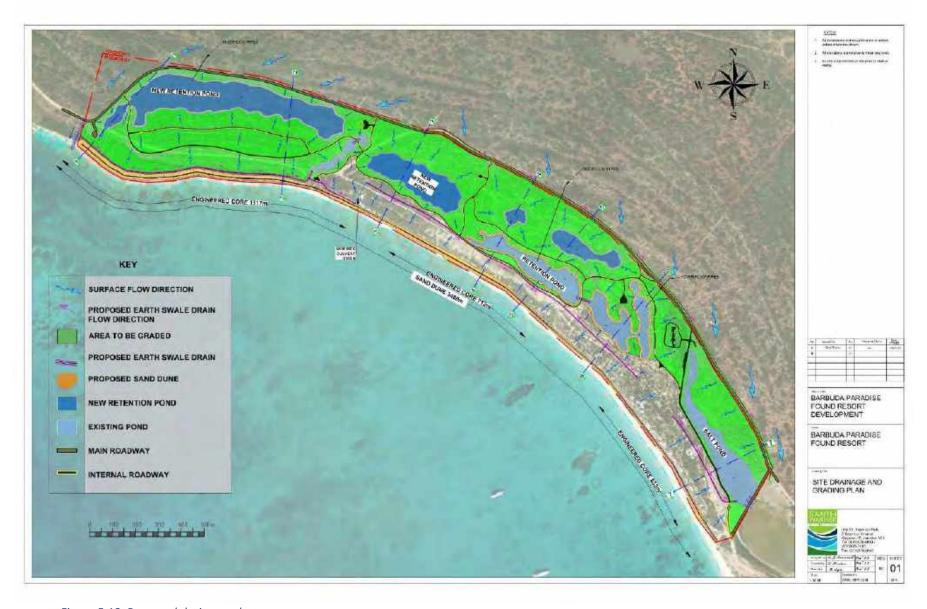
Figure 5.19 Proposed drainage plan

The plan and cross-sections are included in Appendix D. It should be noted that at the extreme western end of the property the bioswale and a public access trail to the coastline will be provided within the limits of the Paradise Found property.
