Environmental and Social Impact Assessment Report for the Paradise Found Development, Barbuda

Submitted to: Mr Darren Flanagan
For Paradise Found LLC

19 May 2023

Smith Warner International Limited Unit 13, Seymour Park, 2 Seymour Avenue Kingston 10, Jamaica, WI

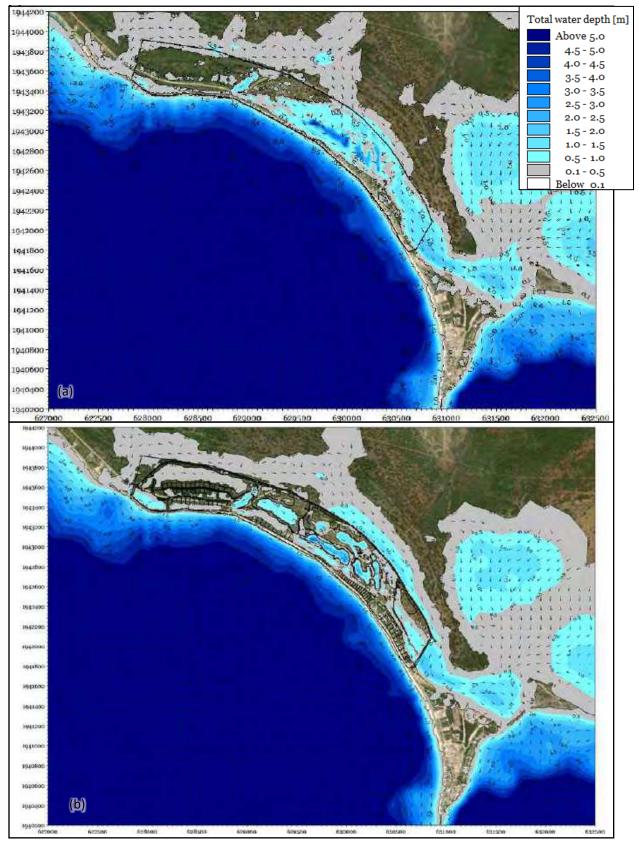
Figure 5.20 Comparison of existing and proposed drainage solutions subjected to a 50-year rainfall event

Figure 5.20 shows the simulation results for a 50-year return period rainfall under existing and proposed conditions. The flow through the site is reduced with the proposed drainage plan in place. The focus of grading effort was to improve the overall drainage of the site by redirecting flows to the new ponds and drainage features. Water that will sheet flow across the site will be collected by earth swales that will carry the water to the existing ponds and drains. In this solution, the existing ponds will have a berm up to 3m above MSL. In the simulation, this berm stopped the ponds from breaching under a 50-year rainfall thus providing additional water storage during heavy rainfall events.

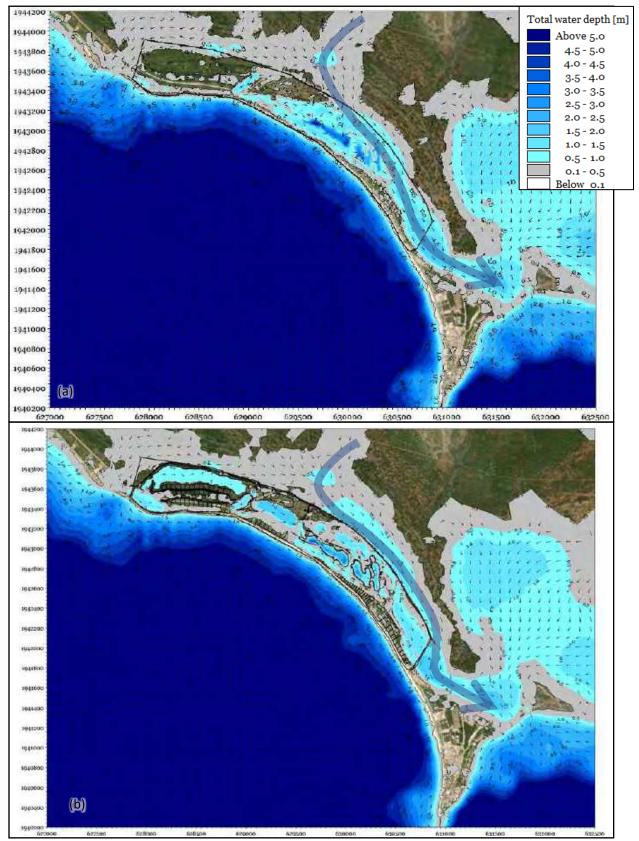
Figure 5.21 Comparison of existing and proposed drainage solutions subjected to a 100-year rainfall event

The 100-year rainfall event was also simulated (results in Figure 5.21) and acts as the design condition for the drains along the perimeter road and internal areas. During this severe event, there was flooding of most areas in the project area. Outside of the project area, there was an increase in flooding at the perimeter wall when compared to existing conditions. This is due to a shifting of the drainage path in the catchment area.

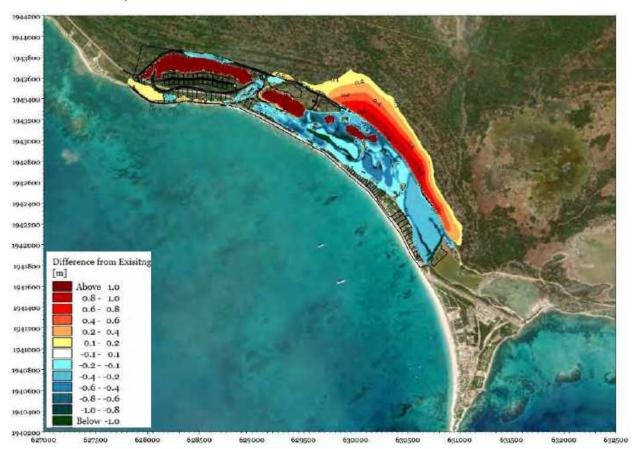
Figure 5.22 Total water depth difference plot for the 100-year event (proposed minus existing)

A difference plot has been produced for the property to show how the flow changes from existing to proposed conditions (Figure 5.22). Positive values represent an increase (red tones) and negative values represent a decrease (blue and green tones). The project site had an average of 0.4m less water depth in the proposed conditions. The new ponds had higher water depths, which is to be expected as they were excavated to hold more water. Outside of the project site, the extents of the increased water depth could be clearly seen. This additional water will be directly addressed with two overflow pipes that connect to the ponds.

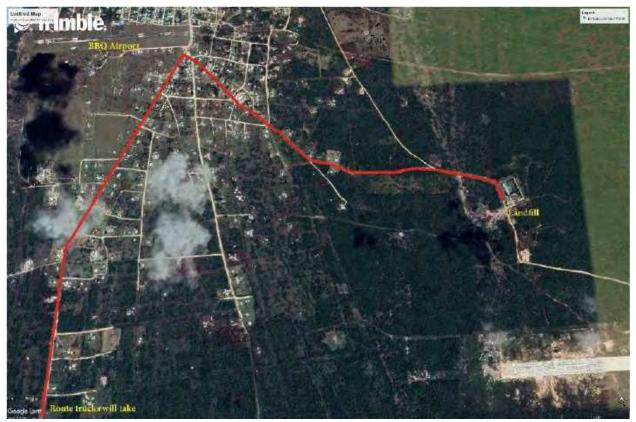
Figure 6.1 Anticipated truck route during construction

There will be times when it will be necessary for the trucks to travel through Codrington, for example, to reach the local landfill or quarry site. Paradise Found anticipates that trucks will need to pass through Codrington 1 to 2 times per week, with a maximum of three trucks on each day. Figure 6.1 illustrates the route the trucks would take to the landfill.

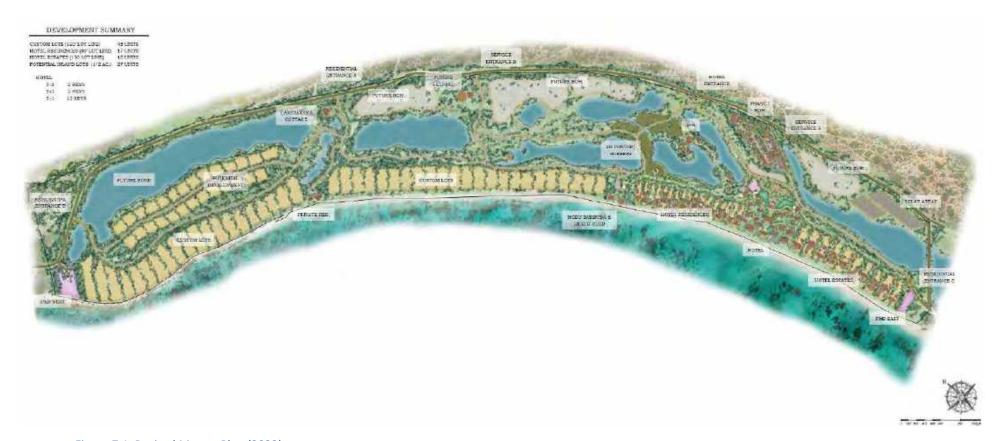
Figure 7.1 Revised Master Plan (2022)

Figure 7.1 shows the current plans, which are less dense than originally planned (see Table 2-1 above for a listing of project elements originally, versus presently).

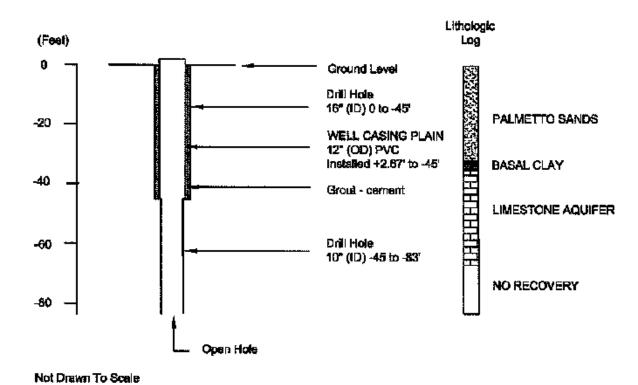
Figure 3-2: SCHEMATIC AS-BUILT DESIGN - SOURCE WATER WELL

- (i) The annular space between the wall of the 16" ID Drill Hole and the 12" OD PVC Casing was grouted with cement down to a depth of 45 ft bgl, some 13 ft below the bottom of the Palmetto Sands Formation, to prevent the seepage of sand into the underlying Highlands Limestone Formation, and
- (ii) The presence of the 3 ft thickness of Clay at the base of the Palmetto Sand Formation, although believed to be localised, can be expected to form an additional seal against the movement of sand into the Highland limestone Formation.
- (iii) The bottom 38 ft of the 10" ID Drill Hole (i.e., 45 to 83 ft bgl) was left uncased/open, to allow for maximum hydraulic connectivity between the well and the aquifer.

The main elements of the As-built Design of the Source Water Well for the Paradise Found Development is given as Figure 3-2, below.

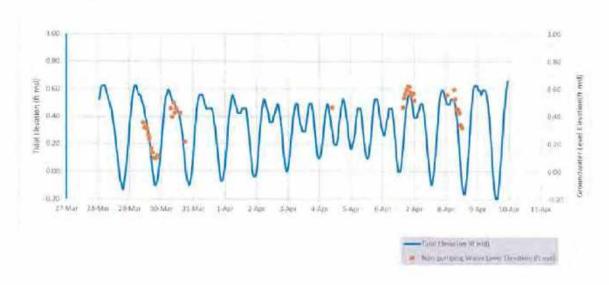
^{1 -} Reference Point for water level measurements 3.33 ft agl (top of Stilling Tube)

(i) The non-pumping water level in the Source Water Well fluctuated in sync with Tidal fluctuations, indicating that the Highland Limestone Aquifer is in direct hydraulic continuity with the Sca. This is illustrated in Figure 3-3, below.

- (i) The non-pumping water level in the Brine Disposal Well fluctuated in sync with Tidal fluctuations, indicating that the Highland Limestone Aquifer is in direct hydraulic continuity with the Sea, as shown in Figure 3-3, above.

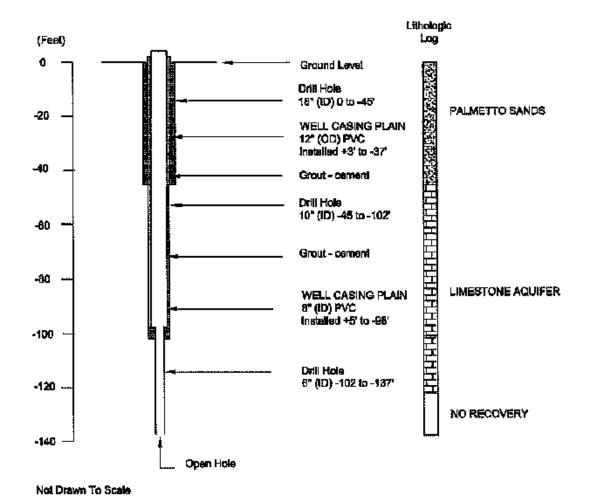
Figure 4-2: SCHEMATIC AS-BUILT DESIGN - BRINE DISPOSAL WELL

- (i) The annular space between the wall of the Drill Hole and the PVC Well Casing was grouted with cement down to a depth of 98 ft bgl; some 61 ft below the bottom of the Palmetto Sands Formation, to prevent the seepage of sand into the underlying Highlands Limestone Formation, and 15 ft below the depth of the bottom of the Source Water Well to avoid the recirculation of the brine effluent.
- (ii) The bottom 35 ft of the 6" ID Drill Hole (i.e., 102 to 137 ft bgl) was left uncased/open, to allow for maximum hydraulic connectivity between the well and the aquifer.

The main elements of the As-built Design of the Brine Disposal Well for the Paradise Found Development is given as Figure 4-2, below.

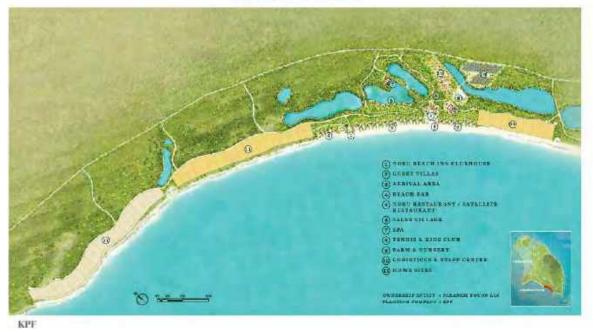
Figure 1.1 Masterplan for project site

It is our understanding that the master plan has been revised to a smaller scale, with a focus on the southern portion of the property. An image of the revised and updated Master Plan of the development is shown in Figure 1.1.

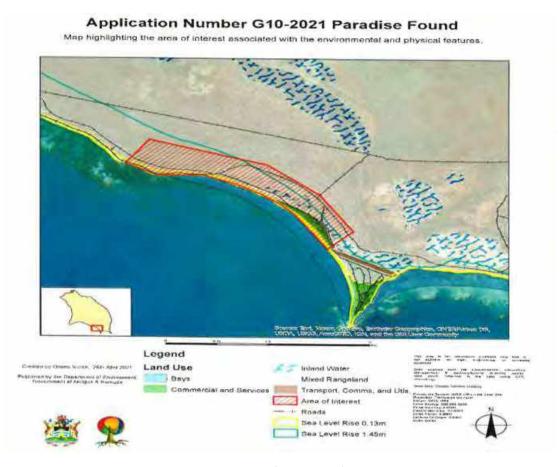
Figure 2.2 Paradise Found development property (in red hatch)

The development is to be located at the site of the former K Club Development on the southeast coast of Barbuda (Figure 2.1 and Figure 2.2). The terrain of the area is characteristic of Barbuda. The site is low-lying and many wetland ecosystems and hydraulic features are present. The Development is within an area zoned for Tourism Development.

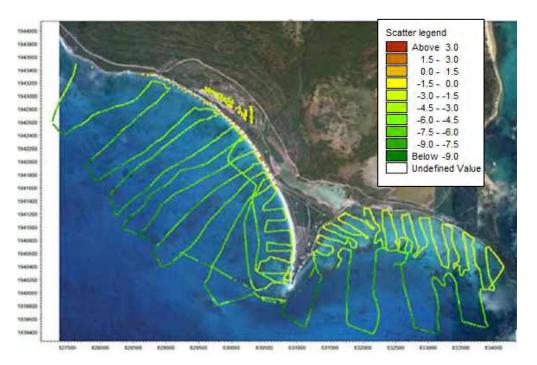
Figure 4.1 Bathymetric data points from the boat-based bathymetry survey

A boat-based bathymetric survey with echo-sounder and GPS was conducted to map the nearshore area as well as within Pond 2 and Pond 3 in July 2016 (Figure 4.1). The methodology consisted of using the boat to traverse the nearshore zone, making a series of tracks from deep water (approximately 10m) towards the shoreline. Horizontal positioning was measured using GPS equipment, and an ODOM EchoTrac CV100 single beam echo sounder provided the water depth information along the tracks. The raw data from this survey was referenced to the UTM 20N system and elevations set relative to the mean sea level (MSL) datum for continuity of data.

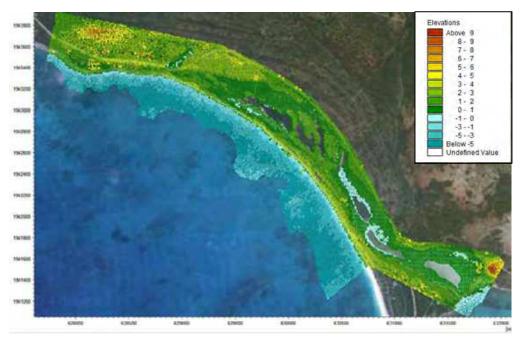
Figure 4.2 Topographic data points from the DEM of the site and nearshore

The topography of the land was quantified by producing a Digital Elevation Model (DEM) from drone topography of areas with low vegetation coverage combined with the surveyor's topographic data (Figure 4.2). Data from the bathymetric survey and topographic DEM were both referenced to MSL for continuity of data. The bathymetry and topography will be used in a computer model to simulate wave propagation up to the shoreline and inundation of the property and surrounding areas.

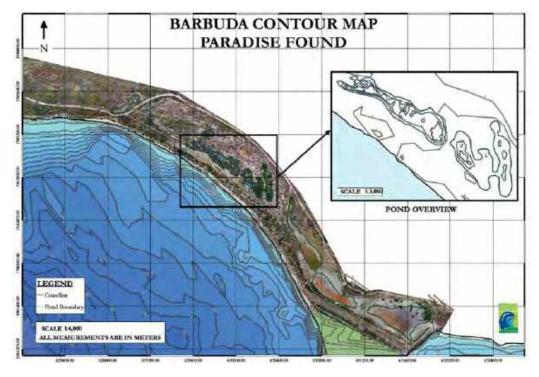
Figure 4.3 Contour Map showing bathymetry and topography of site

Contour maps are then created to show the contours of the nearshore area and the ponds. The maximum depth recorded was -4.1m in Pond 3, while Pond 2 recorded depths of 2m below sea level. The bathymetric and topographic contours, along with water depth in the ponds, are shown in Figure 4.3 and Figure 4.4.

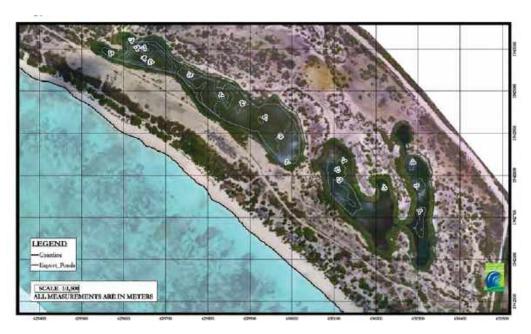
Figure 4.4 Contour Map showing bathymetry of Pond 2 and Pond 3

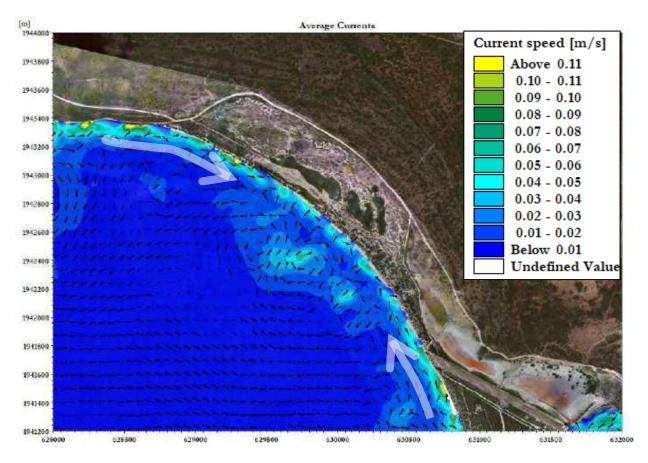
Figure 4.5 Current speeds and directions at the project site

Generally, the currents in this area are slow (below 0.05m/s), which is to be expected because of the gentle bathymetry and low wave energy along this section of shoreline. Stronger currents at this site flow parallel to the shoreline and have an average speed of 0.09m/s. Along the southern shore of the project area there is a north-westerly flowing current, while along its northern shore there is a south-easterly flowing current. These currents meet at the centre of the site and the shear resulting from their interaction gives rise to a small gyre (Figure 4.5). This gyre has the potential to generate two areas of possible rip currents.

Additionally, there are stronger currents over two shallow features in the center of the bay. Thus, the main gyre is affected by these shallow features, which creates smaller, less organised gyres in the nearshore.

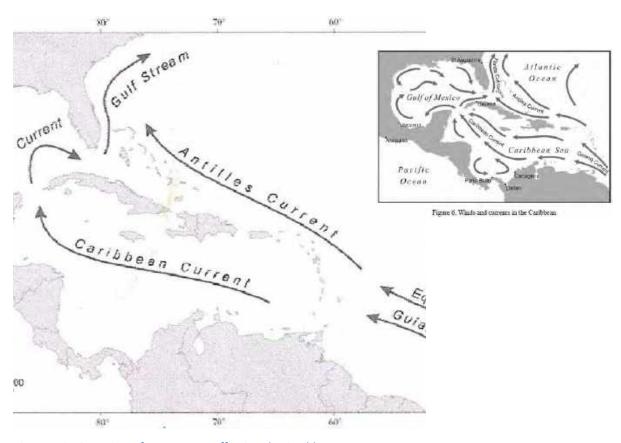
Figure 4.6 Oceanic surface currents affecting the Caribbean

The Guiana Current sweeps north-westerly offshore South America and splits into (i) the Caribbean Current, which enters the Caribbean Sea and (ii) the Antilles Current, which moves on the outside of the Lesser Antilles Island arc, up past the Lucayan Peninsula where it joins the Gulf Stream (Figure 4.6). It is the Antilles Current, as an oceanic driver, that would have the most influence on the shorelines of Barbuda. Further, it is likely, but not shown at a suitable scale in the figures below, that the Antilles Current will result in smaller gyres through its interactions with the islands in the Lesser Antilles.

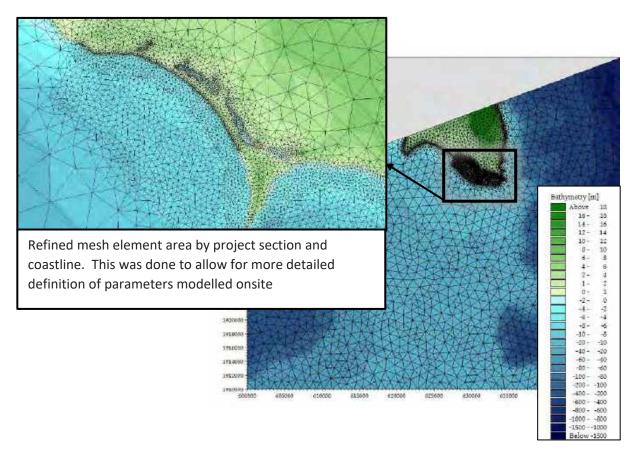
Figure 4.7 Numerical model domain - Flexible mesh used when modelling the existing conditions on the site

MIKE21, a coupled wave-hydrodynamic-sediment model developed by the Danish Hydraulic Institute, was set up for this project area. The model was used to transform wind and wave fields from deep water to the nearshore at the project site and to determine both operational wave conditions and hurricane wave conditions, including storm surge and inundation. Figure 4.7 shows the MIKE21 flexible mesh representing the seabed that was used for this modeling.

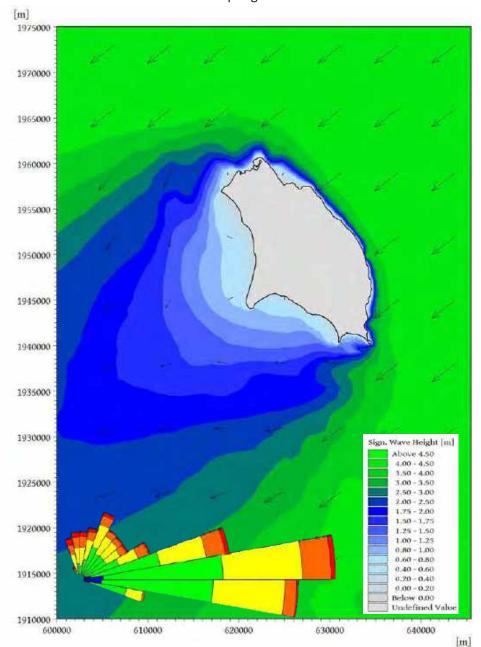
Figure 4.8 Mean annual wave climate around Barbuda and wave rose showing the distribution of wave directions

Figure 4.8 below shows the distribution of wave directions observed in deep water around Barbuda. As expected, most of the wave's approach from easterly directions, generated by the Trade Winds that dominate the wind climate of the Caribbean Sea. The Paradise Found property is on the lee side of the island and is largely sheltered from these waves. The waves having secondary dominance approach from the northwest. These occur in the winter months when North American cold fronts generate waves that

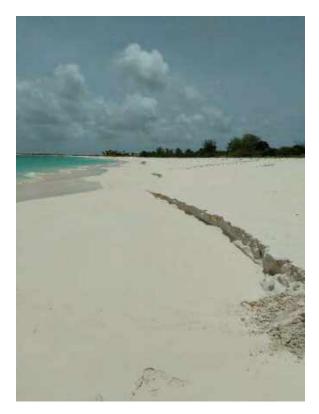
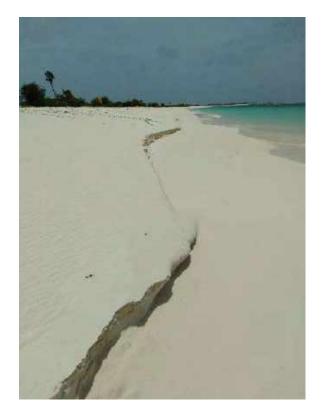
Figure 4.9 Beach profile change

reach the Caribbean as seasonal northwesterly swells. Paradise Found beach, although partially protected from direct impact of these waves by Palmetto Point, would be impacted by these waves more so than from the easterly waves. These distinct wave climates would cause significant seasonal variations in beach slopes, as shown in Figure 4.9 where there are sometimes beach cliffs of more than 2m in height on the shoreline. The beach typically has gentler slopes in the summer months, while in the winter months the swells result in steeper gradients on the beach.

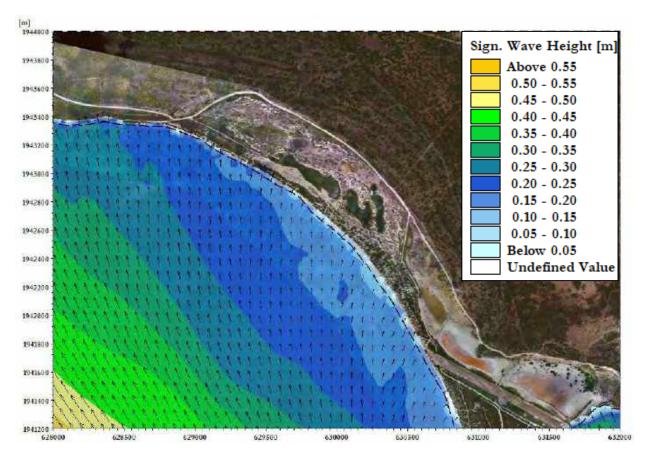
Figure 4.10 20-year mean wave heights and directions

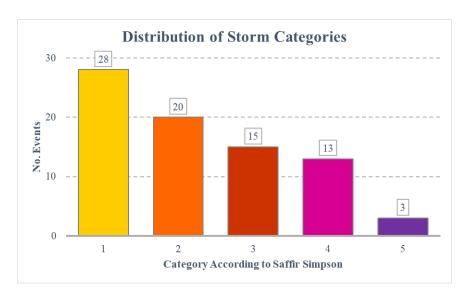
Figure 4.11 Distribution of storms according to the Saffir Simpson scale

Using HurWAVE (Banton 2002), an in-house storm hindcasting program, we determined that a total of 209 hurricanes and tropical storms have passed within a 300km radius of the Paradise Found property since 1852. This search radius was selected as it provides a good balance between storm size and wave generating capabilities. The number of occurrences within each storm category (per the Saffir-Simpson scale) is shown in Figure 4.11. Seventy-nine (79) of these were hurricanes per the Saffir Simpson scale. The data shows that on average one hurricane (Cat 1 to Cat 5) passes this location every 2 to 3 years and one intense hurricane (Cat 3 to Cat 5) passes every 5 to 6 years (Figure 4.12). The bar chart shows that many of the storms that pass the project area are weaker than a Category 3 cyclone. Only 14.1% percent of the recorded storms were Category 3 or stronger. The graph shows that the study area was more frequently hit by tropical storms and was rarely affected by major hurricanes.

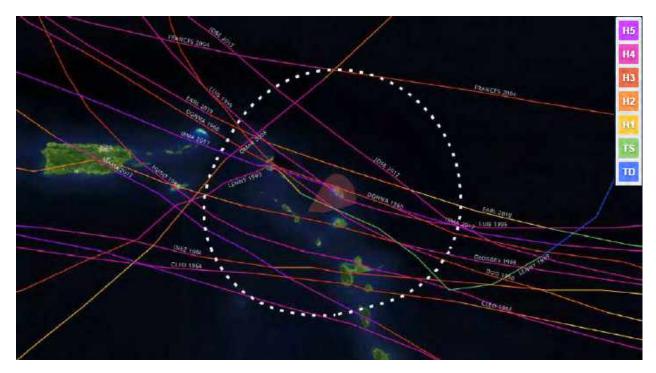
Figure 4.12 Named Category 3-5 Hurricanes passing within a 300km radius of the site

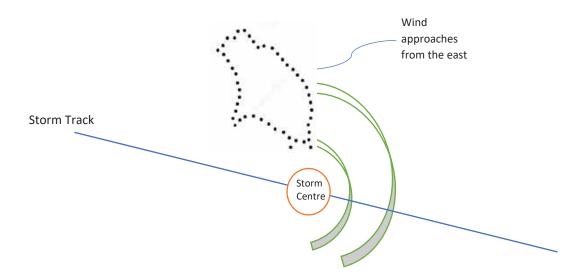
Figure 4.13 Schematic diagram of wind & wave directions from hurricane conditions

Hurricanes typically pass the island in a north westerly direction going either south or north of the island (Figure 4.13). There has been a maximum of three storms affecting Barbuda in a single hurricane season: in 1995 Hurricane Luis, Hurricane Marilyn and Tropical Storm Iris caused significant damage in Antigua and Barbuda. More recently, the island was affected by Hurricane Irma (Category 5) and Hurricane Jose (Category 4) in 2017. While these hurricanes created havoc over the island it should be noted that they passed to the north of the Paradise Found site and limited impact of storm surges from the sea was reported.

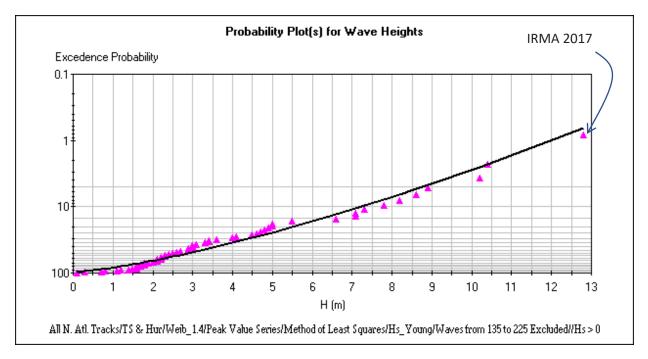
Figure 4.14 Probability of exceedance plots for significant wave heights for past hurricane waves approaching from the south

Deep water wave parameters were calculated for each selected tropical cyclone using parametric hurricane models (Cooper 1988; Young and Burchell 1996). The resulting wave conditions were divided into directional sectors and each set was fit to a statistical function (Weibell) describing their exceedance probability. The wave parameter values for the 50 and 100-year return periods were determined from the best-fit statistical distribution. The deep-water wave parameters corresponding to the 50 and 100-year return periods were computed for five directional sectors of incidence. These return periods were calculated using the probability of wave height exceedance. The 1-in-25, 1-in-50 and 1-in-100-year events have, respectively, a 4%, 2% and 1% chance of occurring (Figure 4.14). The event with the 1% chance of occurrence is typically the design condition used for protecting critical infrastructure. Table 4-1 shows the wave heights, wind speeds, and periods for the directional sectors investigated. These wave parameters will be used in MIKE21 SW with the inclusion of the static storm surge levels to obtain design wave heights in the nearshore of the selected areas.

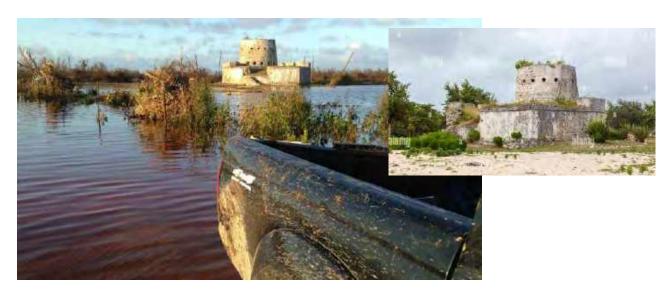
Figure 4.15 Flooding from Hurricane Irma at the Martello Tower

Hurricane Irma (September 2017) was a devastating hurricane that made a direct hit on Barbuda. In addition to the effects of sustained high winds (for over 3 hours), there are reports of extreme levels of storm surge, of between 1.5m - 3.3m. The images below show the landscape around the historical Martello Tower, which is located at the shoreline to the north-west of Paradise Found. The extensive flooding around the tower is evident.

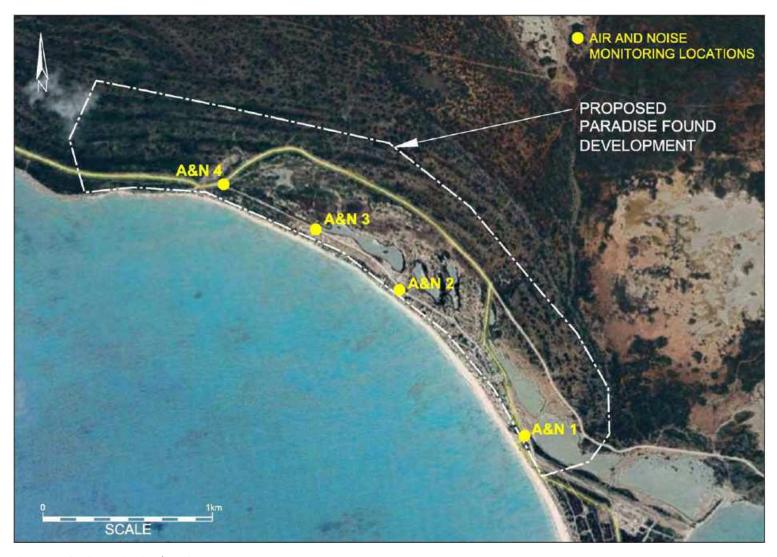
Figure 4.16 Air monitoring locations

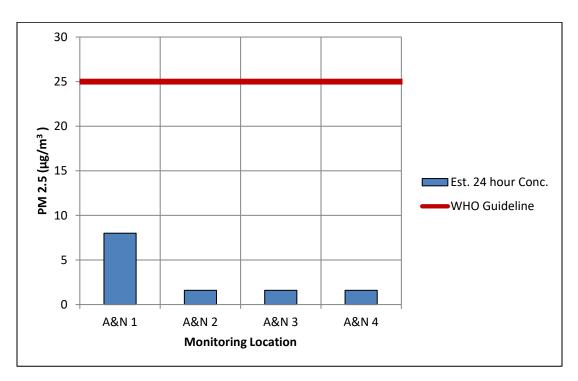
Figure 4.17 indicates that estimated 24-hour concentrations of PM_{2.5} at all four monitoring locations were significantly less than WHO Guideline of 25 μ g/m³ for a 24-hour averaging period.

Figure 4.17 Estimated 24 Hour Concentrations of PM 2.5

Estimated 24-hour concentrations of PM_{2.5} ranged from 1.6 μ g/m³ to 8.0 μ g/m³ at the four air quality monitoring locations (Table 4-7). The highest concentration of PM_{2.5} was recorded at A&N 1.

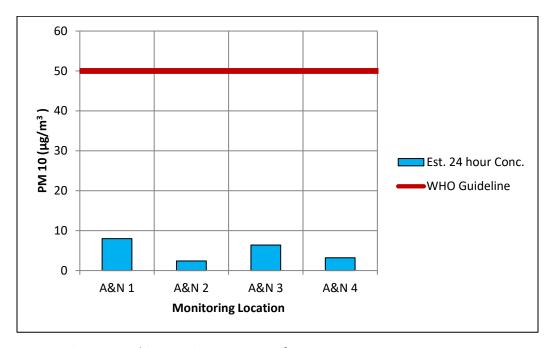
Figure 4.18 indicates that estimated 24-hour concentrations of PM₁₀ at all four monitoring locations were significantly less than WHO Guideline of 50 μ g/m³ for a 24-hour averaging period.

Figure 4.18 Estimated 24 Hour Concentrations of PM 10

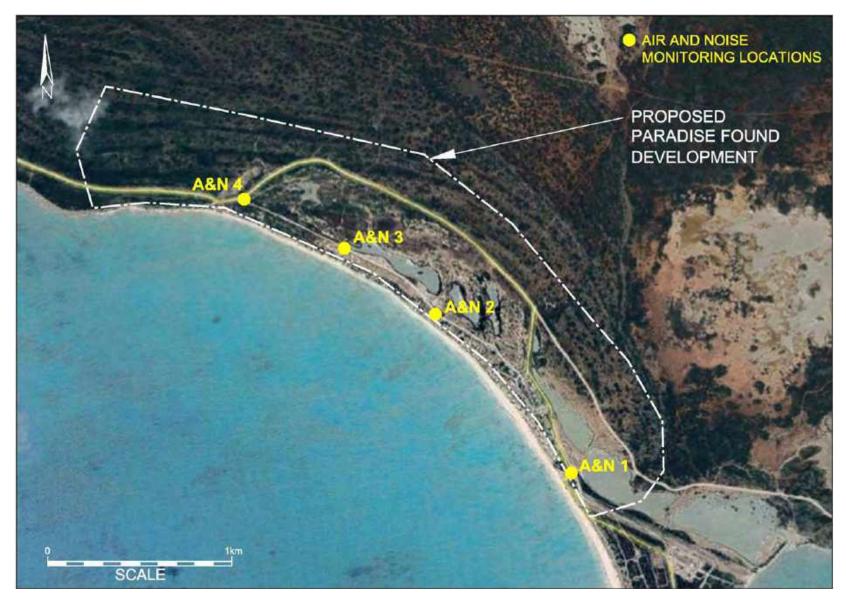
Figure 4.19 Noise monitoring locations

Noise monitoring was conducted for one (1) hour during the daytime and one (1) hour during the nighttime at four (4) locations within the study area on the 15th and 16th of July 2022 (Table 4-9 and Figure 4.19). These locations were selected based on the site boundaries and activities within the area. A&N 1 and A&N 4 respectively are representative of the northern and southern boundaries of the site and A&N 2 is representative of the nearest sensitive receptor. A&N 3 was chosen as construction works for a new helipad were on-going in the vicinity of this area.

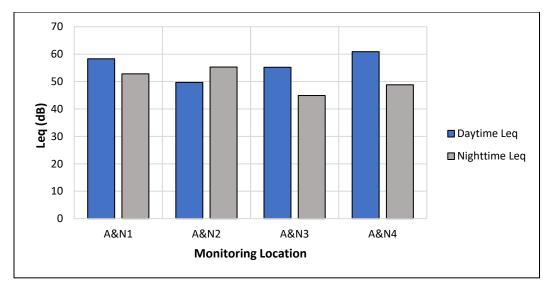
Figure 4.20 indicates that equivalent continuous sound pressure levels (Leq) were higher during the daytime than the nighttime at all monitoring locations except A&N2.

Figure 4.20 Comparison of Daytime Leg and Nighttime Leg

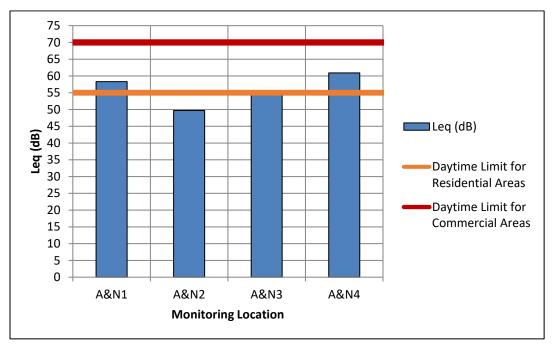
Figure 4.21 compares the daytime Leq values recorded at each monitoring location to the World Bank Group's Noise Guidelines. The chart indicates that daytime Leq values recorded at the four monitoring locations were below the daytime limit for commercial areas. However, Leq values recorded at A&N1, A&N3 and A&N4 were at, or slightly above, the daytime limit for residential areas.

Figure 4.21 Daytime Leq in Comparison to World Bank Noise Guidelines

Daytime Leq values at the four noise monitoring locations ranged between 49.7 dB and 60.9 dB. The highest daytime Leq was recorded at A&N4 while the lowest daytime Leq was recorded at A&N2 (see Table 4-12).

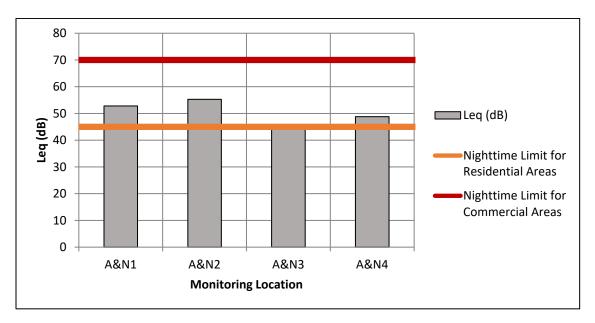
Figure 4.22 compares the nighttime Leq values recorded at each monitoring location to the World Bank Group's Noise Guidelines. Similar to the daytime, nighttime Leq values recorded at all four monitoring locations were also below the limit for commercial areas. However, Leq values recorded at A&N1, A&N2 and A&N4 were slightly above the daytime limit for residential areas.

Figure 4.22 Nighttime Leq in Comparison to World Bank Noise Guidelines

Nighttime Leq values at the four noise monitoring locations ranged between 44.9 dB and 55.3 dB. The highest daytime Leq was recorded at A&N2 while the lowest daytime Leq was recorded at A&N3.

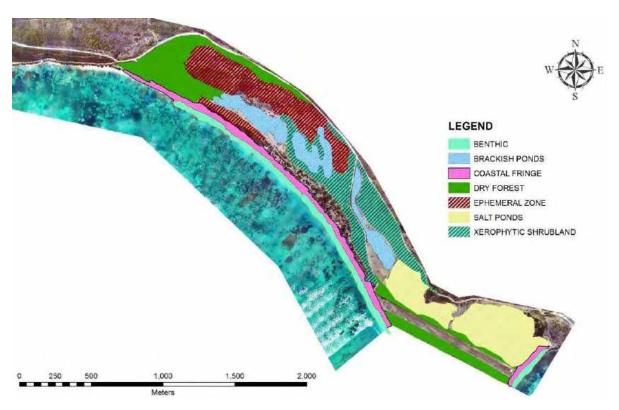
Figure 5.1 Habitat types at the site

The habitats identified during previous surveys in 2016 as well as a review of literature include dry forest, ephemeral zones, xerophytic shrubland, salt pond and coastal fringe (Figure 5.1). In addition, there are brackish ponds that were created for the former development.

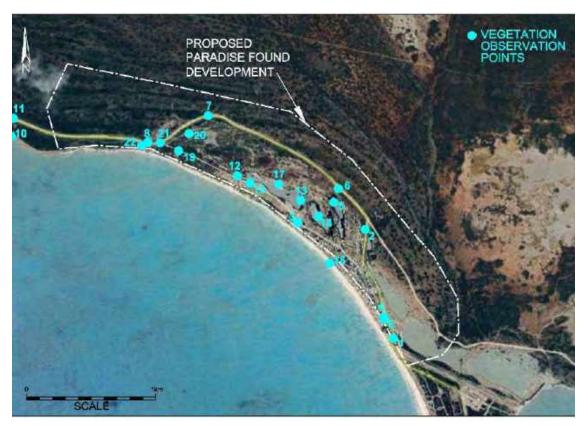
Figure 5.2 Vegetation observation points

To determine the dominance of species in the various floral assemblages on the site, a series of observation points were established across the site to make note of the dominant vegetation (Table 5-1 and Figure 5.2). At each observation point, trees and shrub species within a 20m radius with a circumference at breast height (CBH) of \geq 63 cm were identified. This was used to gauge the dominance of mature tree species. Additionally, plants (smaller trees, saplings, and seedlings) with a CBH of < 63cm were also noted to determine the dominance of the upcoming generation. A handheld GPS unit was

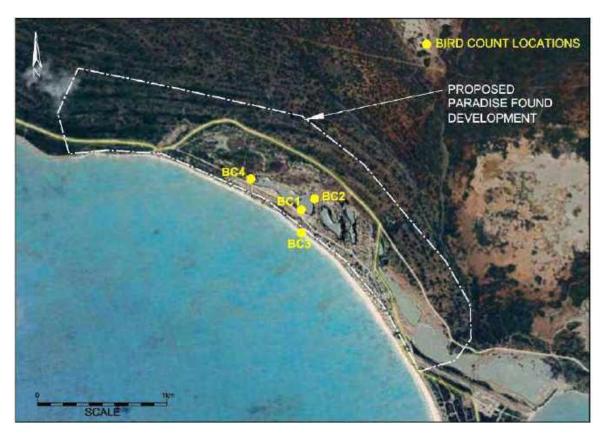
Figure 5.3 Bird count locations

Fixed point bird counts were undertaken to describe the avifauna within the site. Based on factors such as access, vegetation type and cover, four bird count locations were established on the site, and these were recorded using a hand-held GPS unit (Table 5-3 and Figure 5.3). All birds seen or heard within a 10-minute period at each point count location were recorded. Fixed point counts were undertaken twice at each location: a morning and an afternoon count. Species lists were prepared at the end of the survey and cross referenced against designated rare, threatened, endangered and endemic species. Other fauna species were observed opportunistically while doing the vegetation survey and the bird counts.

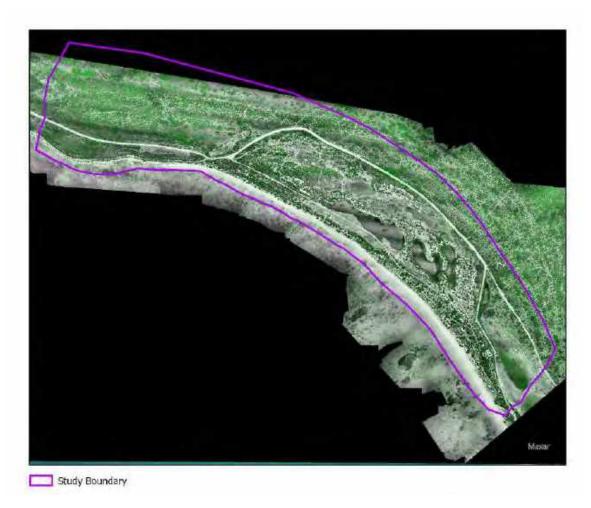
Figure 5.4 A false colour remotely sensed image showing the distribution of vegetation throughout the site. Green areas are vegetation while white areas are bare soil and built structures. Note there are several open bare areas, especially along the ephemeral zone.

Based on site investigations, ecological surveys and literature review, several types of habitat / ecosystems were identified within the site and immediate surrounding study area. The main ecosystem types found at the Paradise Found site were mangroves, dry forest, ponds, sand dunes and rocky shore. The western end of the property is occupied by shrub/scrub type ecosystems with xerophytic vegetation. Various species of cacti dominate the area. Rocky shores exist along sections of the shoreline, sand dunes occur in the middle sections of the property and there are mangrove stands on the landward side, however, not to the easternmost limits. The eastern section of the property is characterised by dry limestone forest, with large areas occupied by invasive wild cotton species along the roadway. A large proportion of the site is bare soil (Figure 5.4 and Figure 5.5). The major ecosystems are described in the following sections.

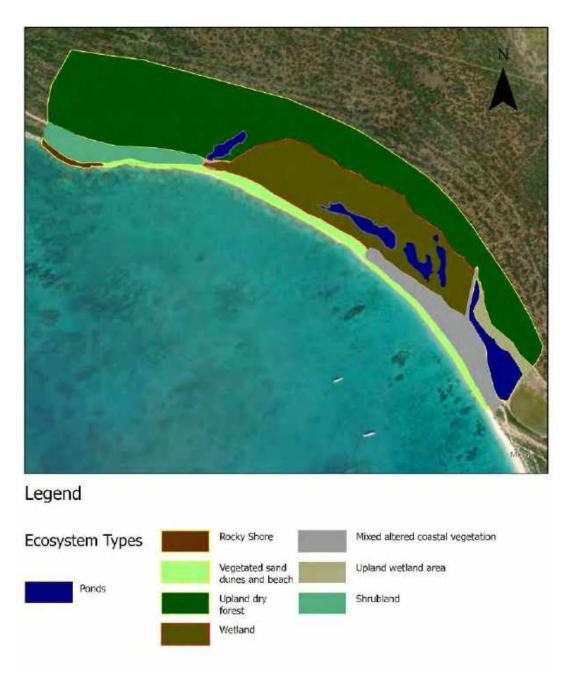
Figure 5.5 Map of the different ecosystem types observed across the proposed development site

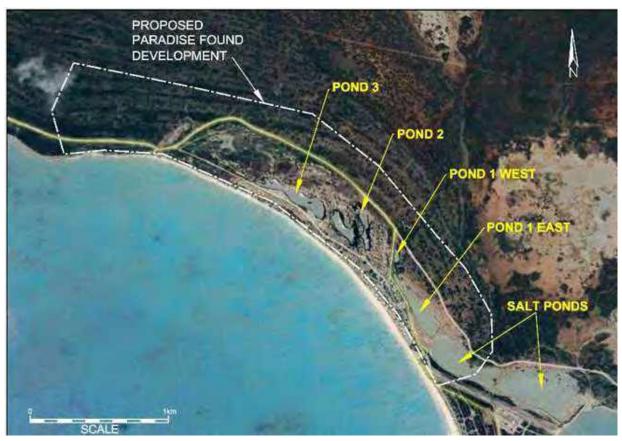
Figure 5.9 Pond locations

The site has three prominent and permanent ponds of varying sizes located at the southern half of the site (Figure 5.9). One pond is natural in origin, the other two are man-made, constructed during the development and landscaping of the former golf course. The topography is flat with groundwater located a few metres below ground surface. The ponds are brackish and contribute to a particular type of habitat.

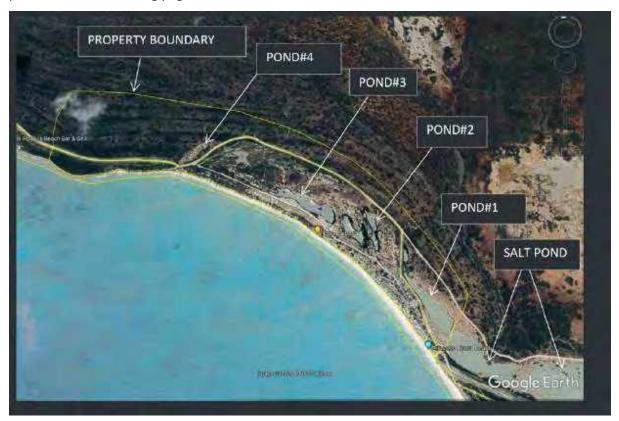
Figure 6.1 Ponds within the property boundary

From satellite imagery (Figure 6.1), four ponds can be observed within the limits of the project site. Anecdotal information from the residents is that three of these ponds are artificial; namely Ponds 2, 3 and 4. The westernmost pond (Pond 4) is reportedly the most recently created. It is reported to have been created (anecdotal evidence) as a result of freshwater exploration, as there is a spring just to the north of it. The depths within the ponds range typically from very shallow at their edges to depths in excess of 10m in the middle sections. From the water quality analyses, all the ponds have high levels of salts. The sample results discussed later in this chapter show salt levels even higher than the ambient

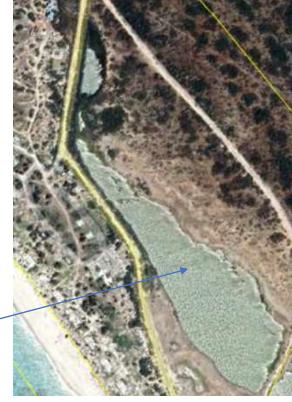
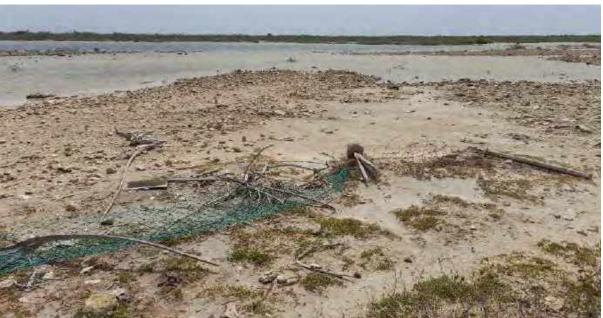
Figure 6.2 A view of pond #1, looking east. The pond is dry in some areas (even walkable) and in other areas there is typically 0.25m and deeper water

Pond one is an elongated pond to the east of the property. A raised marl road separates this pond from the salt pond to the east. During a site visit it was observed that the road elevation was not much higher than the pond's water level. This pond's water chemistry should therefore indicate high salt content from exchange between the two systems during the rainy season when there is hydrologic connectivity. Along the periphery of the eastern section of the pond, there was very sparse vegetation, an indication of saline water conditions. Only a few stands of vegetation could be observed along its eastern limits. At the upper northwest end, however, there were thicker stands of vegetation along the banks of the pond. This is likely due to more tolerable conditions as a result of freshwater input from overland flows originating at higher elevations.

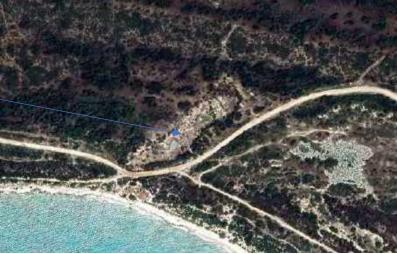
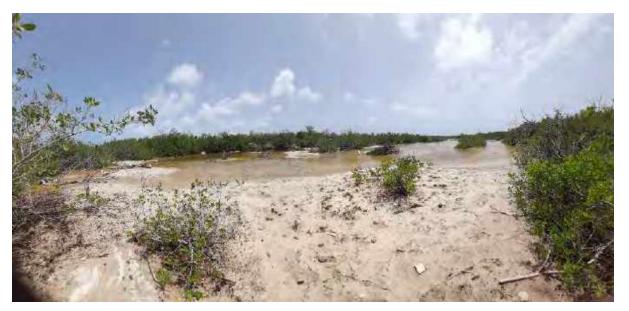
Figure 6.5 A panoramic view of pond#4. Only the lower elevations are inundated as it had not rained for a long time in Barbuda

Pond #4 is located at the north-west corner of the property (Figure 6.5). Its existence is due to the property owners exploring the possibility of freshwater resource development from groundwater in the area as well as for marl material. It was reported that there is a spring north of the pond, which feeds freshwater into it. Anecdotal information provided is that the pond only has significant volumes of water when it rains heavily and runoff from the surrounding catchment contributes to its volume. The beach area elevation is also higher than the area of the pond, hence, flood waters are stored within it. The pond had white mangroves within and along its periphery. The stands were of substantially greater stature compared to those fringing ponds 2 and 3. Landcover around the pond was a mix of trees and shrubs, with no immediate land use in the vicinity except for a few isolated cabins on the southern section of the roadway (on the seaward side).

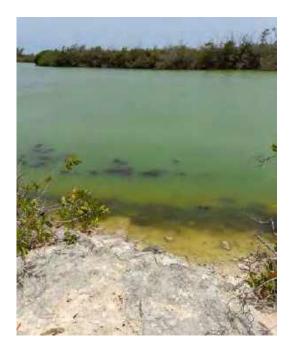
Figure 6.6 A comparison of the water clarity between Pond 2 (left) and Pond 3 (right)

The ponds were assessed for their baseline water quality, to give a picture of what conditions are prior to the development. From field observations, all except pond #2 seemed to show generally good water quality conditions (Figure 6.6). Circulation within the upper regions of the water column was evident from the ripples on the water surface, and wildlife could be observed foraging in and around the ponds. There was also no unusual smell detected from the edges of the ponds. Pond #2, however, showed signs of nutrient accumulation, in that there were significant algal masses along the inner edges of the ponds and the surface showed a distinct green discolouration. This was reportedly observed following the last hurricane (Irma).

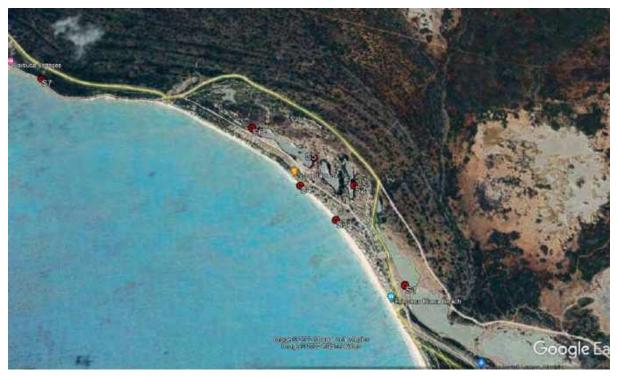
Figure 6.7 Locations of sampling for water quality testing

On the contrary, the physico-chemical analysis of the samples showed that neither nitrate nor phosphate levels were high in the pond. This may require further investigations to determine the cause of the green discolouration in that specific pond. Samples were taken at the locations shown in Figure 6.7. An excerpt of the water quality analysis report is presented in Figure 6.8.

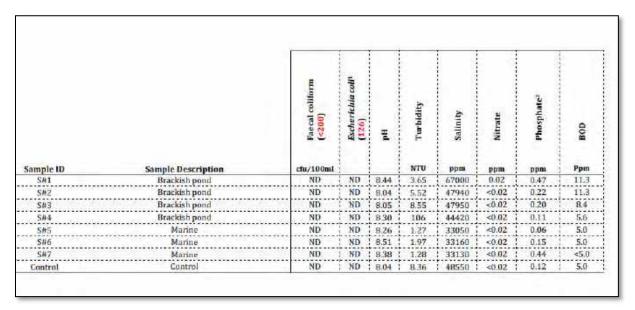
Figure 6.8 An excerpt of the water quality analyses report by the Department of Analytical Services, Antigua. Ministry of Agriculture

The results of the water quality analysis show that BOD levels are higher in the ponds than in the marine environment, which is reasonable given that their salt and turbidity levels (an indication of suspended sediments) are also higher. Both the ponds and the sea environment are within satisfactory ambient standards for Antigua and Barbuda (the US EPA standards) and are in keeping with ambient standards for recreational purposes.

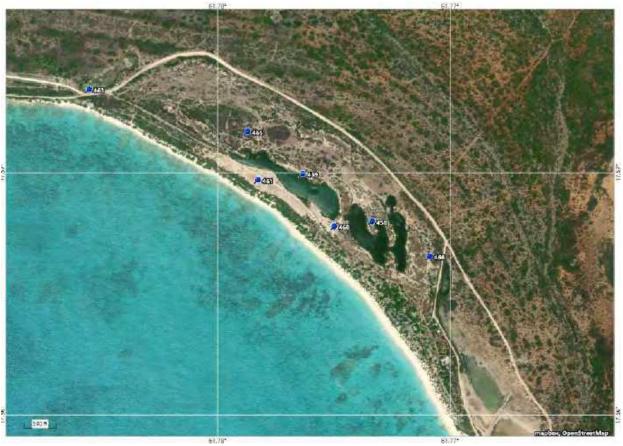
Figure 6.9 The distribution of the water levels monitoring points across the site, established for baseline and post development monitoring

Water level rods were marked and erected at several locations throughout the site, along the periphery of the brackish ponds and within the ephemeral zones, to measure water depths above the surface in the event that the area experiences heavy or prolonged rainfall in the months to come (Figure 6.9 and Figure 6.10 and Table 6-1). The readings would be recorded and measured against an established datum, determined by the topographic land surveyor.

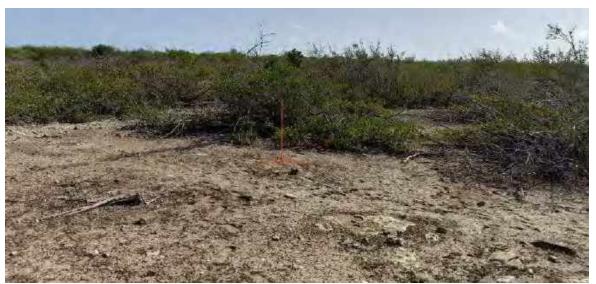
Figure 6.10 Water level monitoring point

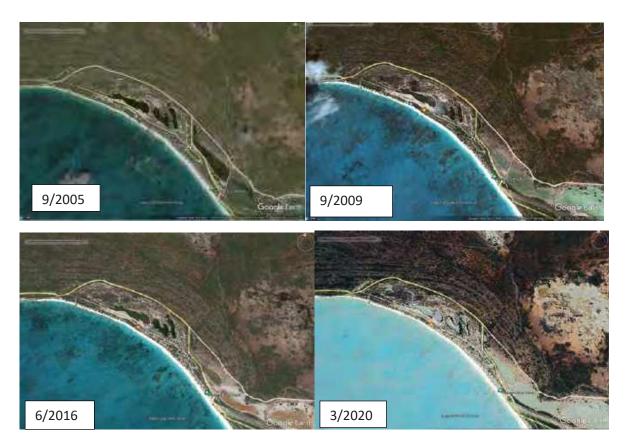
Figure 7.1 Google Earth imagery showing land use from 2005 to 2020

Landcover over the site is a mixture of mangrove stands, dry forest, shrubland and open water bodies. There are ponds that were created (the brackish ponds) and naturally occurring salt ponds. The main land uses are residential and resort development and associated amenities. Land development is minimal and mostly restricted to coastline areas. A comparison of historical imagery using Google Earth shows that land cover and land use have not changed much over the last nearly two decades (Figure 7.1). The upper reaches in the watershed are predominantly shrubland and dry forest, while the lower regions have minimal human development.

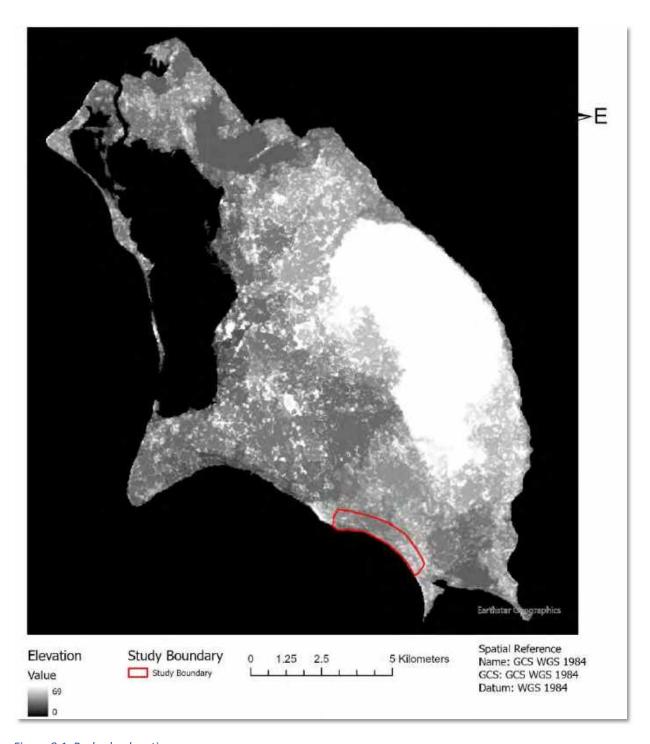
Figure 8.1 Barbuda elevations

The Paradise Found project site is shown in Figure 8.1 at the south-western section of the island shoreline. Elevations over the project area range from sea level (0m MSL) to about 10m above mean sea level, and these elevation changes occur gradually. The watershed drains toward the south, towards the Caribbean Sea. Note that no rivers were detected during the site reconnaissance, hence the flow paths are apparently generated from natural gradients in the topography of the site, where water drains during and immediately after significant rain events, and hence are ephemeral. The drainage density of these flow paths can be described as very sparse, contributing to a short residence time of water within

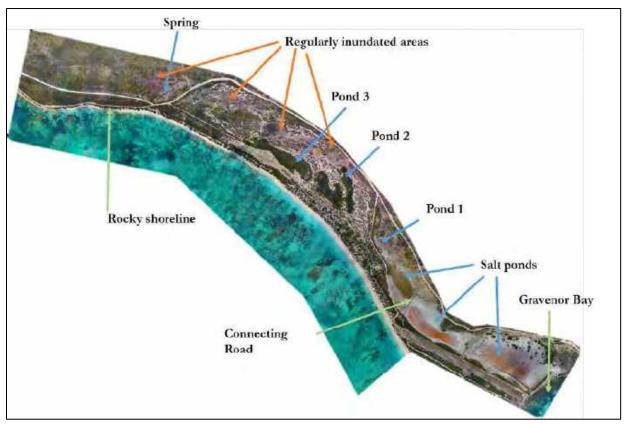
Figure 9.1 Paradise found site characteristics

The site is low-lying and generally floods with small amounts of rainfall. Areas that are quickly inundated are highlighted in Figure 9.1. These areas are generally located around the existing ponds, the spring and along the coastline. The land is gently sloping towards the coastline.

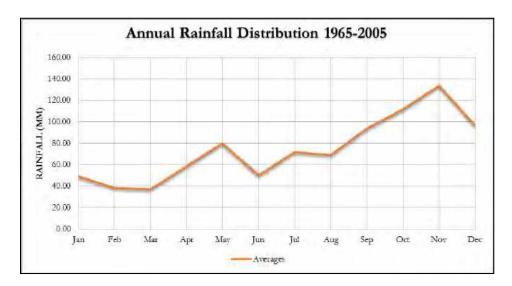
Figure 9.3 Annual rainfall distribution for the period 1965-2005

Rainfall trend graphs were plotted using available precipitation data as shown in Figure 9.3 and Figure 9.4. Barbuda has a dry season from January to April and a primary wet season from August through to November. The wet season coincides with peak tropical storm activity. The largest recorded value for the Coco Point station was in November 1999 where 483mm of rainfall was recorded. This was due to Hurricane Lenny passing south of the island.

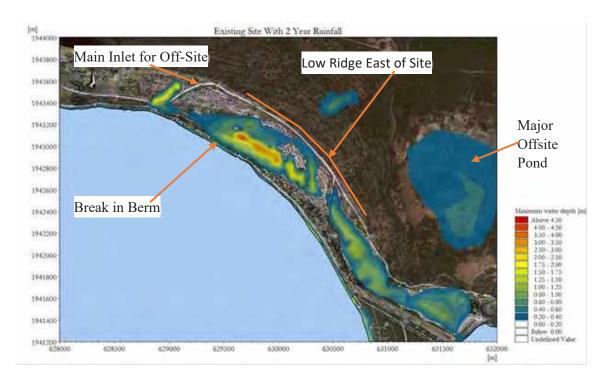
Figure 9.5 Main observations from simulations using existing site with 2yr rainfall plot

Flood modelling was done using the hydrodynamics module of the MIKE 21 software suite (DHI). The bathymetric data mesh, precipitation rates and stormwater discharge values were used as input for inundation plots. Model simulations incorporated rainfall over the entire island for 24 hours to properly assess discharge flows. Soil saturation was assumed by allowing no infiltration on the site.

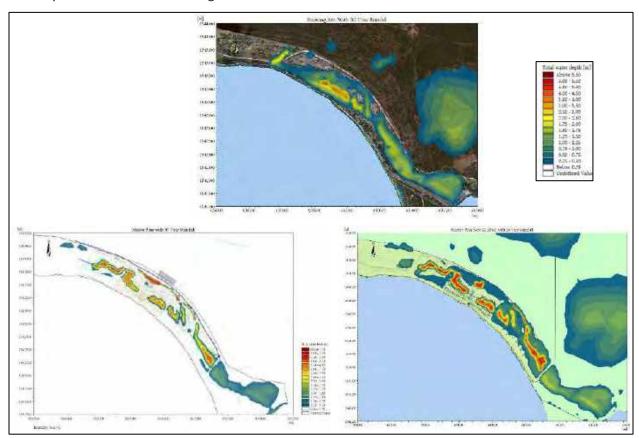
Figure 9.11 50 year event for existing conditions (top), the September Master Plan (bottom-left) and the December Master Plan (bottom-right)

The December 2016 master plan improved drainage in the areas around the main hotel and included lowered berms east of pond 2 and west of pond 1. The reduction in berm height led to larger levels of inundation in these areas. Using the 50-year event as an example; the initial master plan had only small ponds with maximum depths of 0.25m south of the drainage ponds and by pond 1. However, the latest master plan had ponds with larger surface areas and depths of 0.75-1.0m in those areas. The plots for the 50-year event are shown in Figure 9.11

The September 2016 master plan greatly improved flow and reduced inundation across the site. Better definitions of flow across the project site were established and unwanted ponding was reduced, however there were areas of concern west of Pond 1 and north of proposed Pond 2 where depths of 0.25m-1.0m were seen for the 100-year event. Other berms had no inundation after all rainfall events. The initial master plan involved large volumes of fill, which would prove to be a costly venture. Subsequent plans involved lowering the berms to optimise the cut and fill ratio.
