Environmental and Social Impact Assessment Report for the Paradise Found Development, Barbuda

Submitted to: Mr Darren Flanagan
For Paradise Found LLC

19 May 2023

Smith Warner International Limited Unit 13, Seymour Park, 2 Seymour Avenue Kingston 10, Jamaica, WI

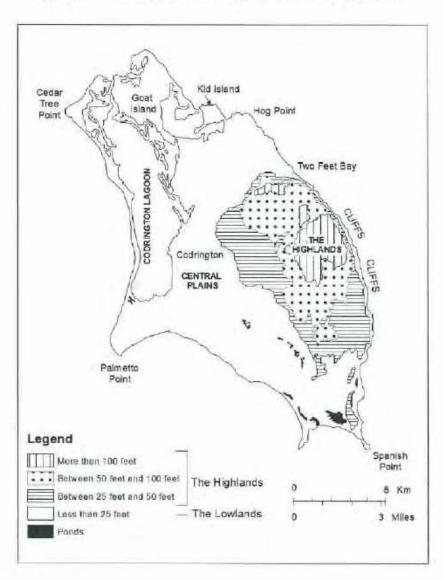
Figure 2-1: PHYSIOGRAPHIC SUBDIVISIONS OF BARBUDA

Barbada may be subdivided into three distinct physical regions, as listed, and shown in Figure 2-1, below.

The Highlands is an area of limestone upland located in the eastern and central sections of Barbuda, occupying about 30% of the island. Surface elevations range from about 25 to just over 100 ft above mean sea level (amsl)

The Lowlands occur to the south, west, and north of the Highlands, forming a relatively featureless plain, with surface elevations < 25-ft amsl.

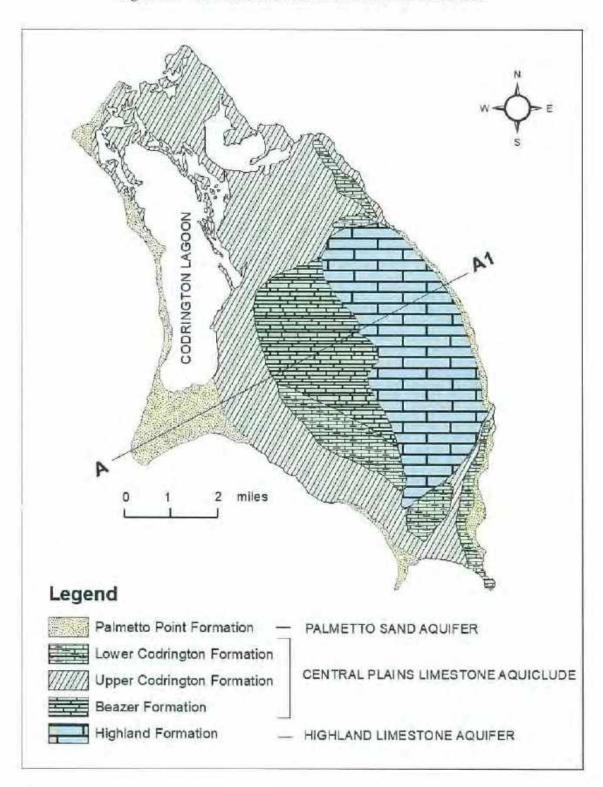
Figure 2-2: HYDRO-STRATIGRAPHIC MAP OF BARBUDA

Their outcrops are given in Figure 2-2 (Brasier & Mather, 1975) and geological sections included as Figure 2-3, to illustrate their subsurface relationships as interpreted by HydroConsult (1992) and revised this Study.

The Palmetto Sand deposits fringe the southern and western leeward coasts of Barbuda and is most extensive in the Palmetto Point headland in the southwest, as shown in Figure 2-2, above. The Palmetto Sand Aquifer is an unconsolidated, fine to medium grained, calcareous sand, with abundant coral and molluscs shell fragments. A maximum thickness of 40 ft have been reported for wells drilled through the Palmetto Sand Aquifer into the underlying Highland Limestone Aquifer, indicating that the Central Plain Limestone Aquiclude is absent from the stratigraphic sequence, in the Palmetto Point area...

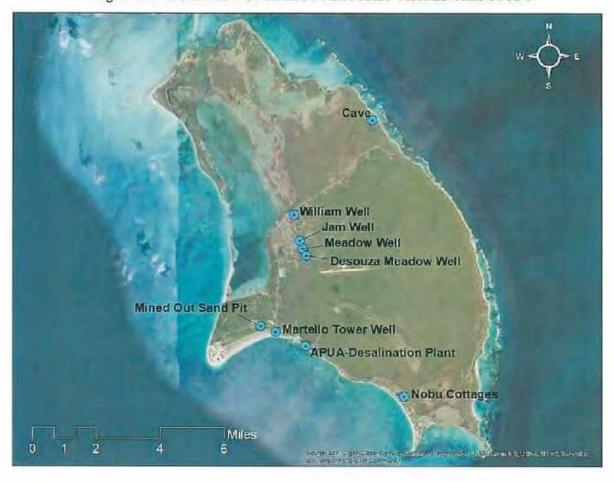
Figure 2-4: LOCATION OF SELECT FEATURES VISITED THIS STUDY

Its existence, not previously reported, was indicated this Study by the presence of fresh groundwater in a collapsed cavern located a few hundred feet from the northeast coast, shown in Figure 2-4, below. This is a clear indication that the Highland Limestone Aquifer was not in hydraulic continuity with the sea at its eastern geological boundary and must therefore be physically separated from the sea by impervious strata, which function as a basal aquiclude.

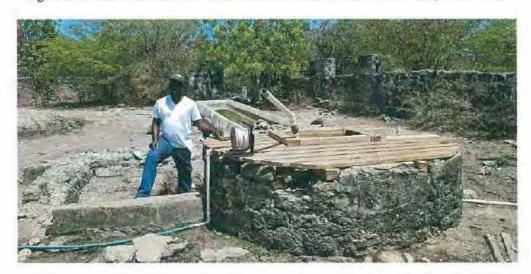
Figure 2.6: JAM HAND DUG MUNICIPAL WELL - CODRINGTON, BARBUDA

The Central Plains Limestone Aquiclude exhibit overall low permeability (and Transmissivity), hence its characterisation as an aquiclude. The equipping of the dug wells with low capacity (i.e., <10 igpm) hand pumps or small electric pumps is evidence of this low permeability. These dug wells are commonly used as household sources of water for non-potable uses. A Municipal Dug well is shown in Figure 2.6, below.

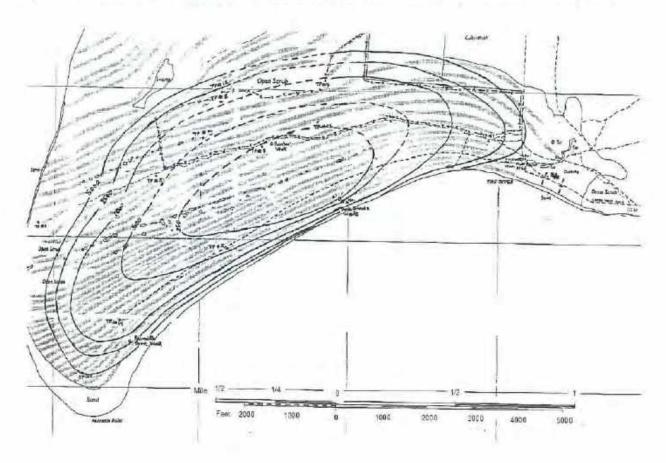
Figure 2-7: PRE-MINING FRESHWATER LENS IN THE PALMETTO SAND AQUIFER, BARBUDA

The area within the 1000 micromhos/cm (or µS/cm) constituted fresh groundwater, suitable for use as a source of domestic water supply. The central thickness of the freshwater lens was about 40 ft as indicated by a Chloride value of 400 mg/l at a depth of 30 ft in a boring drilled into the sand aquifer (Mather 1971). This was consistent with lens thicknesses in the Cayman Islands (Lloyd, 1980) and Hellshire Limestone in Jamaica (HydroConsult, 1982). The location of the Mather (1971) boring is not known. Groundwater flow within the Palmetto Sands Aquifer is intergranular and was radially towards the lens edge.

The sand mining has created a number of mined out pits where excavation has extended down to the water table, exposing the groundwater to the direct effects of evaporation, creating pools with Specific Conductance of 10,400 to 12,500 μ S/cm. The lens structure is still believed to exist within the Palmetto Sand Aquifer, although near totally occupied by brackish groundwater – 10,000 to 12,500 μ S/cm i.e., no fresh groundwater.

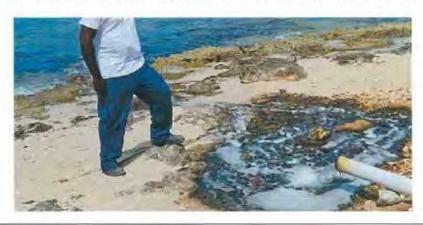
Figure 3-1: BEACH DISPOSAL OF BRINE BY APUA DESALINATION PLANT, BARBUDA

The Antigua Public Utilities Authority (APUA) operates a desalination plant located about miles along the main road southeast of the Martello Tower, and sited <100 ft from the shoreline. The plant has a rated capacity of about 100 imperial gallons per minute (igpm) of freshwater – personal communication with Leonard Desouza, Barbuda Manager. The brine effluent from the plant is discharged via a 4" ID PVC pipeline directly onto the beach, the brine flowing over and through a rocky shoreline into the sea, as shown below in Figure 3-1, below. The APUA Manager for Barbuda, was not aware of any environmental monitoring of the impact of the brine in the vicinity of the entry of the brine into the sea. This Study observed an absence of fish and/or molluses in the immediate vicinity of the outfall.

The beach disposal option is an obvious low cost option that avoids the bio-fouling that is associated with a marine outfall and employs the surface wave energy in rapidly diluting/dissipating the brine effluent. However, it can be expected to create negative environmental conditions for coastal marine life – flora and fauna, by creating coastal waters with much higher salinities than promotes life and growth. The density of the brine is at least 4 times higher than seawater, so the brine will occur as a super saline plume that sinks to the coastal sea-floor and move downgradient or spreading out, until it is fully diluted/dissipated by the receiving scawater. The higher the rate of brine disposal the more significant the negative impacts.

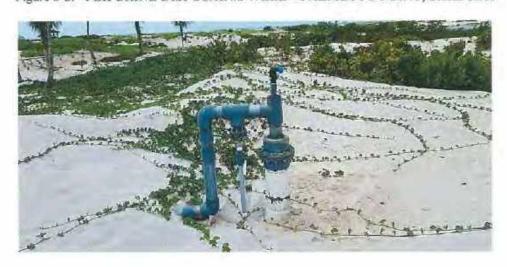
The PLH desalination plant (s) at Palmetto Point dispose of the brine effluent produced via 2 No. deepwells. Each well is 16" OD, reported to be 120 ft in depth, with disposal via the lower uncased section (i.e., open hole) of the wells. Information on the capacity of the desal plants, the rate brine production, and the rate of brine disposal, were not available to this Study. Brine Disposal #2 Well was visited and observed to be adequately disposing of the effluent fed into it. A photograph of the PHL Brine Disposal #2 Well is included below as Figure 3-2.

Figure 3-2: PLH BRINE DISPOSAL #2 WELL - PALMETTO POINT, BARBUDA

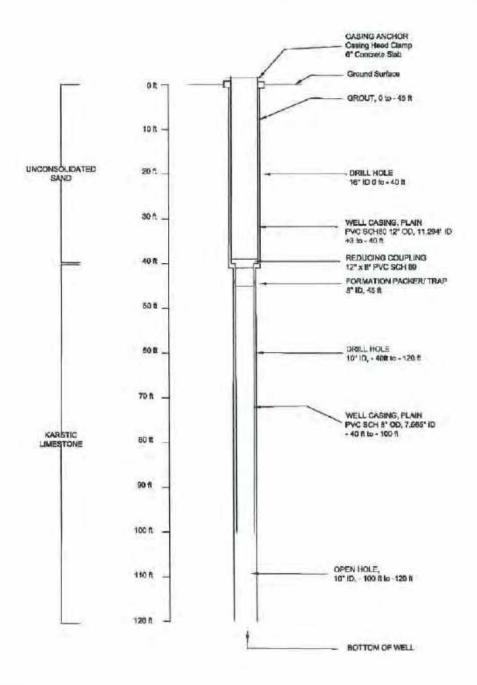
A schematic summary of the design of the Paradise Found Disposal well is presented as Figure 2, below.

Figure 2: SCHEMATIC WELL DESIGN-PARADISE FOUND EXPLORATORY DISPOSAL WELL

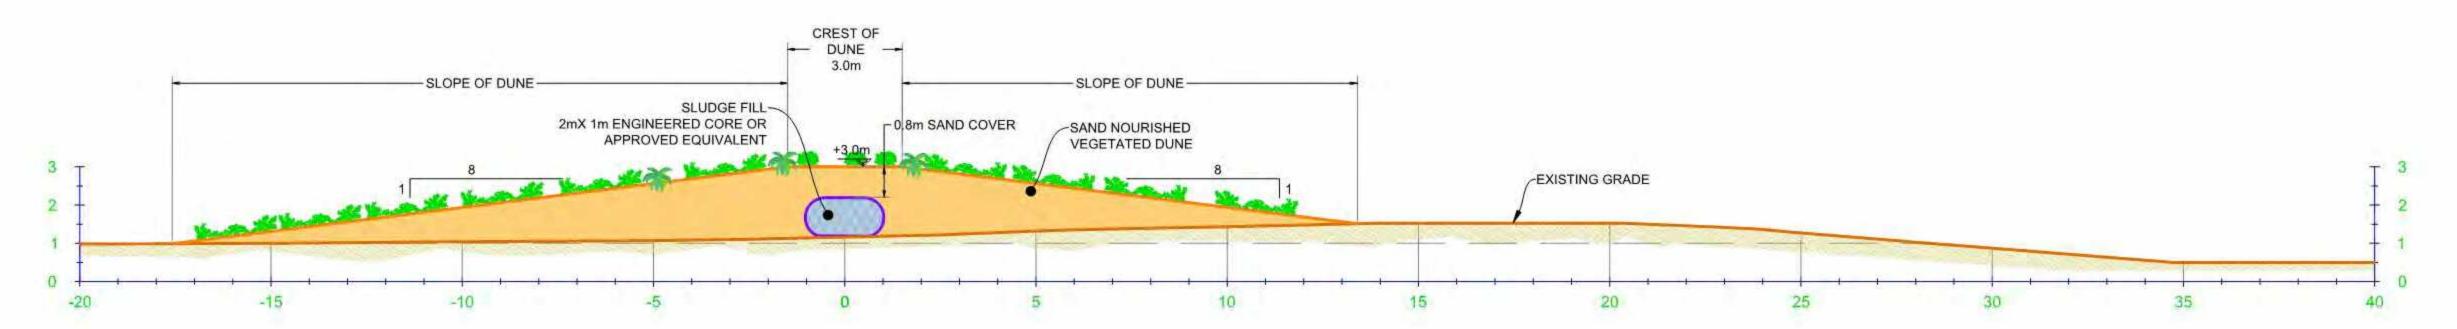
CROSS SECTION 2-2

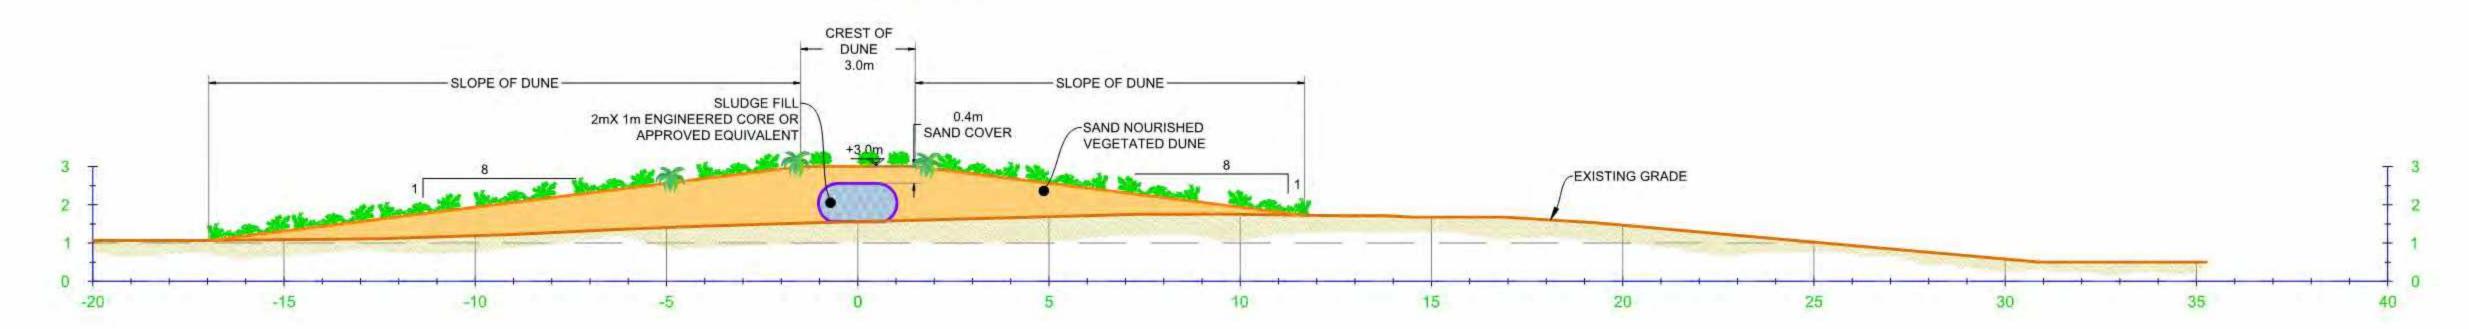
CROSS SECTION 3-3

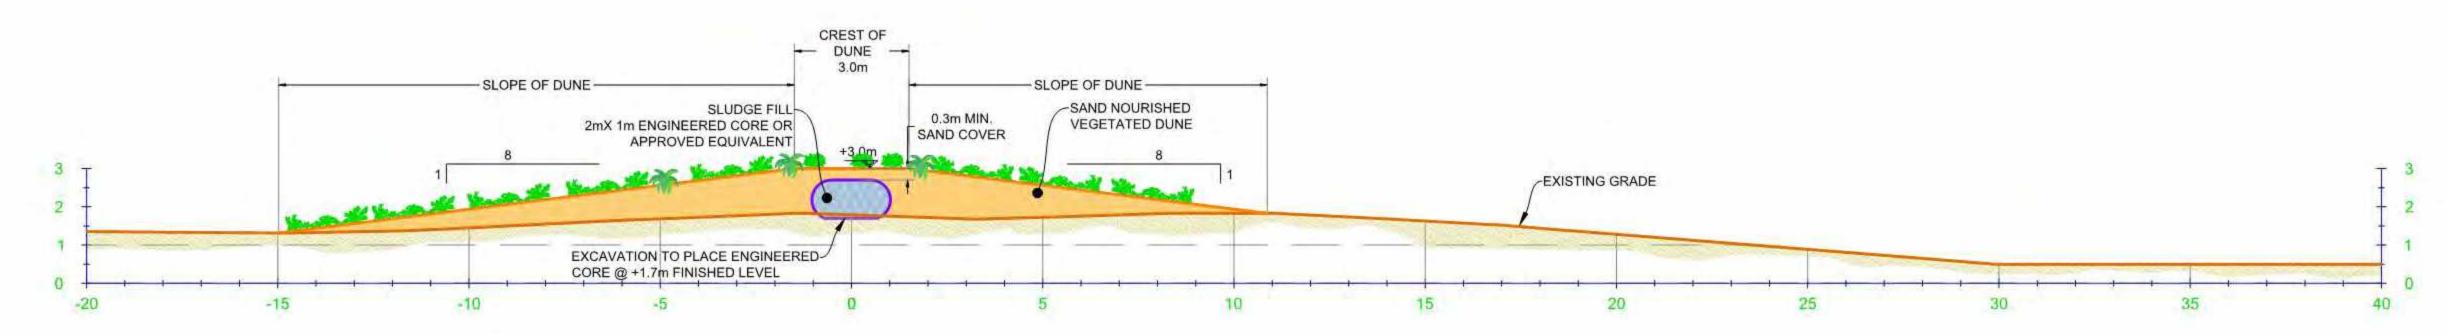
CROSS SECTION 4-4

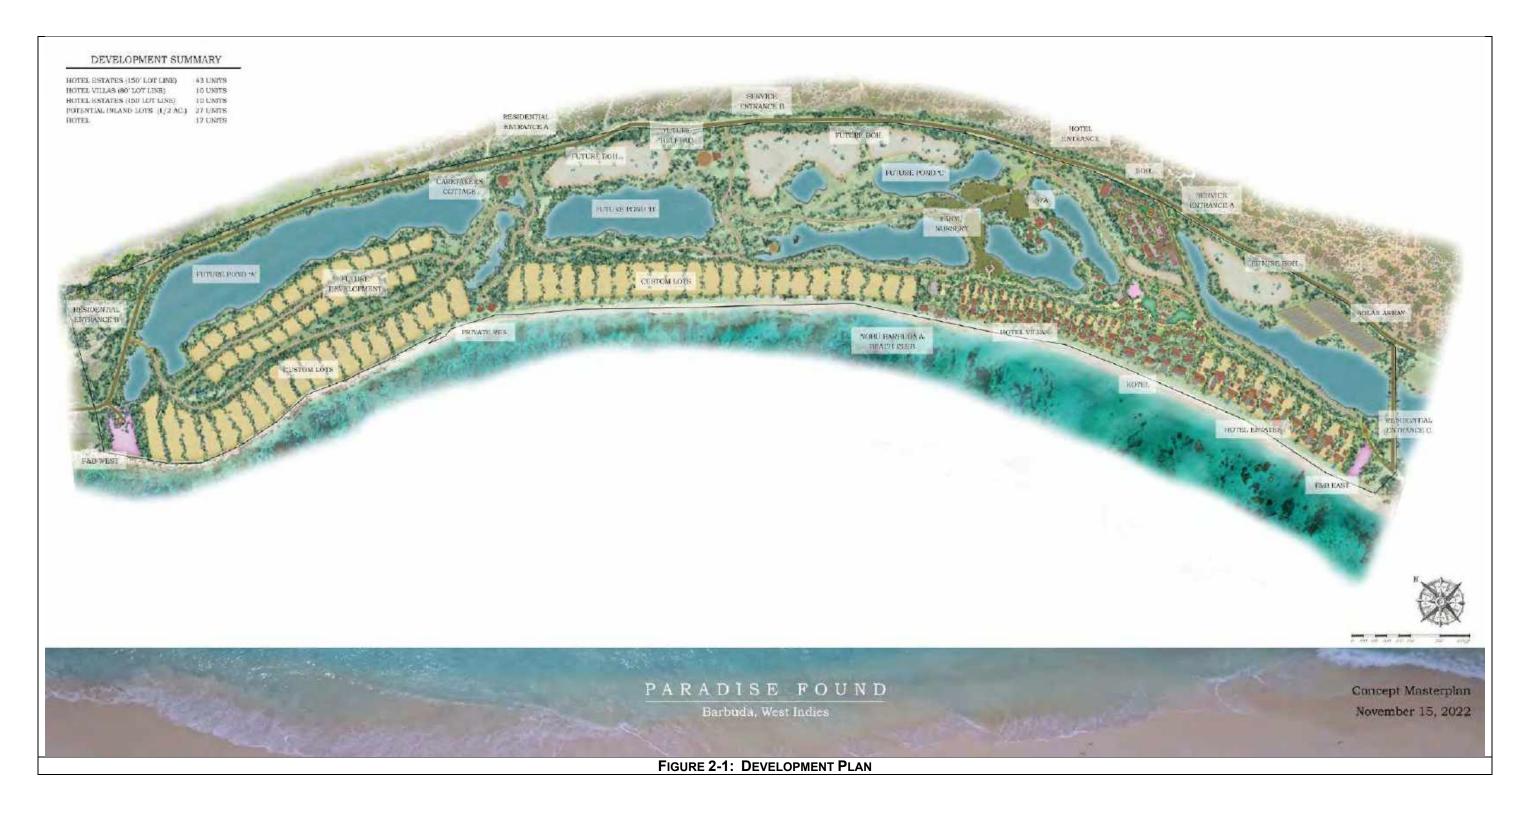
Due to the remote location of the project and the current lack of infrastructure on the island of Barbuda, the project must develop much of its own infrastructure and support facilities. The ambition of the project is that it should ultimately be as independent as possible in food, water, and energy. This is reflected in the Updated Masterplan (November 2022) which is shown in Figure 2-1.

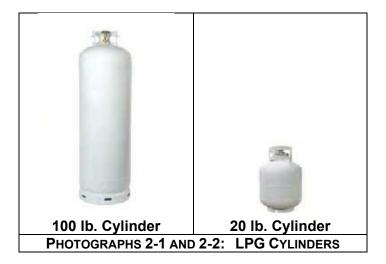
Designs have not yet been completed for these buildings, but one important feature vis-à-vis project risk is that LPG Cylinders (see Photographs 2-1 and 2-2) will be installed both at the new restaurant and at individual homes. Based on present practice, the cylinders at the new restaurant are expected to be 100 lb cylinders, while those at the individual homes are expected to be 20 lb cylinders.

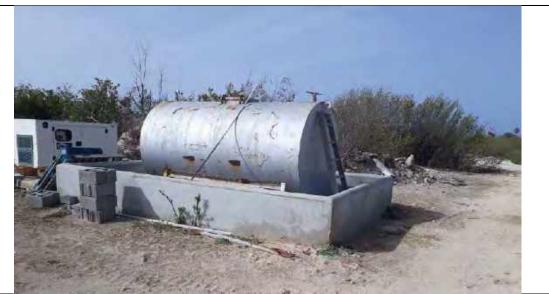
PHOTOGRAPH 2-3: EXISTING DIESEL FUEL TANK ON SITE

When fully built out, the projected electrical load demand for the Development will be 1.5MVA. Due to a lack of existing infrastructure on the island, the electrical power demand will initially be met through the use of diesel generators. To fuel these generators, diesel fuel will be stored on site in 9.1 m³ volume (2.000 imperial gallons / 2,400 US gallons) tanks (see Photograph 2-3). Over time, the reliance on generators will be phased out in favor of more sustainable options, including photovoltaic systems and battery storage. The Development will eventually seek to be energy self-sufficient from these sustainable energy sources, with generators being available to provide a degree of redundancy.
